IMCA Safety Flash 13/18

June 2018

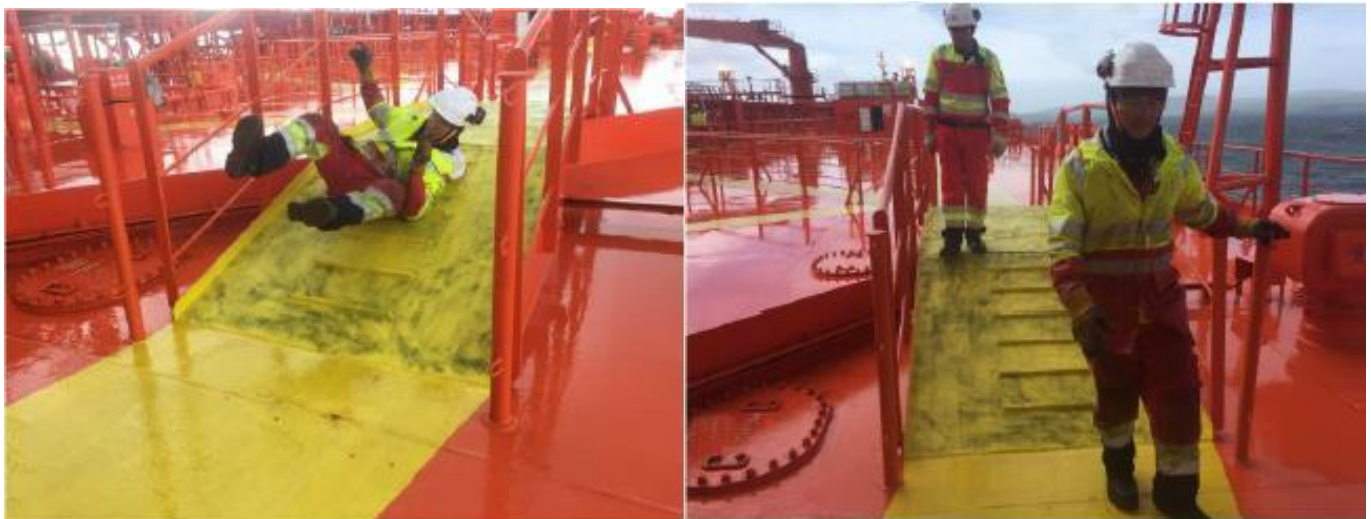
The Chief Officer slipped on a smooth section of ramping deck, landing badly and suffering a fractured elbow. The incident took place at crew change, when the Captain, Chief Officer and Engine Cadet joined the vessel. The Chief Officer and Captain walked along the yellow painted walkway to get into the accommodation. It had rained all morning, so the main deck was wet. The Captain walked over the anti-slip bars in the middle of the ramp, while the Chief Officer stepped onto the ramp and did not hold onto the railings on the side of the ramp. The Chief Officer continued walking on the smooth section of the ramp and slipped, heavily falling backwards and landing on his left elbow and buttocks.

- ♦ Direct cause: improper stepping and handling – the injured person was not holding to the railings. Additionally, he ignored the use of the anti-slip bars that were welded onto the sloping ramp to prevent slips;
- ♦ Root cause: personal factors, Inadequate identification and evaluation of hazard or risks – the Chief Officer chose to ignore a safer option of stepping onto the non-slip bars and walked on a slippery deck. He was over-confident and underestimated the risk, leading to a familiarity bias and perceived control.

- ♦ *“It’s alright, we normally doing this”* – control bias – there will be jobs that are easy to do or easy to understand and can often be regarded as routine. We feel that we are in control and tend to neglect the risk that is actually present. We should keep in mind that even if a job has been done a number of times, there will generally always be some changes, which sometimes may not be obvious or noticeable. We should be more aware of these changes, even if they are deemed to be small;

- ♦ *“The area is safe; it is newly painted with anti-skid coating.”* – expectation bias – in this instance, the crew tend to overlook the situation and other hazards that lead to an unsafe act/condition. For example: wet surface, ship movement or not holding the railings;

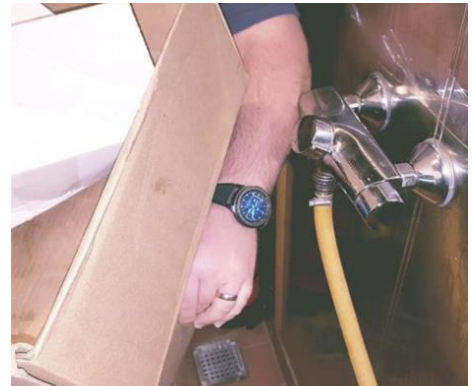
Not long after a vessel departed port, a crew member suffered a serious cut to his hand which led to an LTI. The incident occurred when he was carrying boxes through the galley and caught his hand on the sharp edge of a hose clip protruding in the transit area. First Aid was administered on-board; however, the Master deemed further medical attention was required and the vessel returned to port. The crew member was sent ashore to the local hospital where medication and seven stitches were applied. The crew member was subsequently declared unfit for work for seven days.

The offending sharp edge was quickly covered to prevent further injury. The crew member had only been on-board for two days and it is likely that he was not fully appraised or aware of the hazards in his new work area.

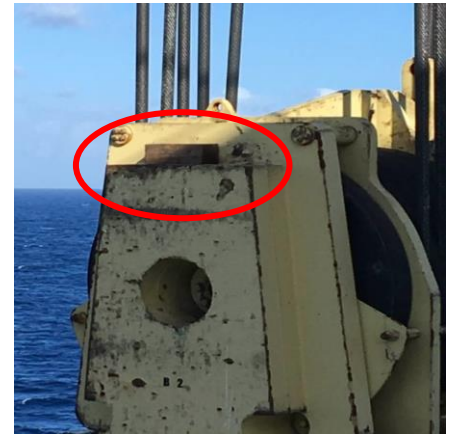
During a voyage in good weather conditions, the Captain decided that the vessel would sail with the cranes secured on deck. On the second day of the trip, the Captain was looking at the main hoist block of the forward crane, which was secured at the same height and just behind the bridge, when he noticed a 30cm long piece of 10x10 timber lying on the side of the hook.

The piece of timber was most likely placed there during a re-reeving operation some months previously, although the investigation could not confirm this and it may have been there even longer. The piece of timber was immediately removed.

- ◆ Ensure that your work area is suitable for using loose equipment (lying on deck, platforms, gratings);
- ◆ Ensure that your work area is checked for loose equipment during your job;
- ◆ Ensure that your work area is cleared up after completion of your job;
- ◆ It is good practice to use a tool lanyard when working at height with tools.

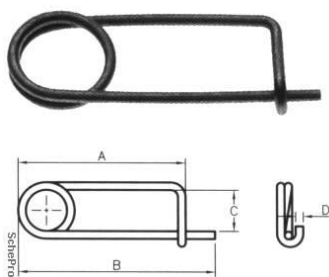
After discussing this incident with the crew, it was clear that the pin was secured with a safety pin of the correct size. What was not known was if the safety pin was still in good shape and not bent open or damaged in any other way. Also not known was if the safety pin fell out of the securing pin by itself (gravity) or if the steering line somehow pulled/pushed the safety pin out.

There was no direct force on the securing pin by the grommets. Due to the rigging, the spreader beam was twisted; it was horizontal but twisted some 30 degrees around its axis. This caused the pin to slide out when the safety pin was gone. The safety pin was not found after the incident.

A new kind of safety pin was introduced

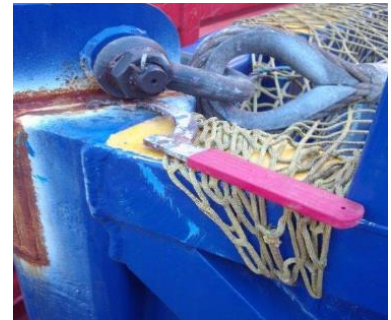
- ◆ Safety alert 18-15: [Potential Dropped Object](#)

During deck cargo operations at an offshore installation, as a container was received on the installation landing platform the crane operator reported that a potential dropped object had been discovered on top of the container. The object was discovered to be from the supply vessel; the previous day, the supply vessel crew had conducted a fire training drill, which included rigging hoses on the main deck amongst the deck cargo. A lapse in attention by the individual using the tool and a failure in the post-work inspection meant that the tool was left on top of the container on completion of the fire exercise. The photographs show that this object was both conspicuous (red handle against blue coloured container) in appearance and left in a conspicuous position on the container. The object ought to have been discovered and removed post exercise.

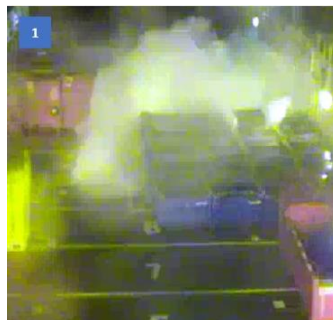
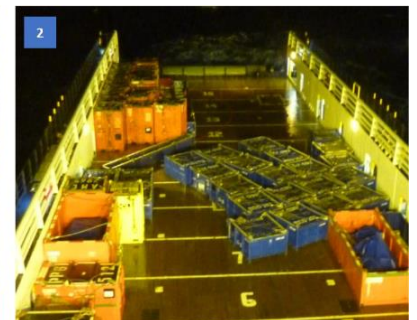
- ◆ Safety alert 18-13: [Cargo Shifted on Deck - High Potential Near Miss](#)

Unsecured cargo, including a 24' basket and 20 mud skips, shifted across the deck when a wave, significantly larger than forecast, passed the vessel. The vessel had been alongside a platform working cargo earlier in the day, but owing to the deteriorating weather conditions, the vessel ceased work and departed the 500m zone. The cargo was unsecured to facilitate cargo operations, and was not re-secured on departing the 500m zone. As conditions improved (to Force 6, 2.5m seas) preparation was made for re-entry to the 500m zone, and at this point, the large wave struck.

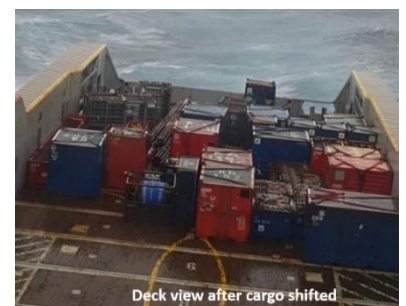
- ◆ Safety alert 18-14: [Deck Cargo Shifted – High Potential Near Miss](#)

A wave struck the stern of a platform supply vessel (PSV) and caused the cargo to move. The incident occurred whilst the PSV was working both stern to weather and stern towards the rig. Wind was 19 m/s and there was a significant wave height of 3.2m. As the cargo operation was about to start, a large wave hit the stern of the ship and water came over the deck. This resulted in shifting cargo; one crew member was located on the deck in an unsafe position, close to the containers. No personal injuries resulted.
