IMCA Safety Flash 14/14

August 2014

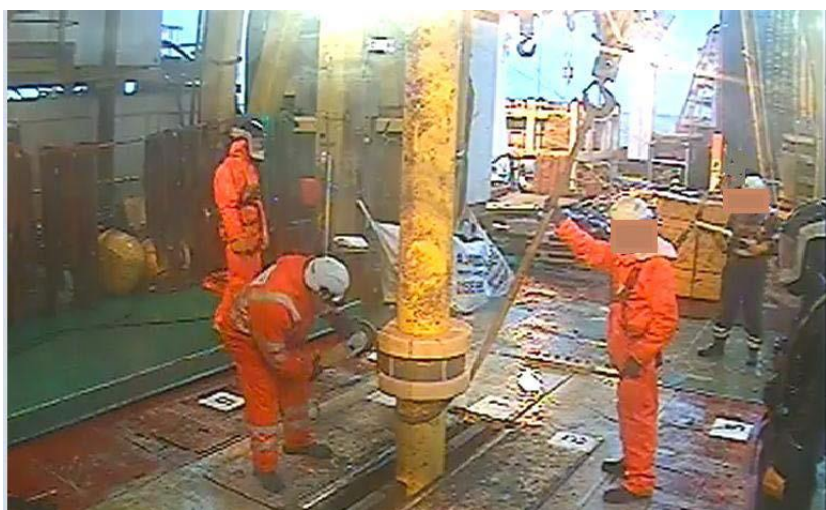
During this recovery process, the incident occurred during removal of the final inner clamp. As a clamp securing strap was being cut, it failed unexpectedly causing the four inner parts of the clamp to fly off in various directions.

Figure 1: typical set up immediately prior to cutting band securing inner clamp

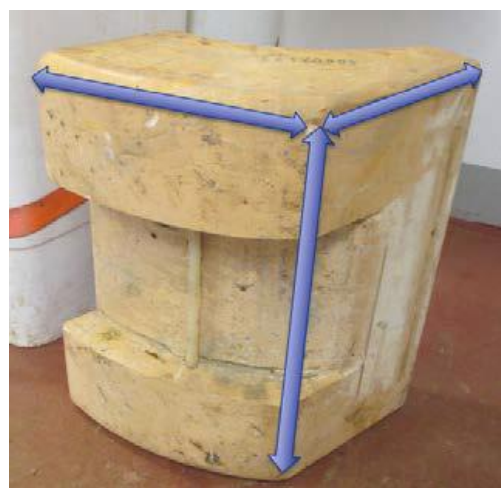
Figure 2: one of four blocks that make up inner clamp, each approx. 20cm x 25cm x 35cm and weight circa 6 kg.

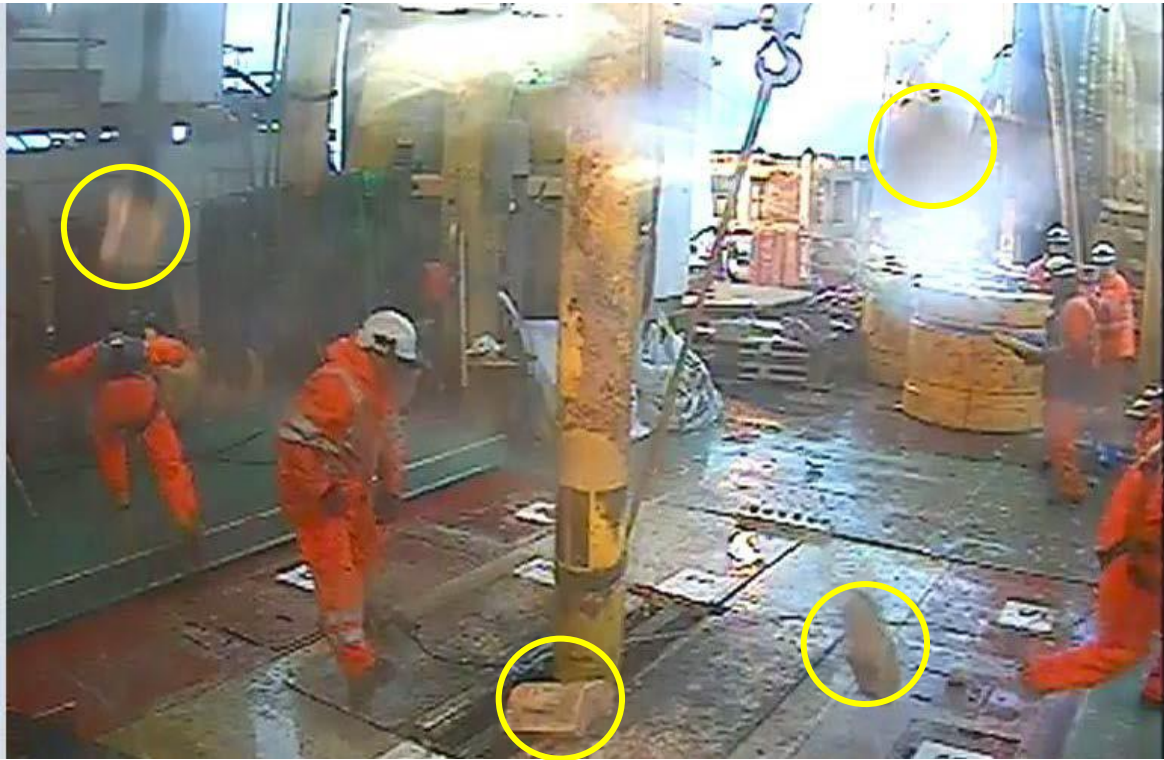
Figure 3: screen capture from a camera shows the blocks being ejected from the clamp arrangement on the riser. (yellow circles indicate the moving blocks)

- ◆ Recent changes to the methodology for removing the clamp were not subject to a Management of Change process;
- ◆ These changes were not seen as significant enough to warrant the Management of Change process; however the changes introduced hazards which had not been risk assessed;
- ◆ The sling fitted below the clamp was over tensioned causing an upward force to be applied and ultimately the clamp to fail unexpectedly;
- ◆ The change to use the sling to stop the clamp falling to deck once cut was perceived as an improvement but the potential risks introduced by this change were not considered.

If there are any doubts about the operation take the time to stop work and reassess the situation. Any changes to procedures should be subject to the Management of Change process regardless of how minor they may initially appear.

- ◆ Reassessed the availability of task procedures and risk assessments;
- ◆ Checked on how well crews understood the above and how they reflect the way the job is actually being carried out;
- ◆ Ensured that when changes are made to improve how a task is carried, that all possible negative effects are fully considered;
- ◆ Ensured that during development of new procedures, adequate consideration is given to getting input from end users.

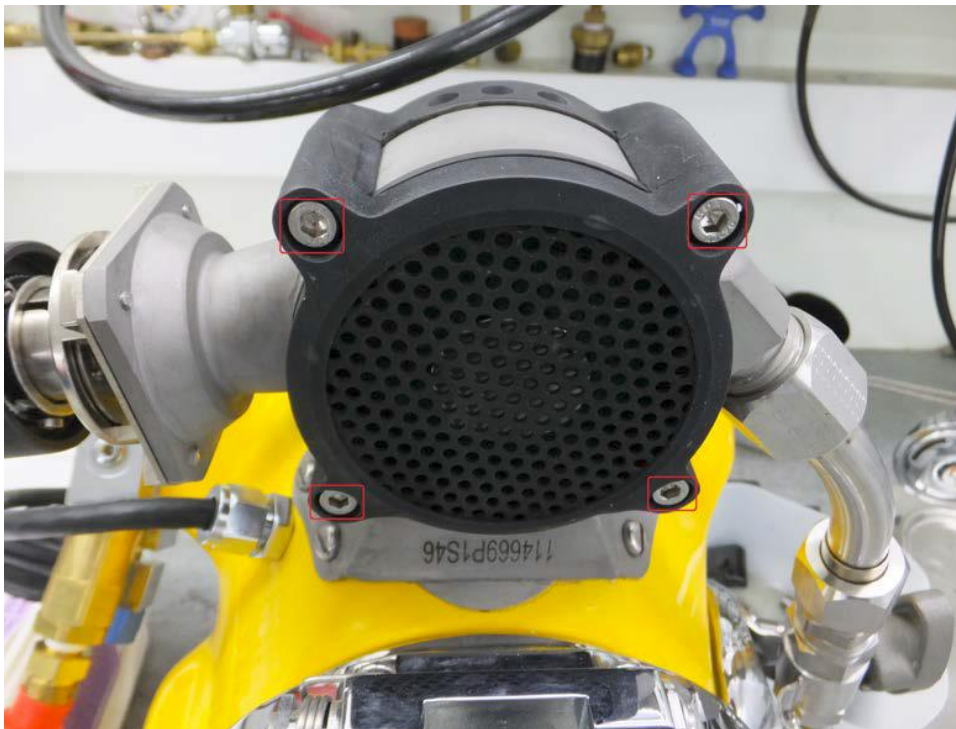
A member has reported a case of incorrect length retaining screws being found fitted to an Ultrajewel 601 diver's helmet, exhaust valve cover assembly. This was discovered by vessel crew carrying out maintenance on a newly received I7C Ultrajewel 601 helmet. The jewel cover (Item 17, Part Number: DM022), retaining screws (Item 18, Part Number: FB240) had been cut down in length and as a result did not give the required thread engagement. The correct length of the screw was 35mm as indicated within the part description column.

Figure 1: showing screws highlighted in red

- ◆ Only use correct screws when maintaining life support equipment and as supplied by the equipment manufacturer;
- ◆ Ensure that any held stock of the screw is adequately controlled to prevent migration into other stocked item locations and that storage bins or bags are clearly marked with the manufacturer's part number;
- ◆ Only trained and competent personnel should be maintaining life support equipment;
- ◆ Never modify manufacturer supplied parts.

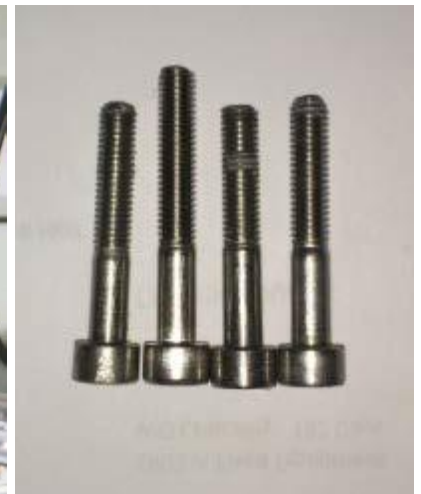
Following the incident an inspection of the screws revealed that three of the four screws fitted had been cut back to varying lengths. The loss of thread certainly severely reduced the amount of thread available to satisfactorily clamp the exhaust valve cover assembly together. Loosening of the screws during use and the eventual separation of the jewel cover assembly could have caused a serious incident.

Figure 2: screws of varying lengths

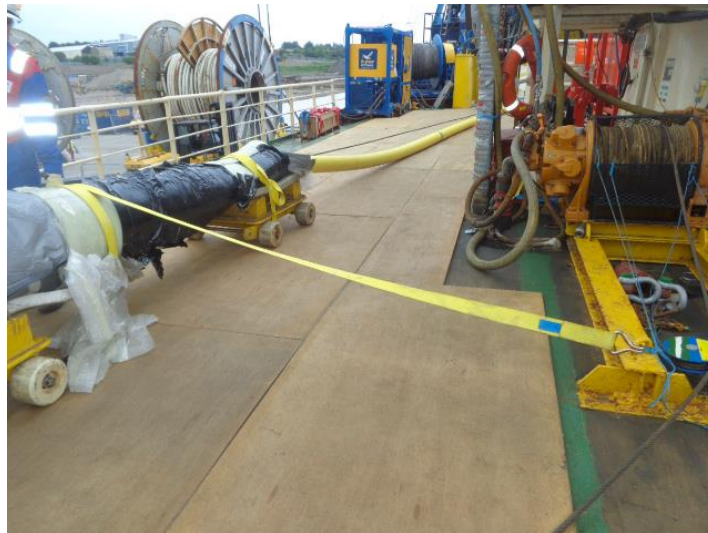
A member has reported an incident in which a crew member fell over a trip hazard on deck and broke both elbows as a result. The incident occurred on a vessel in dock. The injured person was walking towards the stern area to assist the other team members with the next task. En route, he attempted to step over a cargo strap. His foot caught on the strap; he tripped, lost balance and fell forwards, hitting the deck. He instinctively raised his arms in an attempt to lessen the impact of the fall, which resulted in him sustaining two broken elbows.

- ◆ There were no barriers in place or marker tape to highlight the hazard. Additionally, there was a safe route around the hazard which could have been taken;
- ◆ Although trip hazards, generally, were highlighted in the Risk Assessment and in the Toolbox Talk, this hazard was not highlighted individually;
- ◆ Notwithstanding the lack of barriers and with a safe alternative route available, this incident included behavioural based safety characteristics, with two crew members choosing to step over the cargo strap, rather than take the safe route. A second crew member stepped over the strap, just before the injured person did, and was uninjured. Lack of an accident/incident does not demonstrate adequate control.

Figure: showing deck and cargo strap

- ◆ There were numerous failures, omissions and deliberate actions that led to the incident:
 - Inadequate planning/risk assessment – without a cordon or other appropriate barriers/markers, this hazard presented an obvious risk, which was not specifically identified. Failure to adequately identify all hazards can result in accidents
 - Inadequate safety controls/warning signs
 - Lack of awareness/perception of risk
 - Lack of attention/due care/poor work practice
 - Poor decision-making/judgement
 - Lack of adequate Toolbox Talk, Risk Assessment and Hazard Identification.

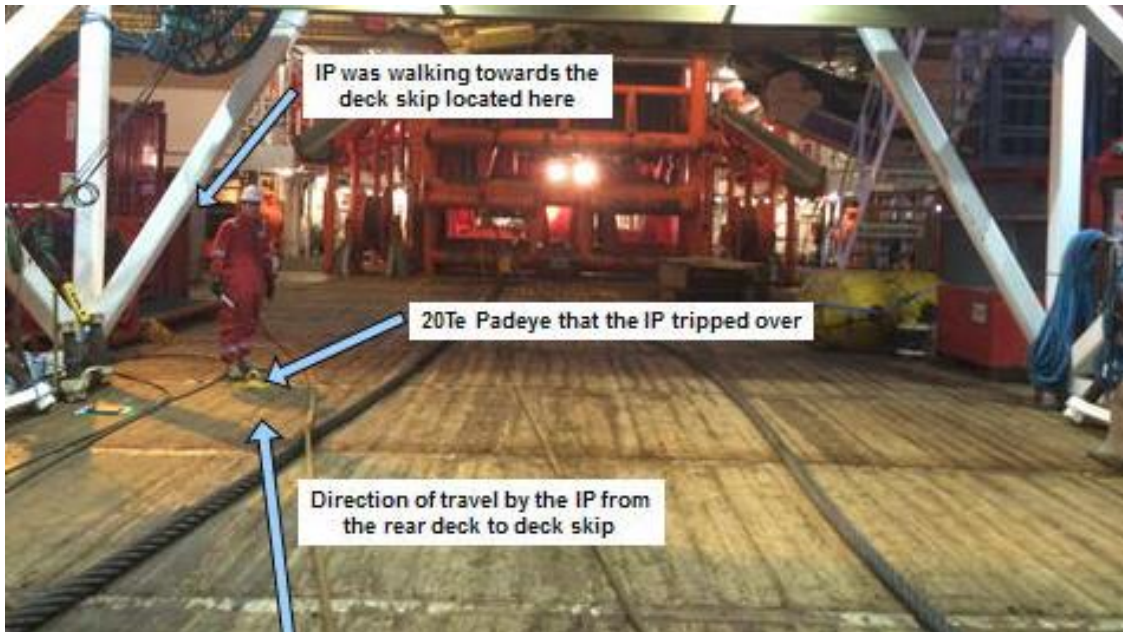
A member reported an incident which someone tripped over, fell and was injured whilst working on the deck of a vessel. The incident occurred during work on the rear skid of the backfill plough on the starboard side of the vessel. The injured person required something to kneel on. He proceeded to walk forward on the deck from the aft of the vessel towards the deck skip. He then tripped over a 20Te pad eye, lost his balance and fell over, landing on his right shoulder and arm. The injured person was taken to the vessel hospital; the vessel returned to port to allow the injured person to be transferred to a shore-side hospital for further treatment.

Figure: showing deck where injured person tripped

- ◆ It has been identified that the pad eye was not actually required until the next interim mobilisation, and hence the incident could have been prevented;
- ◆ Inadequate planning/risk assessment – without a cordon or other appropriate barriers/markers, this hazard presented an obvious risk, which was not specifically identified. Failure to adequately identify all hazards can result in accidents;
- ◆ Inadequate safety controls/warning signs;
- ◆ Lack of awareness/perception of risk;
- ◆ Lack of attention/due care/poor work practice.
