IMCA Safety Flash 14/18

July 2018

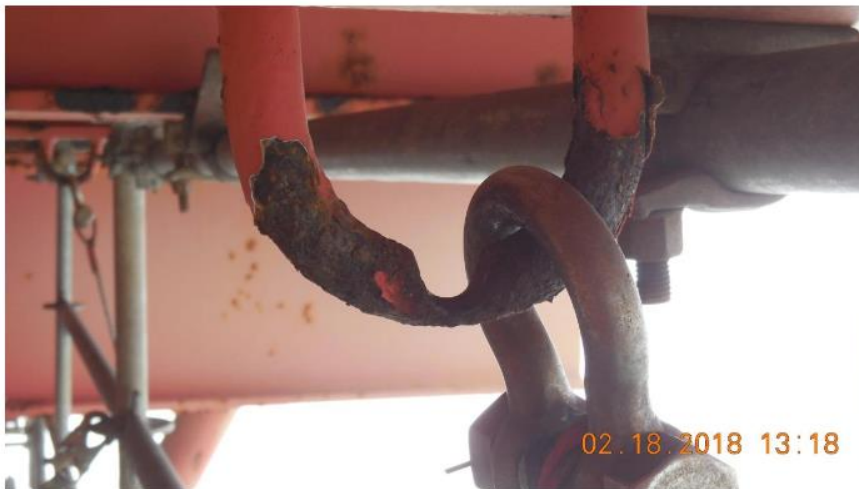
BSEE inspector's photograph of swing rope in place on a Gulf of Mexico facility

- ◆ Review the BSEE safety alert with all personnel who transfer to facilities via swing rope or personnel baskets;
- ◆ Before personnel transfer, inspect and test all hardware associated with the operation and report any deficiencies found;
- ◆ Stress the significance of patience, weather and sea conditions, and the use of the 'stop work authority';
- ◆ Consider developing fitness for duty requirements for personnel involved in transfers.

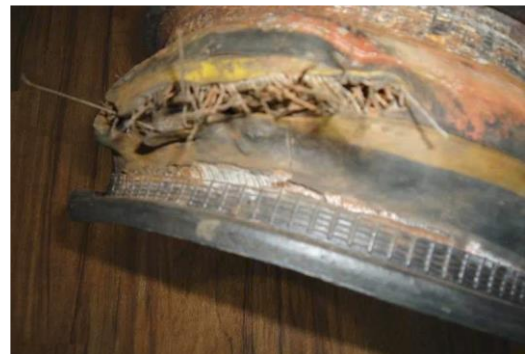
During a trial of fire-fighting equipment, a hose expansion joint or bellows failed. The release of pressurized water hit a crewman who was standing nearby, slamming him backward and knocking him unconscious. The fire pump was shut down and help was sought. CPR was administered; subsequently the injured person was medevaced.

- ◆ There was inadequate management of significant risk;
- ◆ There was no understanding of the life time of the expansion joint or bellows;
- ◆ There was no installation procedure provided for this bellows by the manufacturer;
- ◆ There was no preventive maintenance or inspection/testing of the failed equipment.

- ◆ There had been a similar rupture of a bellows some years previously; this earlier incident was not investigated. Had it been investigated, it might have helped in preventing reoccurrence;
- ◆ Engineering and design of critical equipment during new building should take into consideration personnel safety as well as equipment protection;
- ◆ There needs to be a better design review of pressurized equipment, particularly where different components are in use.

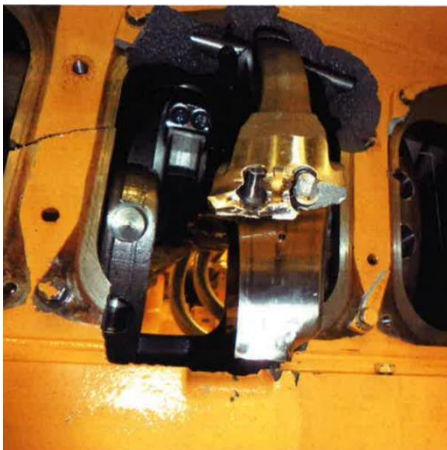
A severe engine failure occurred during a major vessel overhaul. The connection rod on cylinder #12 parted from the connecting rod cap and punched a hole in the engine block. The engine had been running for 17 hours, carrying approximately a 20% load.

Showing the connection rod on the cylinder blown through the engine block

Failure to change out and correctly torque up four temporarily installed connection rod bolts. The four bolts were temporarily installed. Preliminary investigation revealed high pressure on work schedule, poor handovers, lack of checklists and incorrect marking of cylinder #12.

- ◆ Focus on correct and sufficient management of change (MoC) and handovers processes;
- ◆ Use of checklists and marking/signage during work on engines;
- ◆ Limit personnel exposure during start-up of overhauled engines.

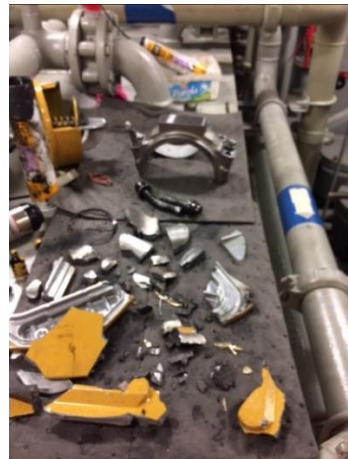
Parts of the engine block were found spread around the engine room, indicating that the outcome of the event could have been much worse, with potential for personnel injuries and a fire. At the time of the event, the engine room was vacated for lunch. No injuries were sustained, there was no spill of fluids and no fire.

Debris found spread around the engine room

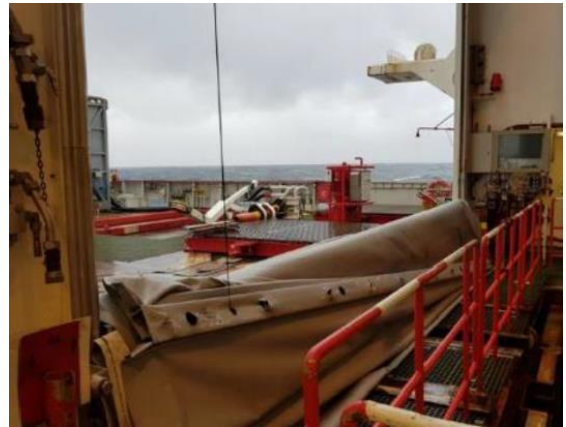
Whilst a vessel was working, there was a failure and collapse of the moonpool hangar doors. Deck crew were working in the area of the moonpool, when they heard a loud bang. When they turned around they could see that the hangar door had fallen down and folded in the guide rails. The door was 7.2 meters wide, 13 meters high and weighed approximately 200 kg. There were four crew members in the hangar at the time of the incident.

The suspension points for the hangar door leaf had failed.

- ◆ Inadequate and weak design for holding hangar door leaf to head box;
- ◆ Increased wear and tear because there were no formal instructions or procedure for the operation of the hangar door;
- ◆ Possible additional wear and tear due to suction from the moonpool;
- ◆ Hangar doors were not part of the recommended planned maintenance system (PMS), and it was not possible to inspect the suspension points holding the door leaf.

- ◆ Implemented proper instructions for the operation of hangar doors and updated familiarization;
- ◆ 6mm stainless steel flat bar was installed inside an aluminium profile holding the folding door to header box in order to make the construction more rigid and solid;
- ◆ Installed safety lashings to prevent the folding door upper mount from falling to deck if overloaded.
