IMCA Safety Flash 15/18

July 2018

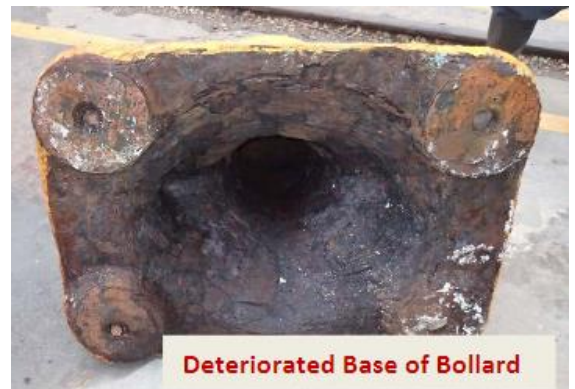
The alert covers recent shore side marine bollard failures whereby moored vessels were cast adrift. In some cases, this resulted in damage to the involved vessel, as well as other nearby vessels and shore side structures. Thankfully, there were no related injuries or deaths.

- ◆ Rotted pilings;
- ◆ Possible pre-existing fractures;
- ◆ Failure of base castings;
- ◆ Deterioration of base of bollards.

The USCG strongly recommended *“that facility owners and operators take steps to develop a routine inspection program for bollards and other mooring equipment. Furthermore, vessel personnel should report discoveries of apparently deficient shore side mooring equipment to facility managers.”*

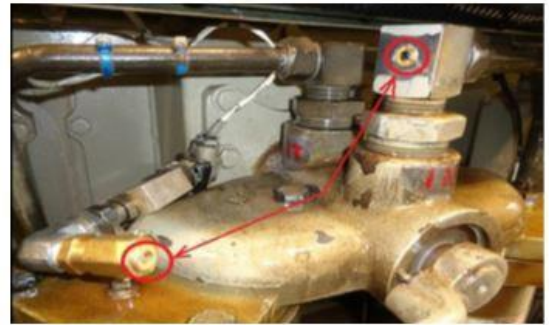
Failed connection as found by duty engineer

Upon further inspection, it was found that the fuel oil secondary filter differential pressure sensor isolating valve on the port main engine had cracked, and this was causing the fuel spray. Approximately 1m³ of fuel was lost.

- ♦ The failure of the valve was caused by a combination of engine vibrations and the weight of assembly acting on the male threaded section of the brass valve;
- ♦ The pipe arrangement had been altered from the original set up because of pressure fluctuations – this interfered with the proper functioning of the sensor; the MSF notes that the long-term effect of this alteration was perhaps not properly assessed by the manufacturer prior to this alteration.

- ♦ Replacement of the brass valve fitting with a stainless-steel equivalent;
- ♦ Addition of a deflector plate above the valve to prevent future failure and prevent fuel spray from reaching the hot engine.

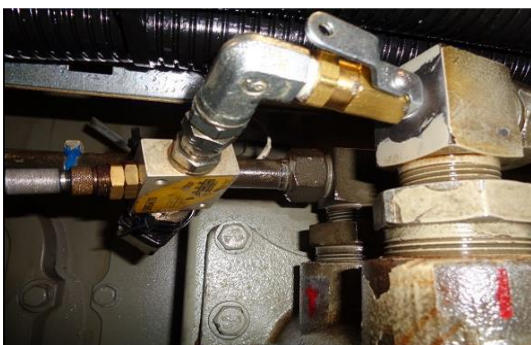
Connection after initial temporary repair

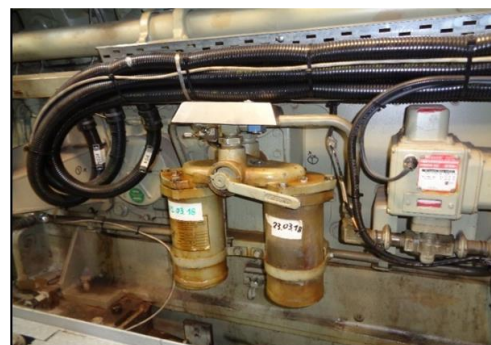
Deflector plate fitted to prevent fuel being sprayed onto the hot areas of the engine

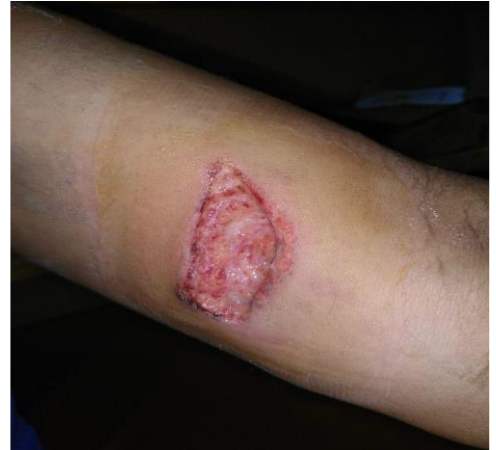
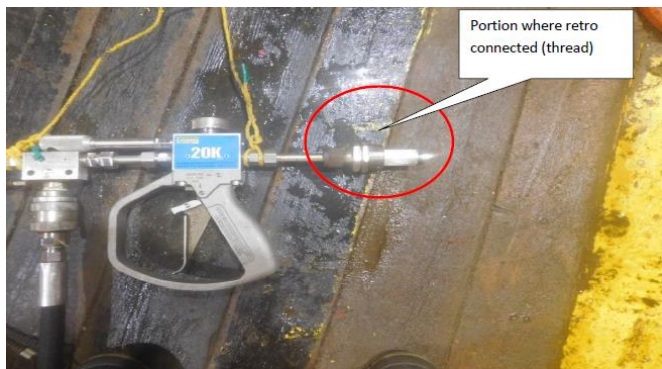
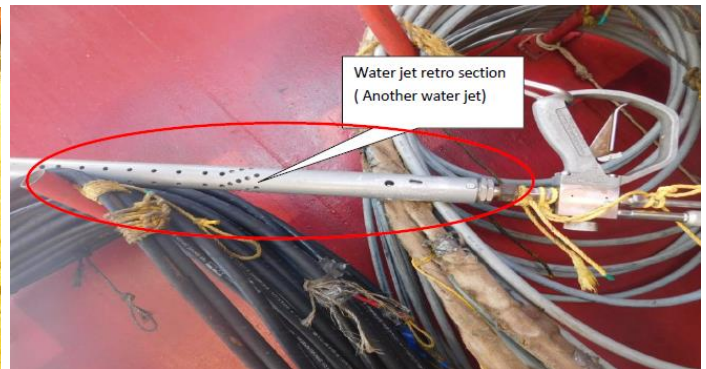
A saturation diver suffered a lost time injury (LTI) to his left arm during subsea high-pressure water jetting operations. The incident occurred when the water jet gun failed, and a part came off the gun. The diver was recovered to the bell and the water jet gun to the surface. The diver received first aid in the bell and further treatment later in the chamber. He was subsequently decompressed and transferred to hospital. Though an LTI, the injury was not severe, and it was expected that the diver would return to his duties within months.

- ◆ Equipment failure: locking bolts on the water jet retro came loose;
- ◆ Unsafe design or construction: locking nuts did not have a holding mechanism besides the threads available;
- ◆ Improper worker training/familiarization: manufacturer manuals provided were not available at worksite. There was no awareness of the need for a planned maintenance system (PMS) for high pressure equipment of this sort;
- ◆ Improper maintenance: it was observed during investigation that maintenance was not carried out in accordance to manufacturer's recommendations.

- ◆ Management of change (MoC) prepared for required changes;
- ◆ Ensure equipment is maintained in accordance with [Code of practice for the use of high pressure jetting equipment by divers](#) (IMCA D 049) and any manufacturer's recommendations;
- ◆ Additional controls put in place to ensure the water jetting equipment is in safe condition, including checking condition of diffuser and locking nuts;
- ◆ Further awareness briefing given to dive team regarding checks of the equipment as per the manufacturer's recommendations.

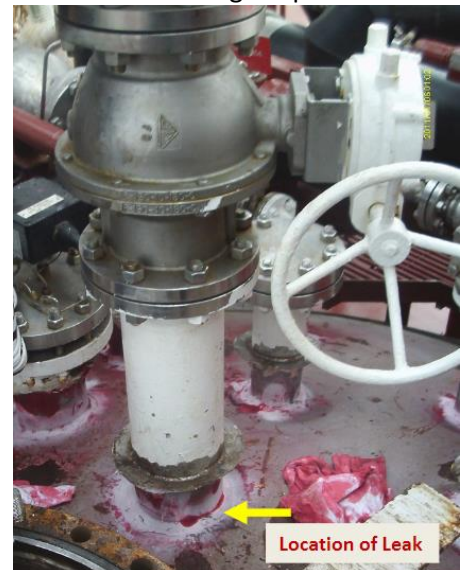
During an examination of a liquefied natural gas (LNG) carrier whose cargo tanks contained ethylene vapors, CO (Carbon Monoxide) gas alarms were received which were traced to an eight-inch crack on a cargo vapor line.

It was noted that the molecular weight of Ethylene (28 g/mol) was identical to the molecular weight of CO, which accounted for the CO PPM readings. Coast Guard personnel contacted the manufacturer who confirmed that gases such as methane, propane, ethylene and mercaptan, could actuate the CO sensor without ever coming into the range of the LEL limits.

As a result of these events the Coast Guard *“strongly reminds all surveyors, marine inspectors, port state control examiners, and any other persons utilizing portable gas monitors and detectors while working onboard on Liquefied Gas Carriers to remain acutely aware that the ethylene gas vapors can exhibit cross-sensitivity. This issue is not limited to the monitors that the Coast Guard uses but also those made by other manufacturers. Everyone using a monitor must be aware that if the CO alarm goes off it may be an indication of dangerous gases or chemical vapors and not the presence of CO. When the alarm sounds users must take corrective action to minimize exposure risks.”*
