## IMCA Safety Flash 16/14

October 2014

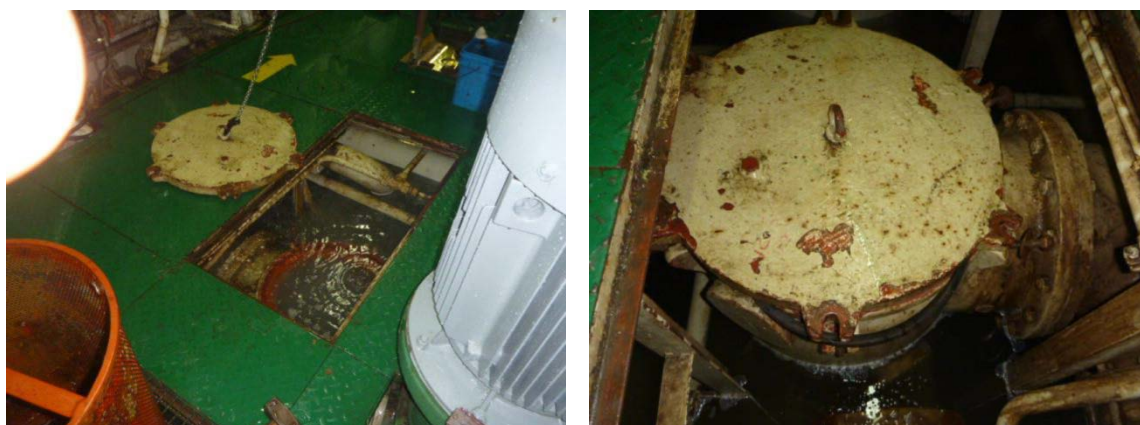
Figures: showing flooding (left) and cover plate of sea strainer (right)

- ◆ **Root cause:** malfunctioning of one of the actuators of the valves in the ballast pipelines caused the valve to close in 1.5 – 2 seconds (normally 15 – 20 seconds). This created a pressure shock in the ballast system. Subsequently, this pressure shock caused the cover plate of the sea strainer to blow off;

- ◆ The actuator of the valve which was closing in 1.5 – 2 seconds was replaced by vessel crew in early 2014 without verification of the opening/closing time of the valve;

- ◆ **Root cause:** communication between engine room personnel and bridge personnel was not sufficiently detailed; this resulted in incorrect actions being taken which caused a worsening of the situation;

- ◆ **Root cause:** ballasting procedure of manufacturer was not followed. The recommended procedure described that pump(s) should be stopped before operating valves in the ballast lines. This was not followed.

- ◆ Introduced vessel-specific procedures for ballasting and added this instruction to the official document list of vessel;
- ◆ Following the hierarchy of control, the company recognised it could not eliminate nor substitute the ballast process on board. Therefore, it focused on the following engineering controls by:
  - improving visual presentation for valve operations on the bridge to emphasize valve position and open lines in the ballast system

- introduction of interlock system to eliminate simultaneous operations of valve(s) and pump(s).

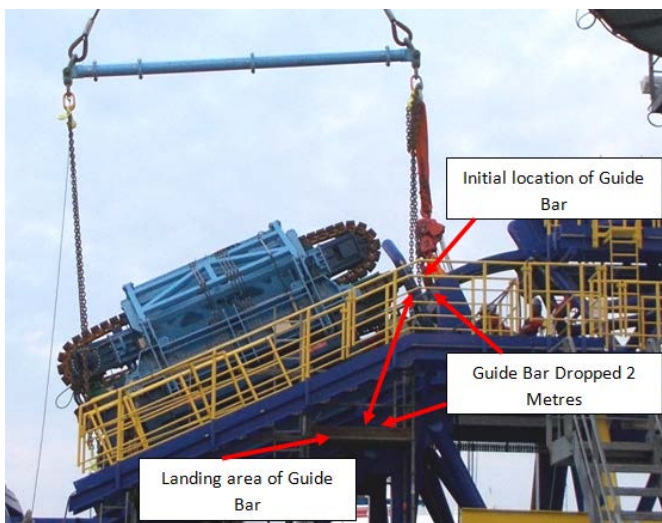
A member has reported an incident in which an object of 100kg fell 2m onto a scaffold platform. The incident occurred in port during the removal of a 55t tensioning mechanism from a horizontal lay system (HLS) on board a vessel. The tensioner was pre-rigged with primary rigging to the main crane and auxiliary rigging to the upper side of the horizontal lay system. The strain was taken on the rigging to allow the unbolting of the tensioner from the HLS. Once the bolt removal was complete the deck foreman instructed the crane driver to take more load on the crane. When the crane took more load on the primary rigging the rigging came into contact with the product guide bars and pushed a guide bar off the horizontal lay system. The guide bar weighed 100kg and fell 2m onto a scaffold platform on the HLS. There were no injuries.

Figure 1: taken after the guide bar had been pushed off the horizontal lay system

Our member was made a number of modifications to the design of the horizontal lay system, in order to prevent recurrence:

- ◆ Limit the requirement for auxiliary rigging to install or remove a tensioner;
- ◆ Fit end stops onto the guide bar slide guides to stop them being pushed off the HLS.

Our member noted that all future lift plans or procedures with respect to the HLS should ensure that the guide bars are removed before installation/removal of a tensioner, or securely lashed together to ensure they do not come into contact with any rigging.

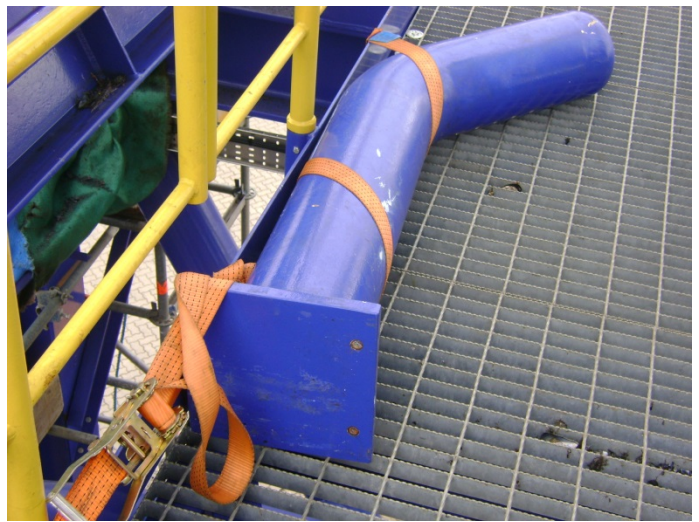
Figure 2: guide bar

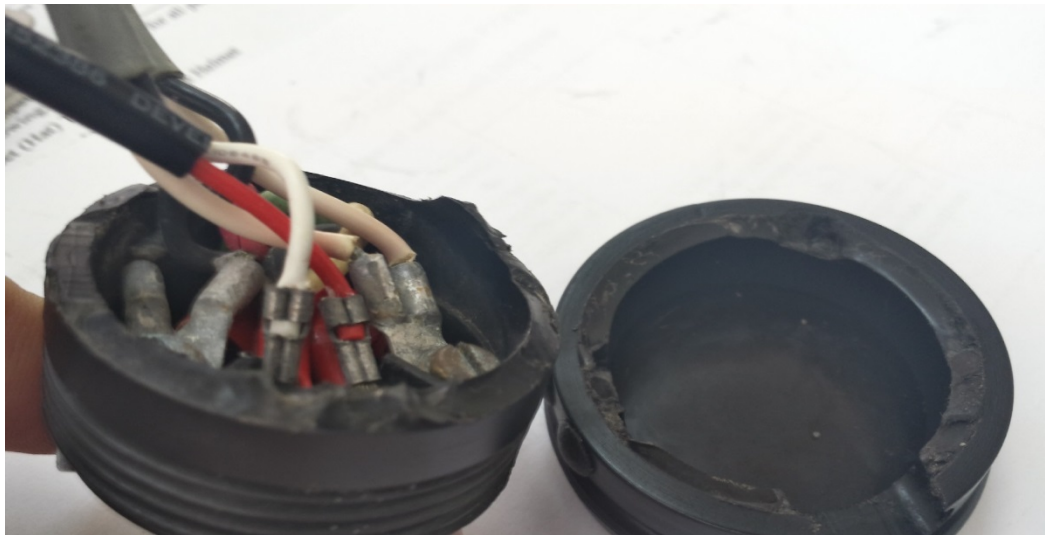
Figure: showing broken helmet communications module

- ◆ The module had never been removed from the helmet;
- ◆ The helmet had been in storage for several years since purchase with minimal use;
- ◆ Water temperature was less than 2°C; Depth: 12 msw;
- ◆ No tool marks were found on the securing nut to suggest over tightening.

The failed module was sent to the supplier for inspection and analysis. The supplier inspected the part and performed in-house testing of off the shelf inventory overstressing at worst case levels. It was reported the parts withstood extreme stress tests at elevated and sub-freezing temperatures and passed all inspection criteria. The supplier found that failure of the module appeared to be an isolated case and referred the member to Kirby Morgan Bulletin #1 of 2009.

- ◆ Supplier would include, in checklists, that the module should be regularly loosened and retightened during checks, by hand;
- ◆ Inspection of all such communications modules - none found with potential failure indications, even in older helmets in more frequent use;
- ◆ A recommended inspection/check process was initiated.

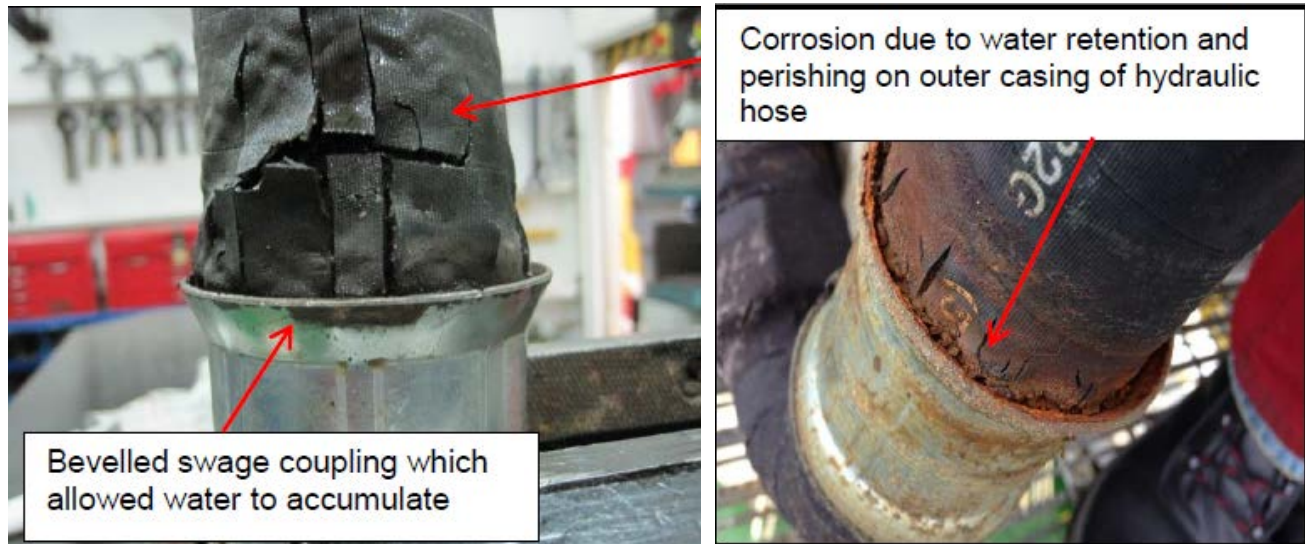
Figures: showing damaged hoses (upper red arrow on left image indicates ruptured area)

- ◆ The ruptured hoses were badly corroded;
- ◆ The design or assembly of the hydraulic fittings had allowed water to accumulate around the neck of the fittings;
- ◆ The collection of water had eroded parts of the hoses resulting in the ruptures;
- ◆ Other hoses onboard were found to be in a similar state;
- ◆ The inspection of the vessel crane hydraulic hoses was conducted by vessel crew and a third-party contractor. The most recent inspection had taken place four months previous to the incidents occurring. It was found the crew and the third party inspection team had not removed the 'denso' tape wrapped around the hose fittings, thus the corrosion was not visible;
- ◆ It was apparent that the corrosion on the hoses had occurred over a long period of time and this should have been spotted by the inspection by vessel crew and contractor, and noted in their report.

Our member immediately replaced the badly corroded hoses and undertook an investigation to ascertain why the contractor and crew had not identified the corrosion during the previous inspection. It was found the 'denso' tape was not removed from hose fittings during these inspections and as a result the corrosion was not visible. Removal of 'denso' tape from hose fittings is now required for all future inspections.
