# IMCA Safety Flash 16/15

October 2015

### I Older "Norfolk Range" Powder Extinguishers from Before 2009

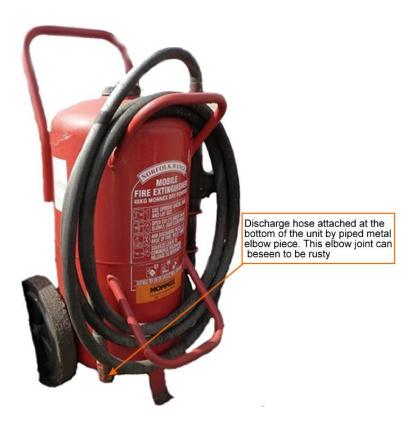
The UK Health and Safety Executive (HSE) has published the following alert regarding a fault in older "Norfolk Range" large dry powder fire extinguishers, manufactured in the United Kingdom before 2009. These extinguishers may be affected by moisture ingress at a threaded joint at the base of the unit, rendering the unit inoperable. The problem may not be identified during routine service inspections.

Type of large dry powder extinguisher affected

Users should identify if their extinguishers are likely to be affected. If yes, and the extinguisher has been left exposed to adverse conditions since its last extended service, the condition of the elbow joint at the base of the unit should be examined by a competent service engineer.
