IMCA Safety Flash 17/15

October 2015

I High Potential Near Miss: Failure of Lifeboat Release Hook Mechanism

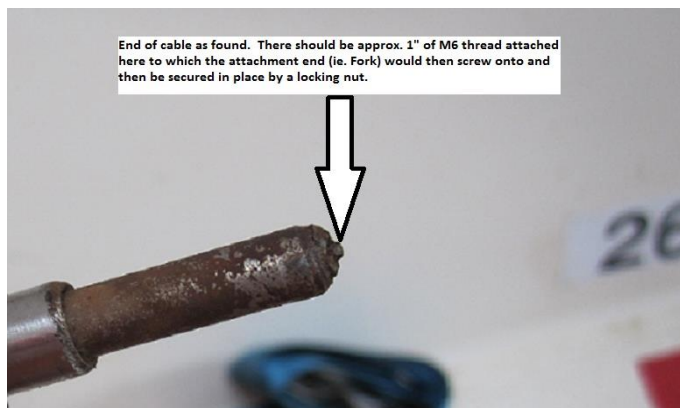
Figure 3: Showing end of failed cable

- ◆ The operation cable was found to have failed at the forward end of the lifeboat. This was likely due to its age, in service use, and the inability to adequately monitor its condition. The cable terminates into a M6 thread; and the failure occurred directly at the locking nut – see Figure 3;
- ◆ With the condition of the operation cable it was unclear if the hook was not properly reset, or failed under load at this time;
- ◆ The vessel had not yet undergone the manufacturer's modification to the on-load release system in accordance with International Maritime Organization (IMO) MSC 1/Circ 1392 – *Guidelines for evaluation and replacement of lifeboat release and retrieval systems*.

- ◆ Check the arrangements on the remaining hooks;
- ◆ Examination of lifeboat hook release mechanisms, irrespective of design to check for integrity and potential damage;
- ◆ Ensure that procedures, toolbox talks, risk assessments relating to the launch, recovery, and routine inspection of lifeboats adequately ensured that routine checks were made of the hook release mechanism.
