IMCA Safety Flash 17/16

June 2016

Summary

The incidents in this safety flash cover maritime safety and seamanship, whether movement of cargo in heavy seas, collision avoidance, or mooring.

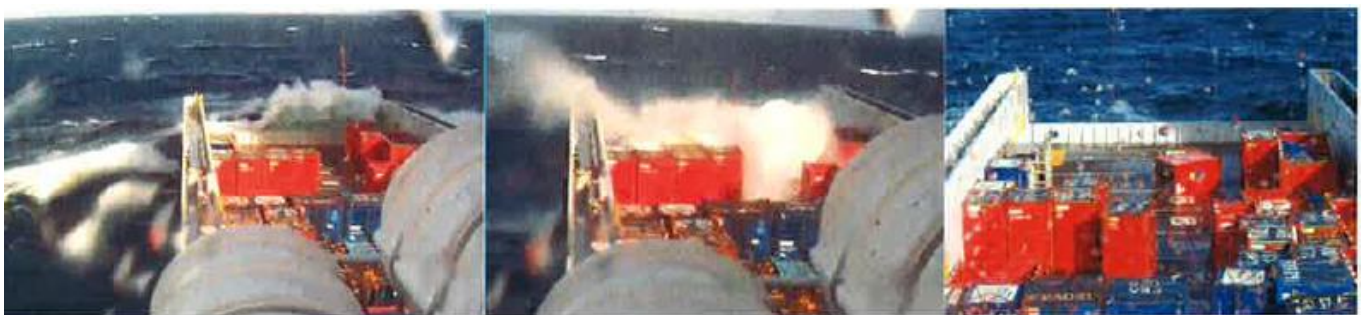
The weather and sea conditions at the time of the incident were wind 25 knots, swell 3m. One larger squall wave hit the stern and flooded the back deck. The water shifted one container and overturned another. The back-loaded containers had not yet been secured due to on-going back-loading.

There were no injuries, no spills, and no external damage to the containers.

Our member noted that this near miss incident was potentially very serious, and the incident has been treated as a potential fatality. The following lessons were learnt:

- ◆ The risk of abnormal waves should be taken into consideration in risk assessment and tool box talks for work, particularly when the vessel is positioned stern to weather;
- ◆ Greater emphasis should be placed on the 'stop work policy' – anyone should be able to stop the job, any time, when in doubt;
- ◆ A new and higher bulwark will be fitted to this and similar vessels working in these waters.

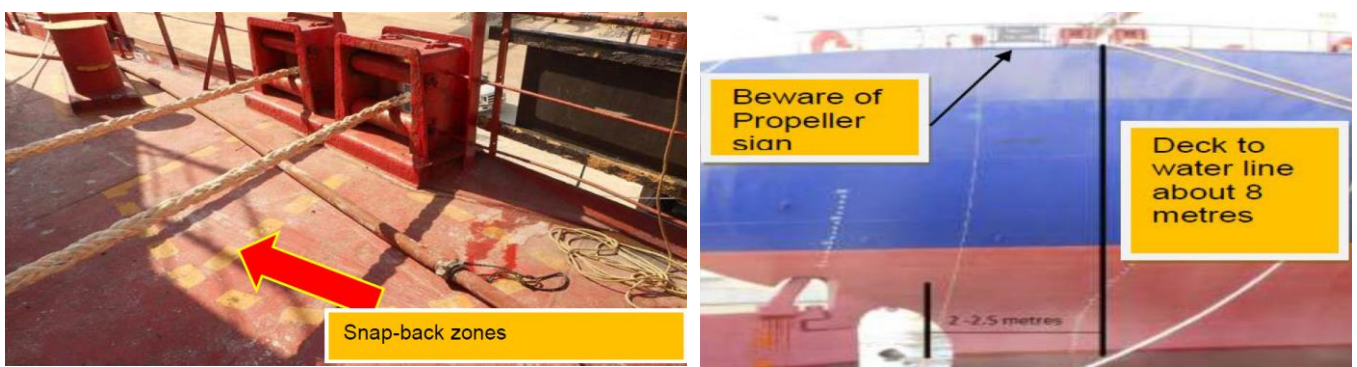
The propeller was fouled – there were damaged rope guards and mooring ropes. The vessel had to come off-hire for repairs (fortunately the stern tube seal was not damaged).

Propeller is almost above the universal leads

- ♦ Crew were using appropriate personal protective equipment (PPE) for the task;
- ♦ The immediate cause of the incident was excessive slackening of the ropes when the propeller was turning;

- ♦ Causal factors included:
 - lack of situational awareness and inadequate understanding of the physical constraints of the ship as the leads being almost directly above the propeller

- ♦ Ensure proper risk assessment carried out for mooring operations;

- ◆ Ensure safety briefing and toolbox talk conducted by the person in charge, ensuring that all crew involved in the mooring operation know the risks and actions to prevent incidents;
- ◆ Vessel joiners should be properly briefed on ship-specific tasks and constraints;
- ◆ Ensure more effective communication between bridge and mooring stations to include warnings as to prevent such incidents;
- ◆ Person in charge to take extra precautions and ensure they supervise the area and task properly;
- ◆ Re-train crew on hazards and dangers involved in mooring operations;
- ◆ Entire mooring deck area should be considered a potential snap-back zone. All crew working on a mooring deck should be made aware of this with clear visible signage.

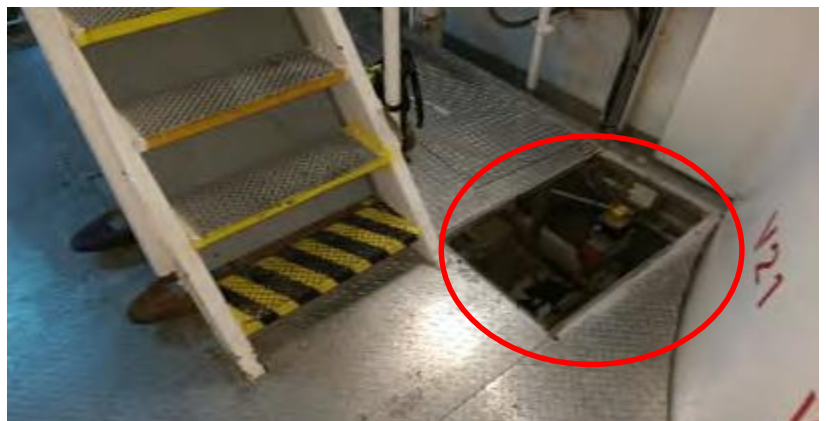
A member has reported an incident in which a bilge cover was left open. During a routine walk around the vessel, crew noticed in the engine room that a bilge cover had been left open. There was no barrier or signage in place. On investigation the bilge cover had been opened to permit brine pump maintenance work. This work had been interrupted and the employees had left the job, putting in place no safety precautions, but with the intent of returning later.

Our member noted that there had recently been two similar near misses in which covers have been left open in the engine

rooms on company vessels. The investigation and lessons learned has been included to the monthly fleet safety meeting presentations and distributed to all fleet for discussion, but the lessons were clearly not being learned.

- ◆ Stopped the job: the opened engine room bilge covers were closed and returned to a safe condition;
- ◆ A safety stand down was conducted with focus on maintaining and following the correct control of work procedures.

- ◆ Maintenance processes in the engine room should be planned, all risks assessed with further implementation of control measures where needed;
- ◆ Any openings or potential trip hazards should be controlled to ensure any risk is as low as reasonably practical;
- ◆ There should be effective supervision at all times;
- ◆ Vessel crews “not learning the lessons” – further effort required to address this.

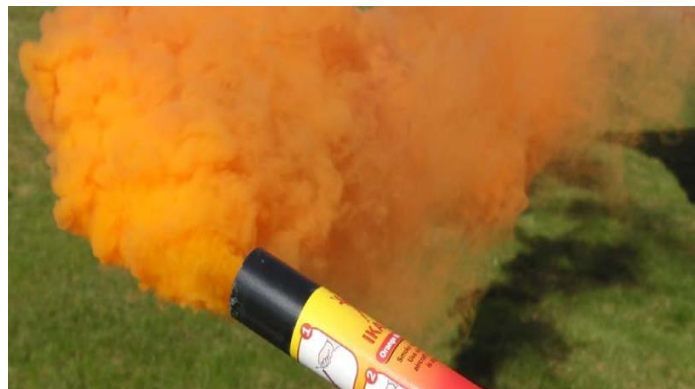
The United States Coast Guard (USCG) has published a safety alert regarding the withdrawal of the Certificate of Approval for certain orange smoke hand distress signals. This action has been taken because the chemical makeup of the signal was changed in October 2013 without Coast Guard approval, and the signal that was manufactured is at risk of spontaneous combustion when dropped.

These smoke signals may be labelled and marketed as “Polar MK 4” by NAMMO LIAB AB or as “IKAROS” by Hansson Pyrotech. “IKAROS” Hansson Pyrotech is the more current manufacturing name.
