IMCA Safety Flash 17/19

July 2019

Dropped Objects

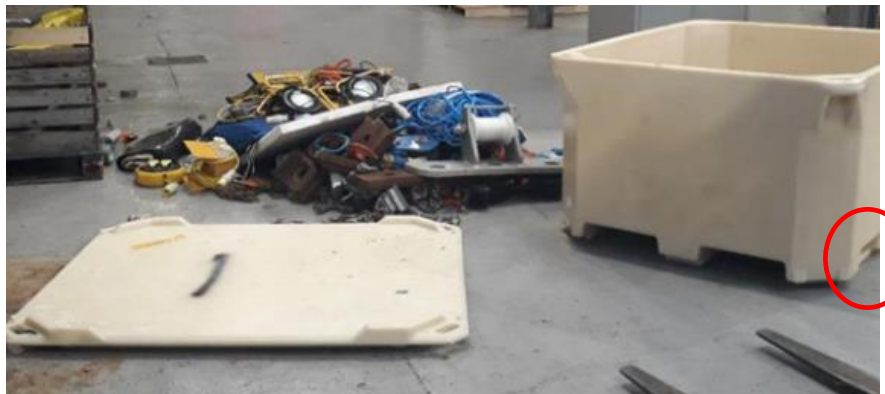
A storage box weighing approximately 770kg fell 4m from the forks of a forklift truck. The incident occurred when storage boxes containing items of equipment located on an intermediate floor at a supply base were being lifted from the level using a forklift truck. This near miss was categorised as a high potential event.

Investigation has identified the storage box was not lifted correctly; it was not lifted from the captive pockets. If the captive pockets had been used, the bottom edge of the box should make contact with the fork itself, preventing tipping forward from the forks. The 'captive pockets' can be seen in the right-hand photograph below, and also in the extreme right of the photograph above (circled).

- ◆ Review instructions on how items are identified, weighed, stored and handled;
- ◆ The lifting location of this box type should be clearly marked and visible from ground level.

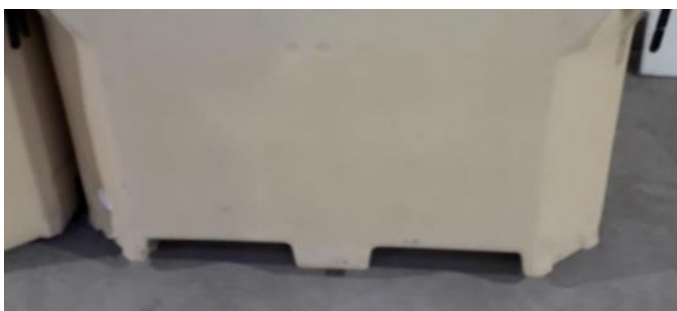
Showing incorrect box orientation with non-captive pockets presented.

Poor communication: the above was identified and followed on all the previous box retrievals. However, this was not communicated to new personnel joining the task which led to the (dropped) box being lifted from the non-captive pockets.

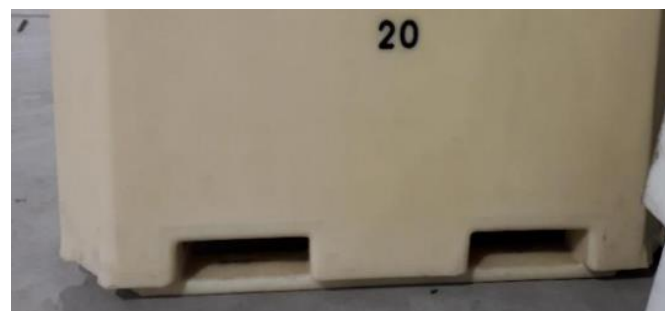
Showing correct box orientation with captive pockets presented.

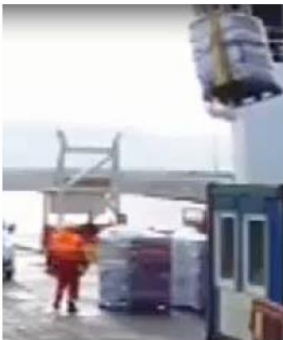
During a routine lifting operation, a pallet laden with about 1 tonne of bottled water, slid off the pallet lifting forks and fell around 8 metres to the quayside area below. The banksman had to run clear of the area to avoid being struck by falling items.

Falling pallet during lifting operations

Inattention, complacency and failure to follow company lifting procedures with regards to lift team size.

- ◆ Follow company procedures and standards with regards to lifting operations;
- ◆ **STOP THE JOB** if worksite controls are not being followed or if work is not safe;
- ◆ Ensure sufficient barrier management is in place for lifting operations.

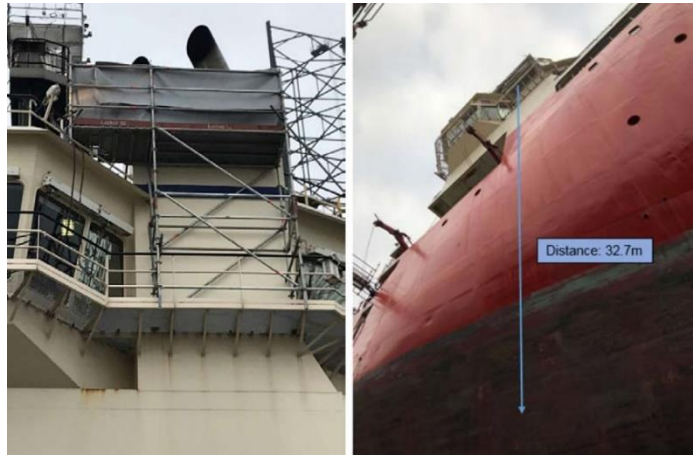
There was a dropped object near miss incident involving a magnet which was used by subcontractors during hot work operations. The incident occurred during a dry docking. Part of the scope of work involved hot work, grinding and gouging, to be carried out from scaffolding put up against the ships funnel. As a dropped object prevention measure, the scaffolding had been partially enclosed on three sides, with the fourth side being against the funnel.

During an inspection of ongoing work, it was noted that sparks were escaping the fire protection and it was requested that the gap in the protection was closed. It was at this time, while the fire protection was being adjusted, that an object fell from the scaffold to the dock; a drop of 32m. The object was later identified as being a magnet which had been used to hold fire protection against the ships funnel. There was no damage and no injuries.

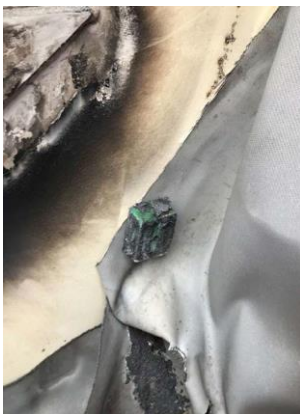
- ◆ The worksite was directly above the dock and no barriers had been placed on the dock to prevent workers from gaining access to the area directly below the worksite;
- ◆ Sub-contractors were using magnets on site and at height without any secondary retention in place. This was not known to the vessel crew;
- ◆ The magnets in use had been engineered to allow fitting of eyelets for secondary retention, but the fitting of secondary retention eyelets had not been considered by the shipyard.

A magnet used to secure fire protection

- ◆ Our member noted that there was anecdotal evidence that magnets are routinely used in shipyards for securing against the ship superstructure. This should be taken into account on future worksites;
- ◆ Ensure that all equipment being used at height is identified and suitable dropped object prevention controls are in place.

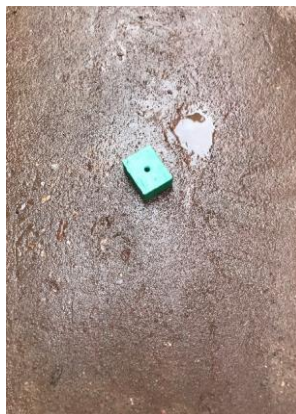
The dropped magnet – note hole for retention eyelet

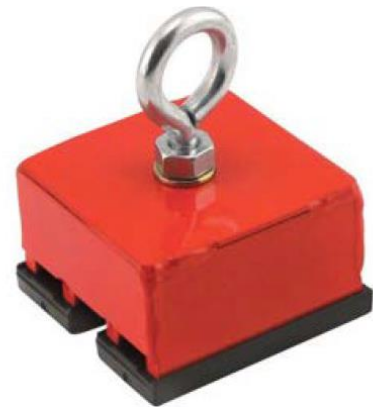
Similar magnet with secondary retention eyelet fitted

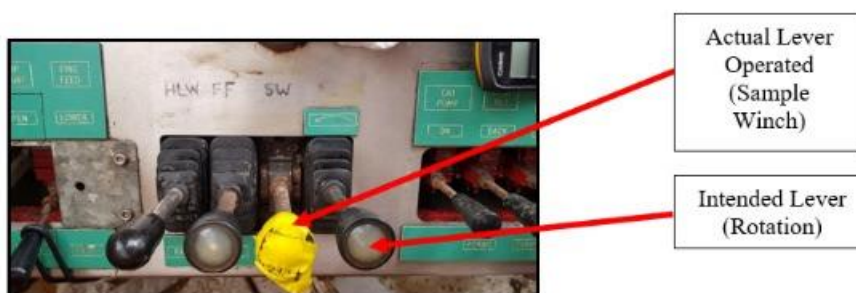
During piggyback drilling operations, a driller inadvertently operated the sample winch control lever instead of the power swivel fast rotation control lever as intended. Activating the sample winch caused a tool to rise from its storage position, resulting in it snagging on a safety hoop of the adjacent vertical fixed access ladder. The tool (weighing 11kg) separated from the wire and fell approximately 8m onto the drill floor below. There were no injuries and no equipment was damaged.

- ◆ The operating driller moved the wrong lever unintentionally.

- ◆ The tool (an 'overshot') was connected to the sample winch wire via a weak link shear pin designed to separate at 450kg. The sample winch has a working load limit of 1.2 tonne;

- ◆ The control console ergonomics and inspection and maintenance requirements had not been properly considered:
 - the possibility of inadvertent operation of the wrong lever had not been identified when the piggyback drilling equipment was installed some months before the incident

- there is no evidence that this had been taken into account (in 1995) when the piggyback drill was designed;
- ◆ There had been ineffective checking and assessment of the suitability or fitness for purpose of this equipment.

- ◆ Undertake a design review and complete a design risk assessment on all similar drilling rigs:
 - to include the operational and human interface with the drill rig and associated equipment
 - planned preventative maintenance check sheets should be updated to reflect the findings of this assessment;
- ◆ Control consoles should be clearly labelled to identify all controls and their function;
- ◆ Develop a thorough familiarisation assessment process for the operation of this kind of equipment.

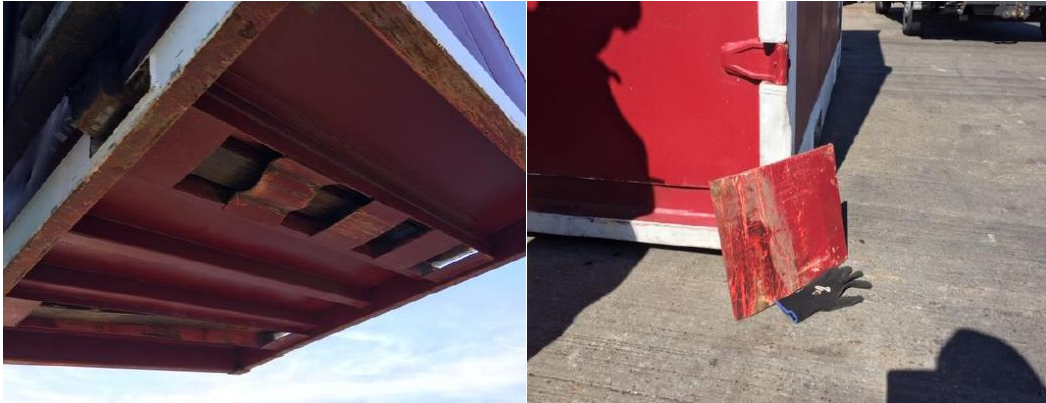
A metal plate weighing 5kg detached itself from a freight container and fell onto the quayside during vessel loading operations. The crew noticed that the bottom of the container had loose debris (rust) falling to the ground, and then a metal plate detached itself from the container. The metal plate was 5kg in weight and approximately 350mm x 300mm – a sizeable steel plate to fall from height. No persons were injured.

- ◆ The design of the forklift pockets in question are liable for the forks to catch, damaging them;
- ◆ The visual check of the underside of the container was not completed as part of the pre-delivery inspection;
- ◆ Current third-party inspections did not cover the underside of containers;
- ◆ It was established that the metal plates were only stitch welded, which has meant that over time, these welds will have degraded. For DNV certified containers, the plates must have full penetration seam welds.

- ◆ Inspect all existing forklift pockets. Those showing signs of damage or having stitch welds should be quarantined until rectified;
- ◆ The underside of containers should be inspected prior to dispatch. Regular inspection and maintenance programs should be implemented.

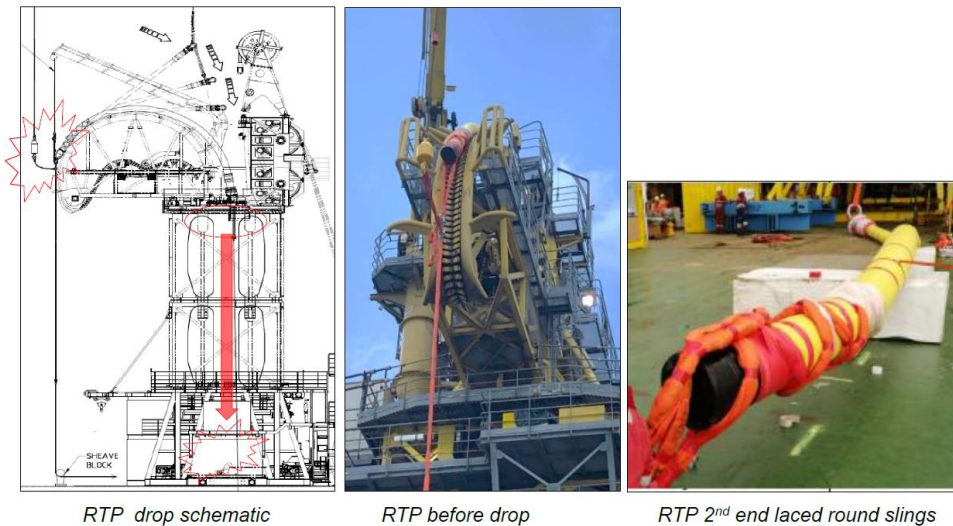
The test piece was lifted, and the operation was paused. The trailing winch operator perceived that there may have been insufficient wire on the winch drum to complete the transfer. The decision was made to reverse the lift. As the trailing winch was hauled in, the laced up round sling slipped free off the pipe and the test piece dropped

RTP drop schematic

RTP before drop

RTP 2nd end laced round slings

- ◆ Lack of intervention at key stages;
- ◆ Incorrect application of laced round sling configuration;
- ◆ Insufficient emphasis on preparation; no load test on hold back rigging;
- ◆ The task was considered routine – a similar operation, although not the same, had been performed on a past project; there was no hazard identification (HAZID) performed on this procedure.

- ◆ Ensure that all 'non-standard or non-routine tasks' are risk assessed and HAZID carried out;
- ◆ Prepare clearly defined guidelines for laced round sling configurations and circulate consistently across fleet.
