## IMCA Safety Flash 18/16

July 2016

### Summary

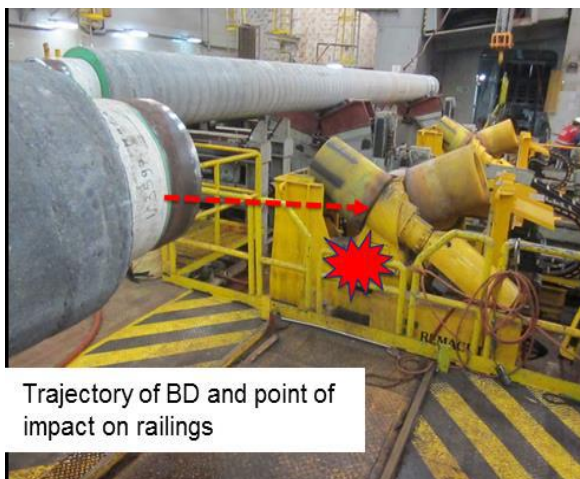
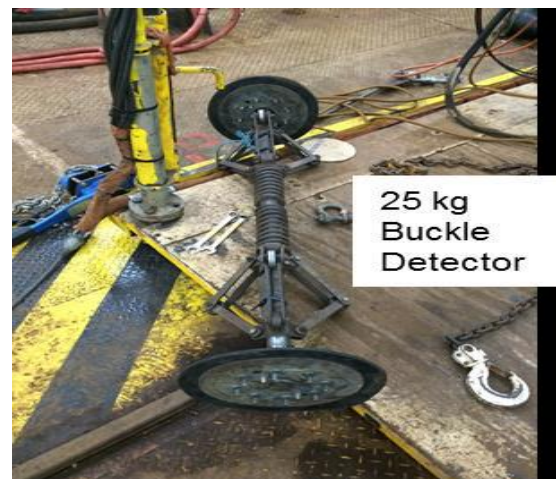
A member has reported a near miss incident in which a buckle detector tool was expelled from a pipeline under pressure and landed approximately 2m away. The incident occurred during retrieval of the buckle detector (BD), which weighed approximately 25 kg. The buckle detector came close to two crew members. Had either of them been struck by the tool as it ejected, it could have caused significant injuries.

Our member's investigation revealed the following:

- ◆ Back pressure on the buckle detector had not been identified as a risk during the job risk assessment (JRA);
- ◆ The task plan did not identify appropriate barriers required for the job;
- ◆ The procedure for use of the buckle detector was not risk assessed at the hazard identification & risk assessment (HIRA) stage of the project.

- ◆ An 'all stop' on buckle detector launch and recovery activities followed by 'time out for safety' with all personnel involved to illustrate dangers involved;

- ◆ An updated task plan to:
  - ensure “no go” areas are fully documented
  - show means of preventing future recurrence by using a double wrapped sling on the pipe attached to a shackle on the buckle detector cable;
- ◆ Ensure plans available of where barriers should be installed to keep people out of the “line of fire” when conducting launch and recovery of buckle detector;
- ◆ Consider revision of hazard identification & risk assessment (HIRA) and job risk analysis (JRA) for pipe buckle detection work;
- ◆ Consider pipe back pressure as a risk;
- ◆ Ensure future buckle detection task plans include clear instructions on where to install barriers;
- ◆ Identify other means of launching buckle detector, such as crawler systems which do not require pressurised air.

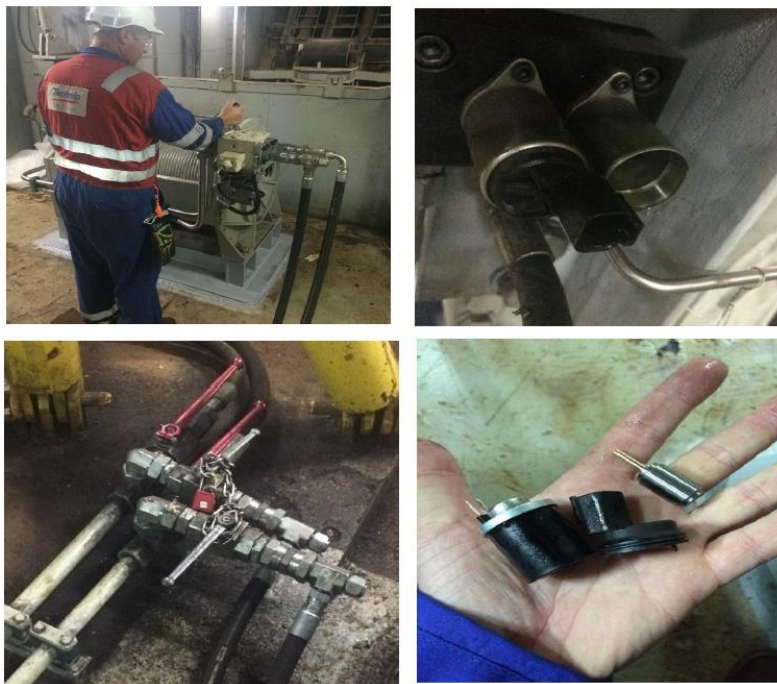
A member has reported an incident in which a part was expelled from a hydraulic system under pressure, causing a leak of hydraulic oil. The incident occurred when the hydraulics were activated to turn the winch drum to install a new wire rope. There was a loud bang from the hydraulic pack as a sensor was forced out of the unit. The sensor hit the bulkhead to the right. Approximately 2 litres of hydraulic oil was also expelled from the winch onto the deck and bulkhead.

- ◆ Company safe system of work had not been followed – there had been no permission or sanction to test this equipment;
- ◆ The hydraulic system had not been commissioned properly. The hydraulic hoses had been fitted the wrong way around;
- ◆ The handover between technicians following crew change had not identified these issues.

- ◆ Improve communication between crews at handover especially at crew change;
- ◆ Formal "sanction to test" should be completed before it is handed over to the responsible person in charge;
- ◆ Suitable and sufficient risk assessment and pre-use check list to be created and used for this work and equipment;
- ◆ Status and condition of equipment should be clearly defined before planned maintenance is carried out.

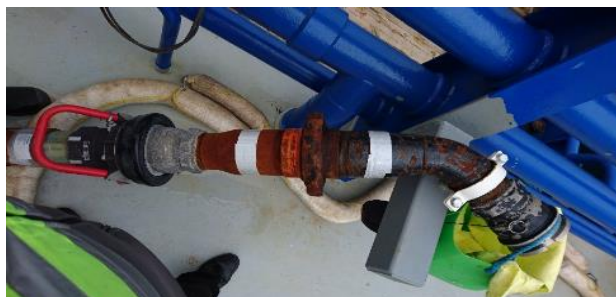
The Marine Safety Forum has published a safety alert regarding a minor fuel spill during offshore fuel transfer. A platform supply vessel (PSV) was on location ready to deliver fuel, and the hose was connected. Crew were posted nearby on watch. The pump was started on a low rate in order to prove the line with the installation. Very shortly after starting the pump a spray of fuel was noticed from another fuel connection – not the one in use on this occasion. Bunkering operations were stopped immediately. Less than 1 litre of fuel was estimated to have escaped to sea.

This incident serves as a good reminder that all connections (not just the ones in use) should be checked before starting bulk transfer operations. All valves should be correctly closed with appropriate caps correctly fitted in place. Regular maintenance and inspection of manifold valves and connections are an important factor in preventing spills of this type.

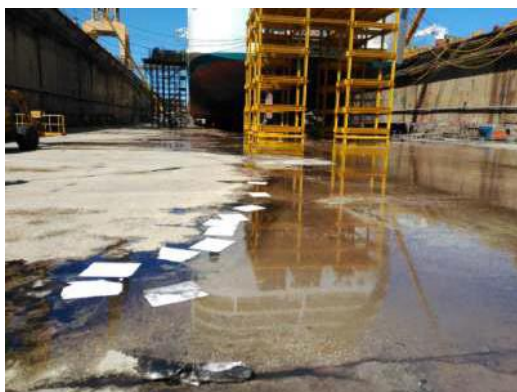
A member has reported an incident in which there was an accidental discharge of bilge water during a dry dock. The incident occurred when dry dock personnel mistakenly opened the bottom plug of the 'Engine Room Bilge Water' tank which caused bilge water to be drained into the graving dock.

- ♦ Dry dock personnel wrongly opened the bottom plug of the ship's tank without checking with Chief Officer;
- ♦ There was inadequate communication and coordination between ship and dry dock personnel;
- ♦ There was inadequate supervision on dry dock personnel.

- ♦ All bottom plugs were checked and marked in the docking plans, highlighted the critical bottom plugs and discussed with dry dock personnel during pre-docking meeting;
- ♦ Particular care should be taken to ensure that the bottom plugs of tanks are opened after confirmed identification and under the direct supervision of the Chief Officer;
- ♦ Effective pre-operation risk assessment and tool box talk should be conducted before carrying out the task – and this should be recorded.
