IMCA Safety Flash 19/14

December 2014

I Injuries due to Failure of Diver's Emergency Gas Cylinder

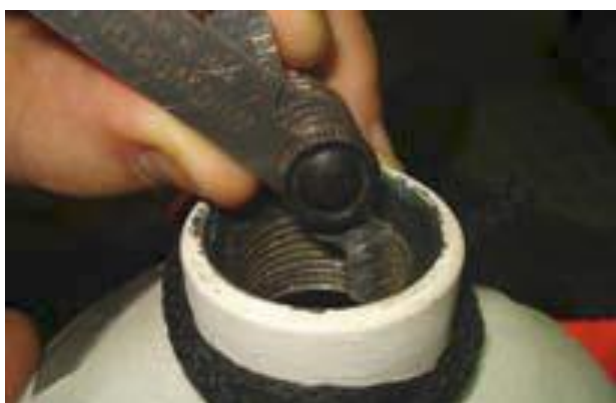
Investigation is still ongoing but preliminary assessment has confirmed that the inner thread on the HP cylinder was not compatible with the outer thread of the pillar valve. The pillar valve outer thread was an M25x2 parallel thread and the inner thread of the HP cylinder was a 3/4"x14 TPI parallel thread. How the incompatible valve and HP gas cylinders came to be used together, is still being investigated.

Figure: inspection of the inner thread type at a HP gas cylinder

The main lesson learnt is that the incompatibility of the valve thread and HP cylinder thread led to a serious incident. Members involved in diving operations should perform an immediate check to confirm the compatibility of the HP gas cylinders and valve threads in use at their operations. They should also clearly mark and register both HP gas cylinders and valves separately, so that compatibility can be verified and assured.

- ◆ Make documented check of all HP gas cylinder threads and pillar valve threads for compatibility;
- ◆ Mark the cylinder thread size for all HP cylinders; mark the thread size for all pillar valves, applying a unique identification that will be permanently visible and traceable;
- ◆ Develop and implement a working procedure and instructions that include the verification of the compatibility of both the pillar valves and HP gas cylinders;

- ◆ Include the HP gas cylinder and pillar valve identification numbers in the six-monthly inspection certificates;
- ◆ Include compliance with this working procedure in the IMCA DESIGN audits which validate the six-monthly internal and external inspections of HP gas cylinders.

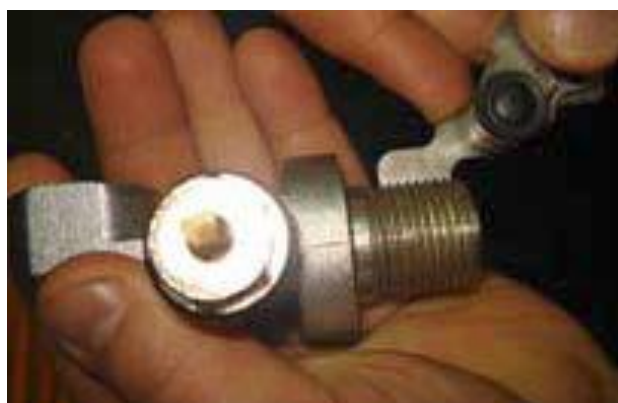
Figure: inspection of the outer thread type at a pillar valve

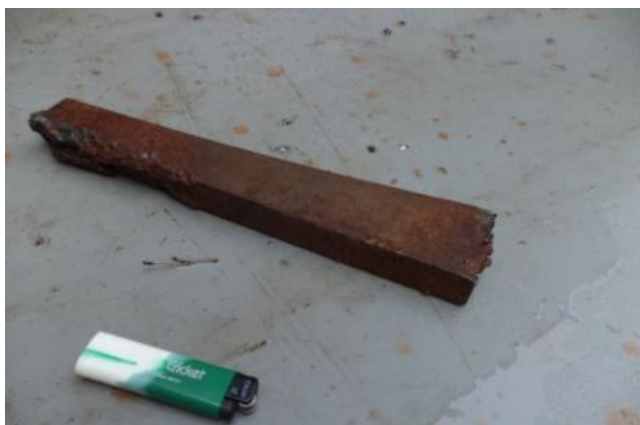
A member has reported a near-miss incident which a crew member was almost struck by a falling object. The near-miss occurred when the crew member was executing a daily sea-fastening inspection. A steel object of approximately 1.8kg fell from a height of 12m onto the deck, landing close to the crew member.

Figure: dropped object

- ◆ Immediate inspection of the cargo for other loose items and removal thereof – insofar as the objects could be reached safely;
- ◆ Creation of exclusion zones underneath areas which could not be cleaned;
- ◆ Circulated this incident report to re-emphasize the hazards of dropped objects;
- ◆ Ensured pre-job risk assessments emphasize the possibility of loose objects on the cargo;
- ◆ Ensured client awareness of the responsibility to deliver the cargo in safe state.

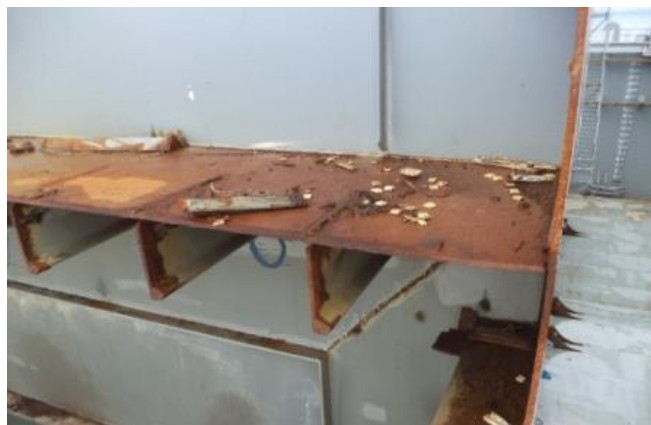
Figure: cargo showing loose debris

- ◆ The cargo was not sufficiently cleaned or prepared before loading;
- ◆ During vessel movement, the loose object moved towards the edge and at a certain moment fell over the edge;
- ◆ The immediate causes were identified as follows:
 - insufficient cleaning of the cargo prior to delivery
 - insufficient checking of the cargo prior to loading by the member;

- ◆ The root cause was identified to be insufficient awareness of client failure to clean the cargo could result in a hazardous situation.

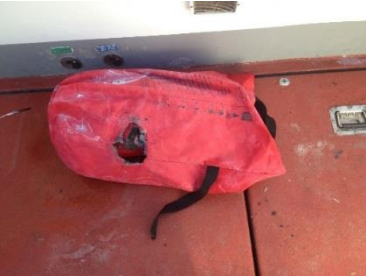
Figure: damaged survival suit

- ◆ At the time of the incident, several items had been stored in the underdeck space including a number of solid buoyancy lifejackets, a stretcher in its valise, a chart canister, a vacuum cleaner and three immersion suits in storage bags. One suit and its protective bag suffered burn damage;

- ◆ Heater connections on other vessels to be checked to ensure all hoses and connections are secure and in good condition;
- ◆ Storage of items in the underdeck space to be prohibited pending a review of alternative arrangements;
- ◆ Use of laminated sheets in confined spaces and/or near heat sources to be prohibited;
- ◆ The use of dry powder extinguishers behind the wheelhouse console, whilst effective, resulted in considerable contamination of electrical systems and components delaying the return to service of the vessel. Ready availability and use of CO² extinguishers would obviate this problem;
- ◆ Access to the interior of the wheelhouse console and the underdeck area was difficult and a review of firefighting provision for this space should be undertaken;
- ◆ Contact details of clients, including out of hours contact, should be readily available in case of emergencies.

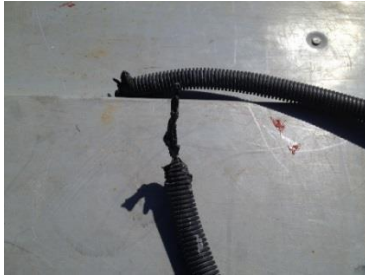
Figure: main control cable conduit burned through

- ◆ The main control cable conduit had been burned through. The exterior sheath of the main control cable itself had been burned although the internal sheathed strands appeared undamaged;

- ◆ The **root cause** of the fire appeared to have been a detached outlet hose from the electrical heater which allowed hot air to melt and possibly ignite the outer casing on the main control cable. Burning or molten material from this cable then dripped onto the laminated sheet immediately beneath the cable, and possibly the bagged immersion suit underneath. The burning materials would have fallen onto the bagged immersion suit and the flames subsequently burned through the demister conduits immediately above;

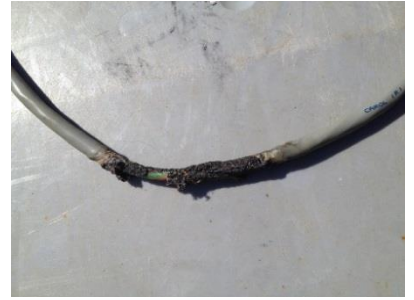
Figure: exterior sheath of the main control cable burned through;

- ◆ Electrical engineers examined the control cable and system but found no faults that would have caused the cable to ignite. Damage to the cable appeared to be mainly external indicating a separate heat source;

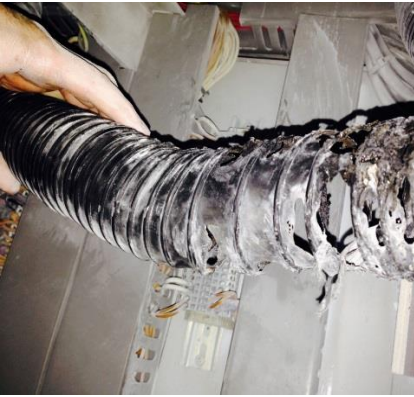
Figure: Flexible hoses to the windscreen demisters in the wheelhouse had burn damage

- ◆ Flexible hoses to the windscreen demisters in the wheelhouse had burn damage;
- ◆ Signage in the form of laminated paper sheets had been secured in several locations within the underdeck space. Some of these signs were damaged in the fire. Charred remains of such sheets were found in the area;

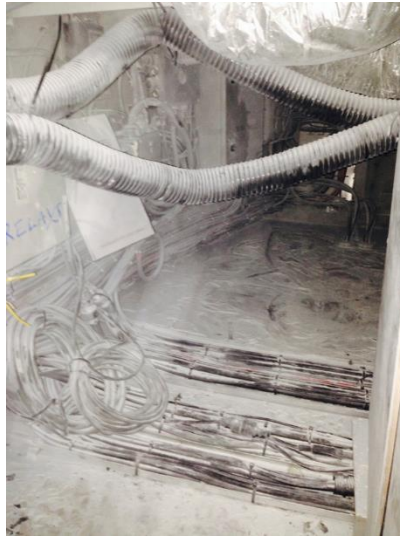
Figure: damage caused by dry powder extinguishers

- ◆ The underdeck storage area and all electrical connectors and circuit boards were heavily coated in powder from the fire extinguishers.

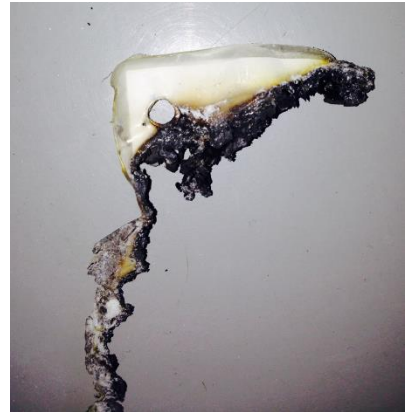
Figure: charred remains of laminated notices

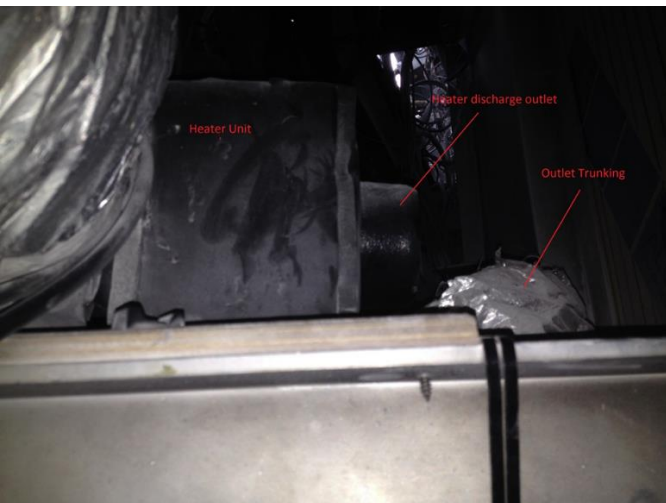
Figure: main discharge trunking from the heater system was seen to have become disconnected from the heater

- ◆ The main discharge trunking from the heater system was seen to have become disconnected from the heater. The crew had commented that prior to the incident, the heating in the wheelhouse had been erratic although the console had been warm, occasionally hot;

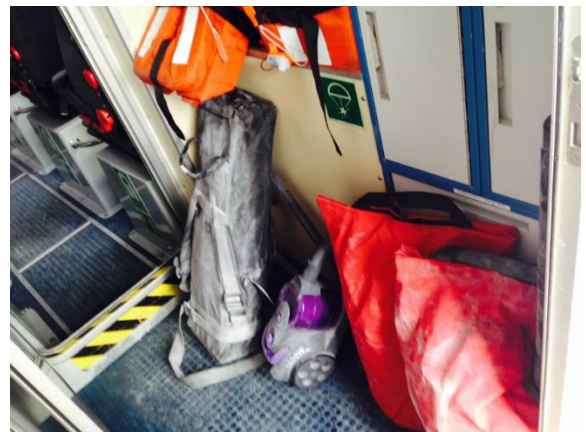
Figure: several items had been stored in the underdeck space
