## IMCA Safety Flash 20/16

August 2016

### Summary – Diving Incidents

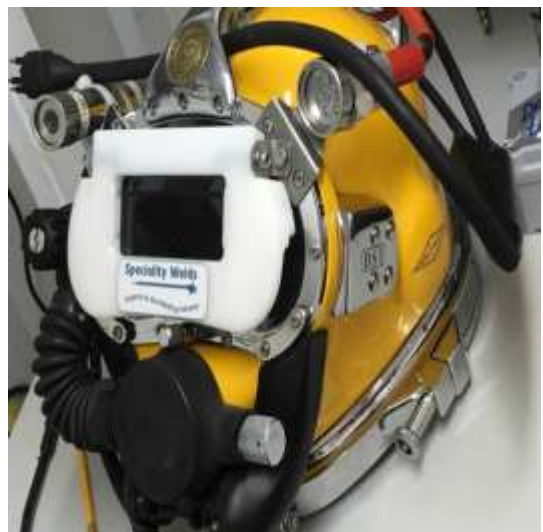
A member reported a near miss incident during diving operations in which the neck dam and helmet separated whilst the diver was wearing a Kirby Morgan 37. The incident occurred in 9m water and there was minor water ingress into the helmet. The diver maintained vertical position, activated his free-flow and was recovered to the surface safely. The hat did not flood and communications between the diver and supervisor were maintained throughout. On his safe arrival to the surface, he was examined immediately by the on board doctor and pronounced well.

- ◆ Immediately after the incident the helmet was quarantined and inspected by qualified personnel;
- ◆ The helmet appeared to have no defects, structural damage or other identifiable issues which may have caused or contributed to the separation;
- ◆ Separation occurred via the mechanism designed for releasing the helmet from the neck dam;
- ◆ The certification of this particular helmet was valid in accordance with company standards;
- ◆ Pre-dive checks were logged and reported with video evidence available of them occurring;
- ◆ The investigation team concluded with the information available to them that the **root cause** of failure was human error. It appears that the tender did not fit the hat correctly to the diver during pre-dive checks.

- ◆ Stress the importance of a well-defined and highly detailed pre-dive call out checklist;

- ◆ Divers pre-water entry “call out” list to be repeated a *second* time and signed off by the diver’s tender and a competent second person;
- ◆ Helmet lock pins should be fitted with approved Kirby Morgan sleeves as an additional control;
- ◆ Duties and responsibilities for all personnel should be made clearly known by tool box talk on a “Dive by Dive” basis, i.e. each person is to know his exact emergency location in the event of a diving related in water emergency;
- ◆ In this case, owing to the distance between the diving launch and recovery systems, a swim line was placed between the two to allow the emergency/standby diver easier and quicker access to any stricken diver;
- ◆ Training around the risk of complacency should continue.

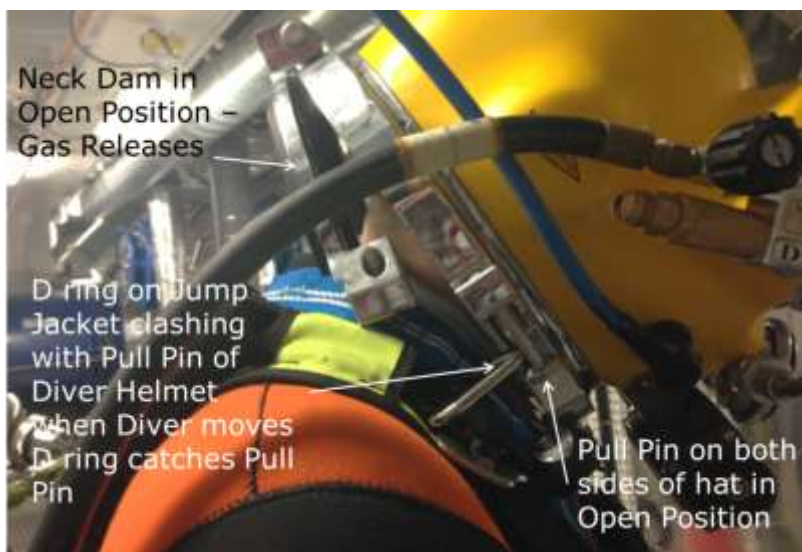
*Incident details*

A member reported two incidents in which there has been unintentional release between neck ring and helmet on a KM17C diving helmet during saturation diving operations. Members are encouraged to ensure that diving personnel are aware and that they check the interface between helmet and its securing arrangement towards other equipment supporting the diver. Working conditions could also give same results, e.g. working close to (taut) wires or large insertion bolts, etc.

- ◆ Verify that interface between helmet and other diving equipment is such that it cannot hook up the release mechanism;
- ◆ Be aware of the potential of release such that operational measures could be taken to prevent this;
- ◆ Report any further problems (with helmet and locking mechanisms) immediately.

The manufacturer has developed a **Pull Pin Sleeve** which may also work to prevent this from recurring. See the Kirby Morgan website for more details: [www.kirbymorgan.com/support/bulletins/2012/bulletin-07-2012](http://www.kirbymorgan.com/support/bulletins/2012/bulletin-07-2012).

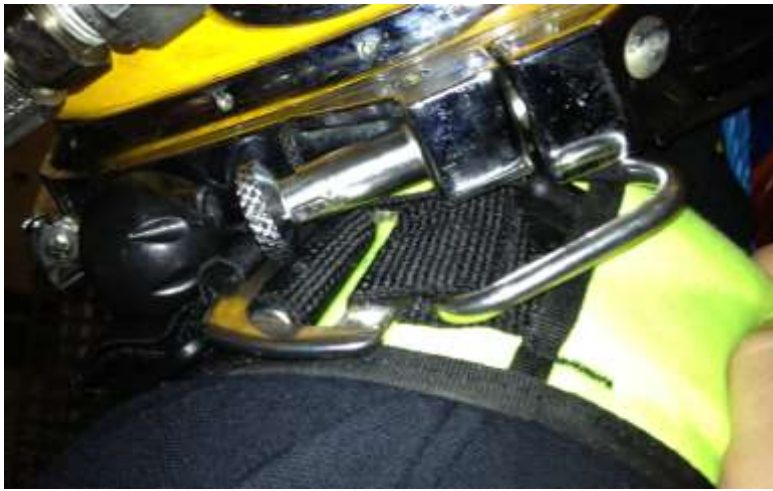
*Clash between diver helmet Pull Pin and jump jacket*

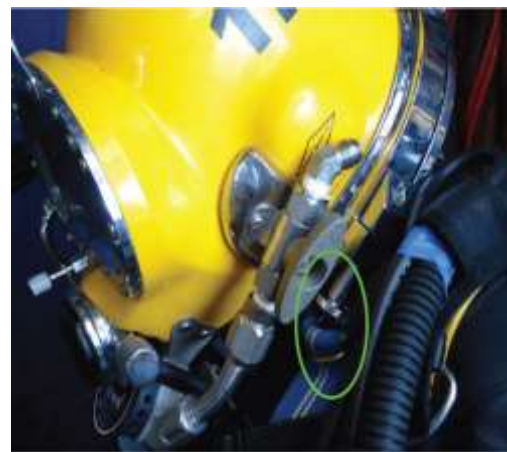
*Position of Helmet/Neck Ring Pull Pins in relation to divers harness with head bent forward looking down*

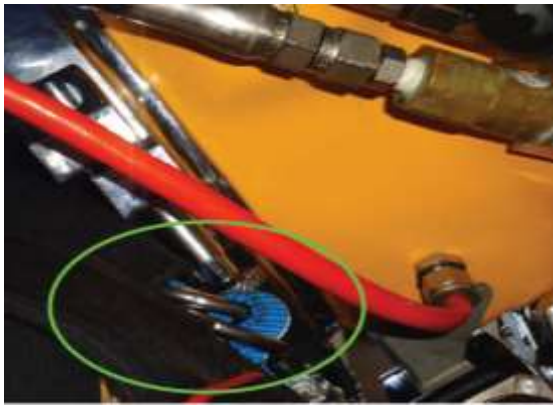
*Position of Helmet/Neck ring Pull Pin in relation with Bailout/Jump jacket equipment with head bent forward looking down*

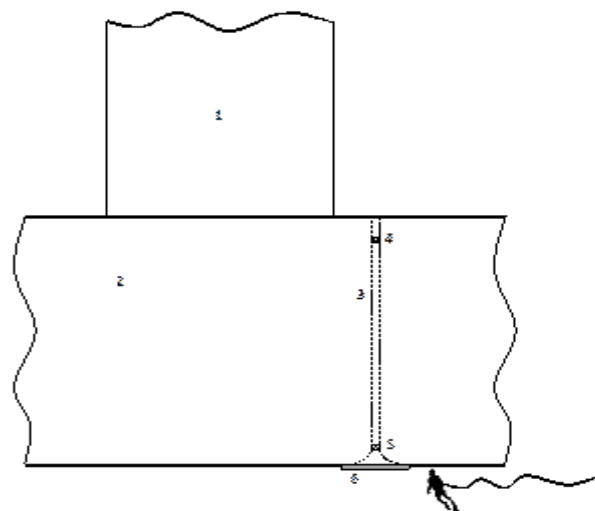
*Figure 1. Schematic drawing of worksite.*

When the diver introduced air into the pipe an artificial, undiscovered concrete plug on top of the upper valve broke and the divers head and left arm were sucked into the pipe causing great pain. The standby diver, being fully dressed, entered the water immediately (within 30 seconds) and the wounded diver was brought to the surface within 9 minutes. At the time he had stopped breathing, but his breathing and pulse were regained through CPR. The diver was sent to hospital where he died two days later.

This fatal diving incident was due to uncontrolled differential pressure.

1. The column going up to the top of the rig
2. The port fwd side of the port pontoon
3. The torpedo pipe
4. The upper valve, approx. 1.2 m from top of pontoon
5. The lower valve, approx. 1m up from flat bottom
6. Cover used to seal the lower opening of the pipe

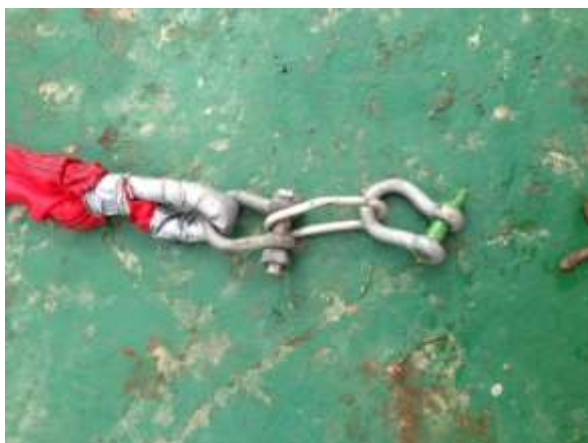
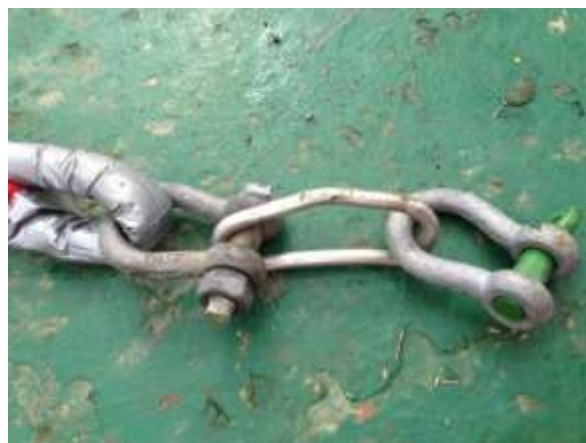
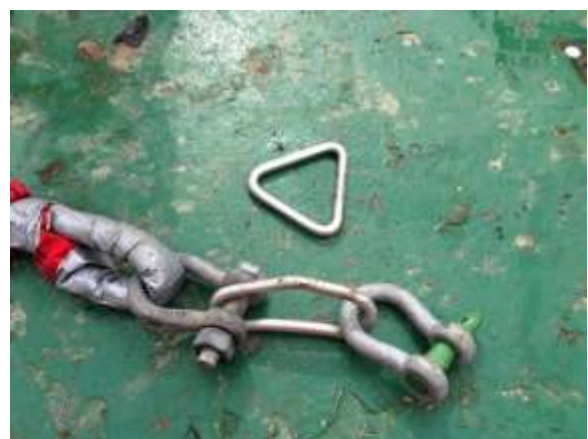
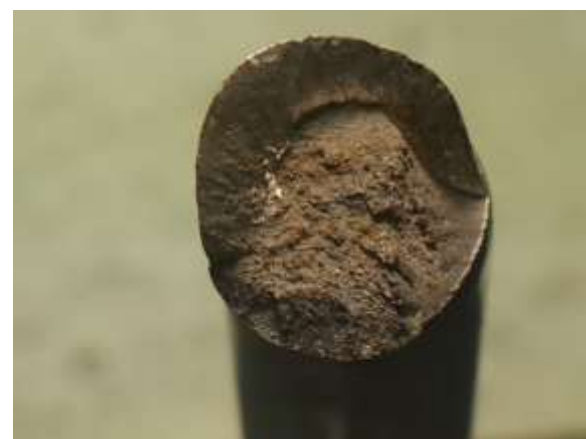
- ♦ The **primary cause** of the incident was the failure of the stainless steel lifting link;
- ♦ Had the diver or his umbilical not been clear, the results of the failure of the lifting link would have been catastrophic;

- ♦ It appears that this was caused by the failure of the material (stainless steel) of which the lifting link was made;
- ♦ The lift bags were new and each bag had a certificate;

- ♦ The safety factor recorded in the certificate is 6 times the normal operating load, i.e. 3 tonnes SWL with a safety factor of 6;
- ♦ Metallurgical analysis of the failed ring was conducted, and it was discovered that:

- tests show it starting to fail at 10KN = 1 tonne – rather than 18 tonnes (3 tonnes SWL with a safety factor of 6) as in the certificate
  - the rings were bent and welded during production, which compromises strength significantly;

- ♦ The conclusion reached by our member is that the supplied lift bag certificates were counterfeit and the equipment supplied was incorrectly designed.

The broken lifting link is shown in the accompanying photos together with a link from another bag for comparison.

- ♦ After careful examination of the failed material, it was decided to condemn all of the remaining 3 tonne bags and before recovery of the remaining bags on the pipe-line, the ROV was used to puncture the bags so that divers could safely recover the deflated bags;

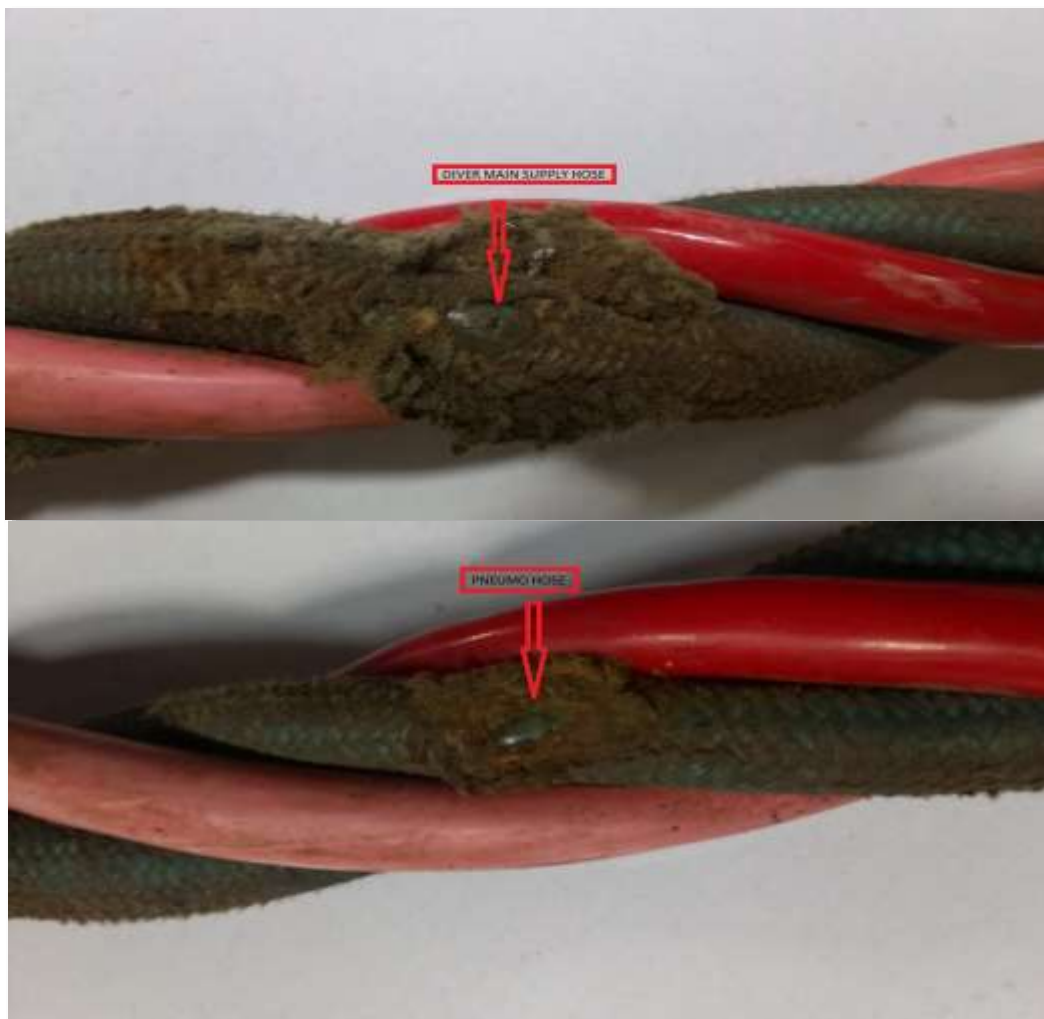
Before the final test pressure could be reached the umbilical breathing hose ruptured at about 14 Bar pressure.

- ◆ There was damage to the outer coating of the divers breathing hose at the area of the leak;
- ◆ The actual hose had some mechanical damage that may have contributed to the cause of the burst during the pressure test;
- ◆ The damage on the breathing hose was 80m from the diver's end. Since the damage was found 80 meters from the diver's end, the damage is likely to have occurred somewhere on the diving platform;
- ◆ The outer coating of the pneumo hose was damaged at the same location;
- ◆ The umbilical was part of a diving system that had just returned from a project and was undergoing a pressure test as per company procedures.

Our member noted that pressure testing should be carried out in a clearly marked designated area, and that all nearby personnel should be informed when a pressure test is to be carried out. Personnel conducting the test should be using the correct personal protective equipment (PPE). There should be close visual inspection of the umbilical for surface damage before the pressure testing starts – if any area is found to be damaged, the adjacent area should be cordoned off whilst pressure testing.

Our member reiterated the importance of safe umbilical handling and making efforts to keep the divers' umbilical safe from any damage even on the diving platform at all times.
