IMCA Safety Flash 20/18

September 2018

Theme: Dropped Objects

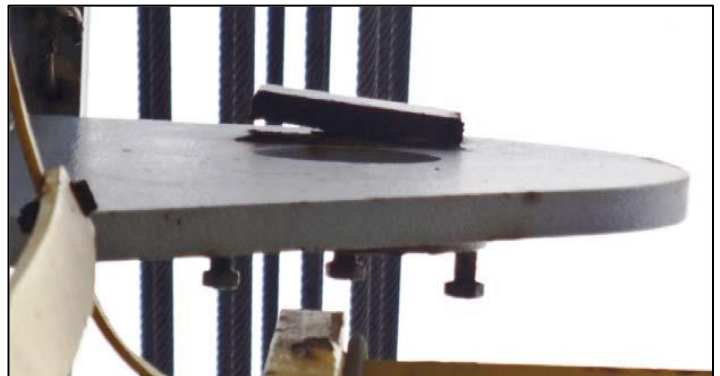
During inspection of the vessel crane, it was noted that a steel spacer plate had become partially detached due to corrosion forming behind the plate. The plate had been installed by the manufacturer during the crane installation but had not been removed as intended. On touching the spacer, it detached completely but was prevented from falling.

The spacer plate had been present since original vessel/crane build. It weighed 1.5kg and had the potential to fall 40 meters to deck. The only means of attachment for the steel plate to the structure was by tack welding. This was an accepted form of attachment by the manufacturer for temporary use, but not for permanent equipment.

- ◆ Be vigilant during dropped object reviews for items with similar method of attachment i.e. tack welded;
- ◆ Ensure that any identified items are securely attached;
- ◆ Report any incidents of non-continuous welding and obtain guidance on corrective actions;
- ◆ If required, adjust maintenance actions to monitor for corrosion.

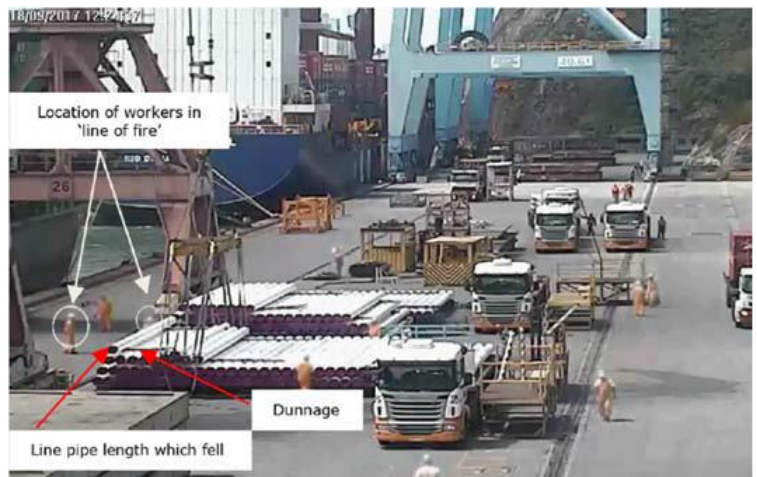
During line pipe load out operations, three high potential near miss incidents occurred involving quayside crane lifting operations. All of the incidents had the potential for fatal consequences from line of fire situations. Two of the incidents resulted from the line pipe being dropped from the quayside storage positions, and the third as a result of line pipe contact with the ship's hold bulkhead which could have caused the pipe to drop.

- ◆ There was no work instruction available to detail the task and process of securing and lifting pipe from the quayside into the hold of the vessel;
- ◆ There was no requirement within the line pipe supplier's management system to verify that their subcontractors executing the pipe load out understood and were experienced in the task, nor to verify the training and competency of those subcontractors;

- ◆ The communication process between the banksman and crane operator was not clearly understood (there was no documented process);
- ◆ The crane operator found it hard to see the banksman during the lifting operation, yet continued the lifting operation;

- ◆ The pre-job briefing did not cover all of the tasks to be conducted;
- ◆ There was a lack of experienced supervision at all stages of the pipe load out activities;

- ◆ The quayside slewing crane used was not as suitable for the task as the gantry crane, which was not always available for use.

- ◆ In evaluation of potential suppliers:
 - a focus should be placed on the high-risk activities that bidders are proposing to subcontract out
 - do not assume that suppliers are knowledgeable and experienced in all aspects of their contract.

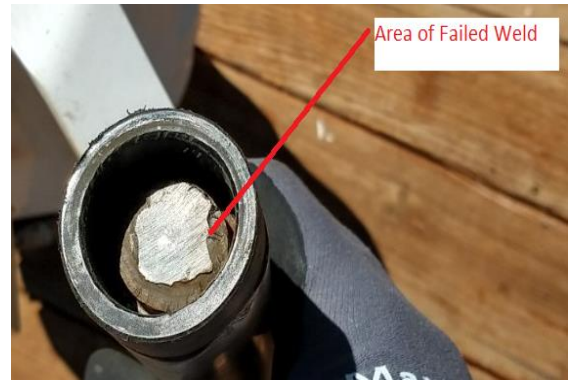
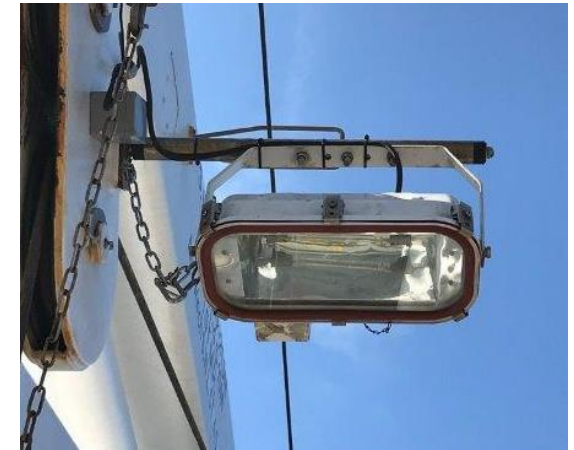
A floodlight fell from its position on the knuckle boom of the vessel's crane. The floodlight arrangement was supported on a stainless steel bracket, comprising a bar and attachment plate that is bolted to the knuckle boom head. This arrangement allowed the floodlight to swivel and illuminate the load area.

The weld between the bar and the attachment plate failed due to the poor quality of the weld, which upon inspection revealed undercut, poor penetration and overdressing, resulting in a minimal fusion area which was insufficient to withstand vibration and exposure in the marine environment.

- ◆ Inadequate engineering;
- ◆ Inadequate QC/monitoring of design and build at point of fabrication (crane manufacturer).

The floodlight was restored to its original position, with a security chain installed as a retrofit attachment.

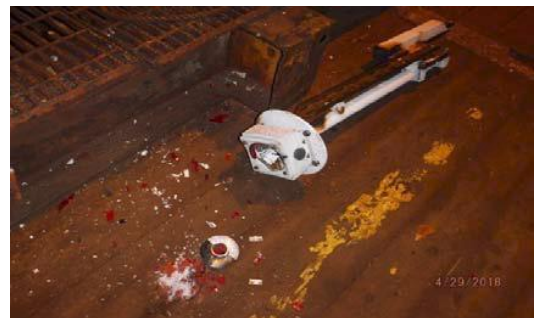
Incident 1

A light and fitting on a third-party ship, weighing 8kg, fell 20 metres to the deck narrowly missing one of the crew members. The light was fitted to a post which had previously been identified as heavily corroded.

Findings: the corroded item had previously been identified by the ship owners, but no corrective action was taken to secure the light and remedy the situation. Subsequent inspection by our member identified other items at risk of falling.

- ◆ Outstanding defects that pose a risk of dropped objects should be categorised as dangerous and either removed or rectified;
- ◆ Worksite management should ensure that only the correct secured tools are used when working at height;

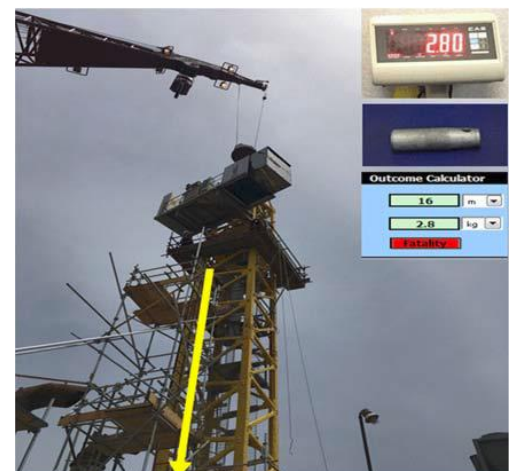
Incident 2

A 2.8kg steel pin fell 16 metres to the deck. The area immediately below the drop area had barriers set, however if the pin had hit the structure and was deflected it could have endangered the deck crew.

Findings: the task was not planned, or risk assessed correctly:

- ◆ The removed pin was placed on the tower structure instead of in a scaffold clamp type basket;
- ◆ The rigger was unfamiliar with the task and was not made aware of the required rules when working at height;

- ◆ Tools in use by the work team did not have the required lanyards and could have also fallen to the deck.

- ◆ Tools used at height should be fitted with the appropriate securing devices to prevent them falling;
- ◆ Ensure that all work at height is subject to a specific risk assessment which addresses the potential for dropped tools and work equipment, and identifies the controls to prevent this happening;

- ◆ Barriers under towers should be set at a sufficient distance considering the possibility of items deflecting off any structures;
- ◆ Prior to third-party vessels being taken on hire, evidence should be produced by the owner to prove that there has been a DROPS survey conducted, and a regime is in place to inspect, maintain and correct any defects affecting the security of equipment at height.

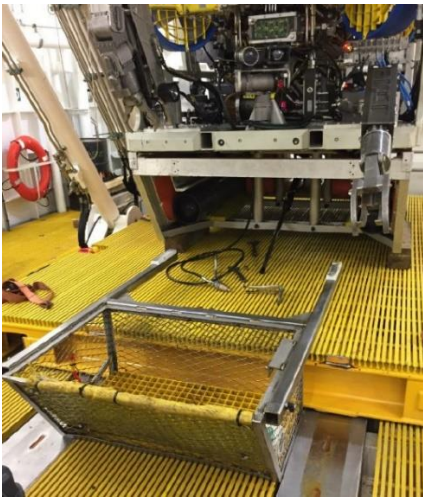
Incident scene

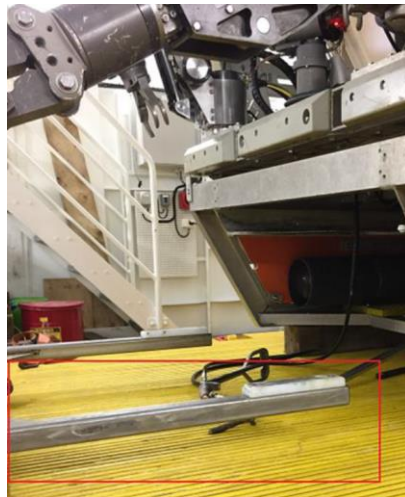
Tooling tray guide arm that made contact with the IP

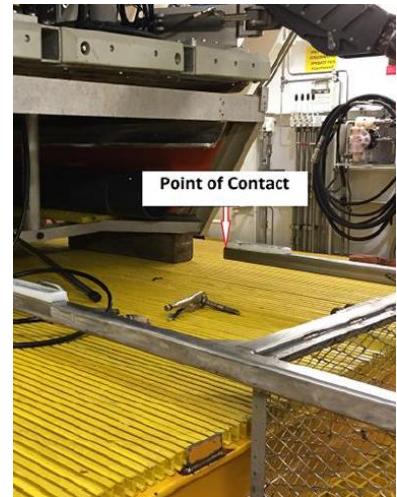
Additional view of guide arm

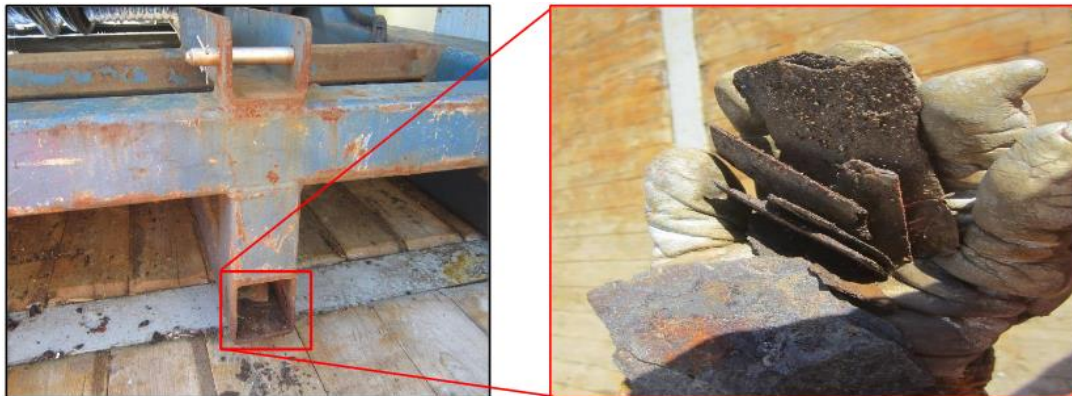
The Marine Safety Forum (MSF) has published [Safety Alert 18-20](#) on *Potential Dropped Objects in Frame Pockets*. When preparing a heavy lift to be discharged from an offshore supply vessel to an offshore installation, the vessel's AB's were carrying out final checks, which included checks for any potential dropped objects. During these checks, they discovered some debris within the frame pocket. The items were estimated to weigh approximately 1kg.

Cargo checks onshore failed to spot the items before the lift had been loaded onto the PSV. This was apparently due to the lift frame positioning on the trailer which may have hampered the checks at the gantry.

- ◆ The potential dropped objects were removed from the pocket and the lift was safely and successfully discharged to the offshore installation;
- ◆ This alert highlights the importance of final checks on all lifts prior to discharge offshore even though there had been previous checks onshore.
