## IMCA Safety Flash 21/15

December 2015

The focus or theme of this safety flash is lifting. All the incidents involve cranes, lifting or loading operations.

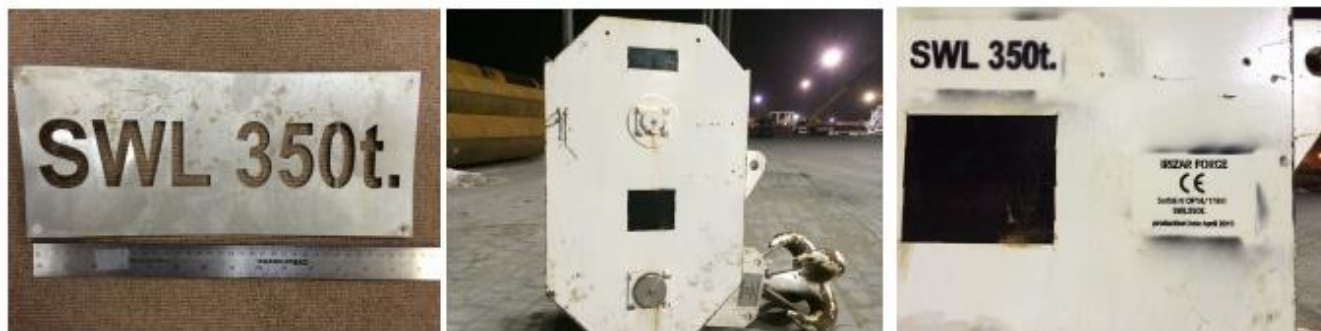
A member has reported a near miss incident in which an object – a steel SWL plate weighing 0.7 kg - fell from a crane block onto the deck. The incident occurred when a crane fast line was being used for loading operations from the quayside. A banksman and two riggers were on the quay in the process of choking off the lifting slings and connecting them to the crane fast line hook. During this task a steel SWL plate (0.7kg) fell from the Crane Auxiliary Block which was not being used at that time. The SWL plate fell from approximately 71m in height and landed at approximately 5m away from the working party. The DROPS calculator tells us that such an object falling from such a height could have caused a fatality had it hit someone.

- ◆ The SWL plate fell from the crane auxiliary block and there were similar plates still on this block and on the main block. Both these blocks, and the whip line block, had all been replaced during the re-fit period to enable the crane to operate subsea for a particular project;
- ◆ The means of securing the plates was of poor design – several plates including the one dropped were attached by four rivets of dissimilar metals (aluminium vs steel) promoting galvanic corrosion process and salt water corrosion;
- ◆ All plates showed signs of corrosion behind the plate – however deterioration of the rivets was not visible on the plate surface;
- ◆ All plates were flush against their fixings and looked secure to any visual inspection;
- ◆ There was no significant weather at the time of the incident.

The plates were removed. SWL and other identifying information was stencilled on the crane instead. There was an inspection of similar hook blocks elsewhere to verify that there were no loose objects or unsecured plates. The crane supplier/manufacturer was informed of the incident (lessons learnt to prevent further reoccurrence).

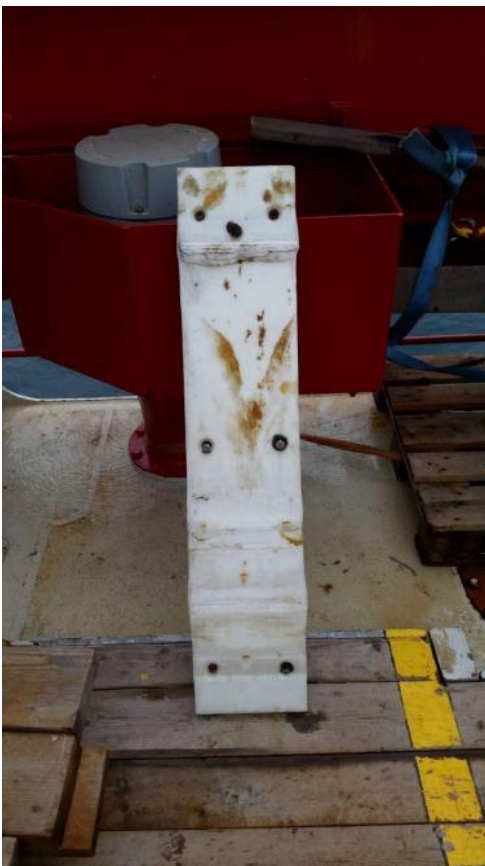
Teflon pad.

- ◆ Inspection of the dropped pad revealed that sheared parts of only two of six securing bolts remained in the pad;
- ◆ A similar incident had occurred on the same vessel some 10 months earlier, where the pad was found to be loose due to sheared retaining bolts;
- ◆ This earlier occurrence had not been investigated, allowing a repeat incident to occur with greater consequences;
- ◆ The Teflon pads and their retained bolts were inadequately or poorly designed;
- ◆ More frequent inspections of crane rest pads should be conducted to identify defects.

Our member concluded that the fundamental design of the pad was flawed. The purpose of the pad is to buffer impact and movement between the crane and the crane rest to provide protection to the crane boom during parking, stowage and start up. The weakness in the design was demonstrated by the fact that this was the second similar incident to have occurred. Additionally, had the earlier incident been investigated and remedial action taken, this second incident need not have occurred.

- ◆ Inspection of the condition of crane rest pads and associated retaining bolts;
- ◆ Addition of crane rest pads to planned inspection/maintenance routines;
- ◆ Considered the use of secondary retention devices on crane rest pads;
- ◆ Reinforced the importance of reporting incidents in a timely manner;
- ◆ Ensured deck crews took a “Time Out for Safety” (TOFS) to reinforce safe crane technique, including the requirement to bank the crane at all times – including parking and releasing the hook/headache ball from its stowage box.

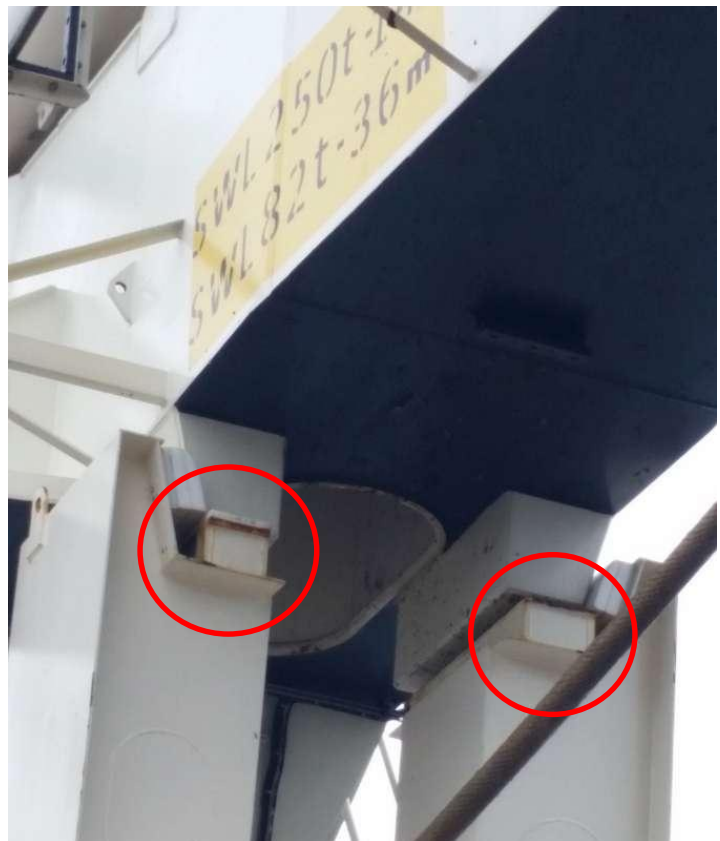
During piling operations on a chartered vessel, the crane had been used to recover an upending tool to deck. After de-rigging the crane, the riggers left the deck, while the crane operator proceeded to park the crane. Upon placing the crane boom in the rest, a Teflon pad weighing 6.9kg, dropped 8.8 meters from the starboard side of the crane rest down to the deck. The pad dropped directly to the deck and landed in an open area, just aft of the crane rest.

Location of Teflon pads on crane rest.

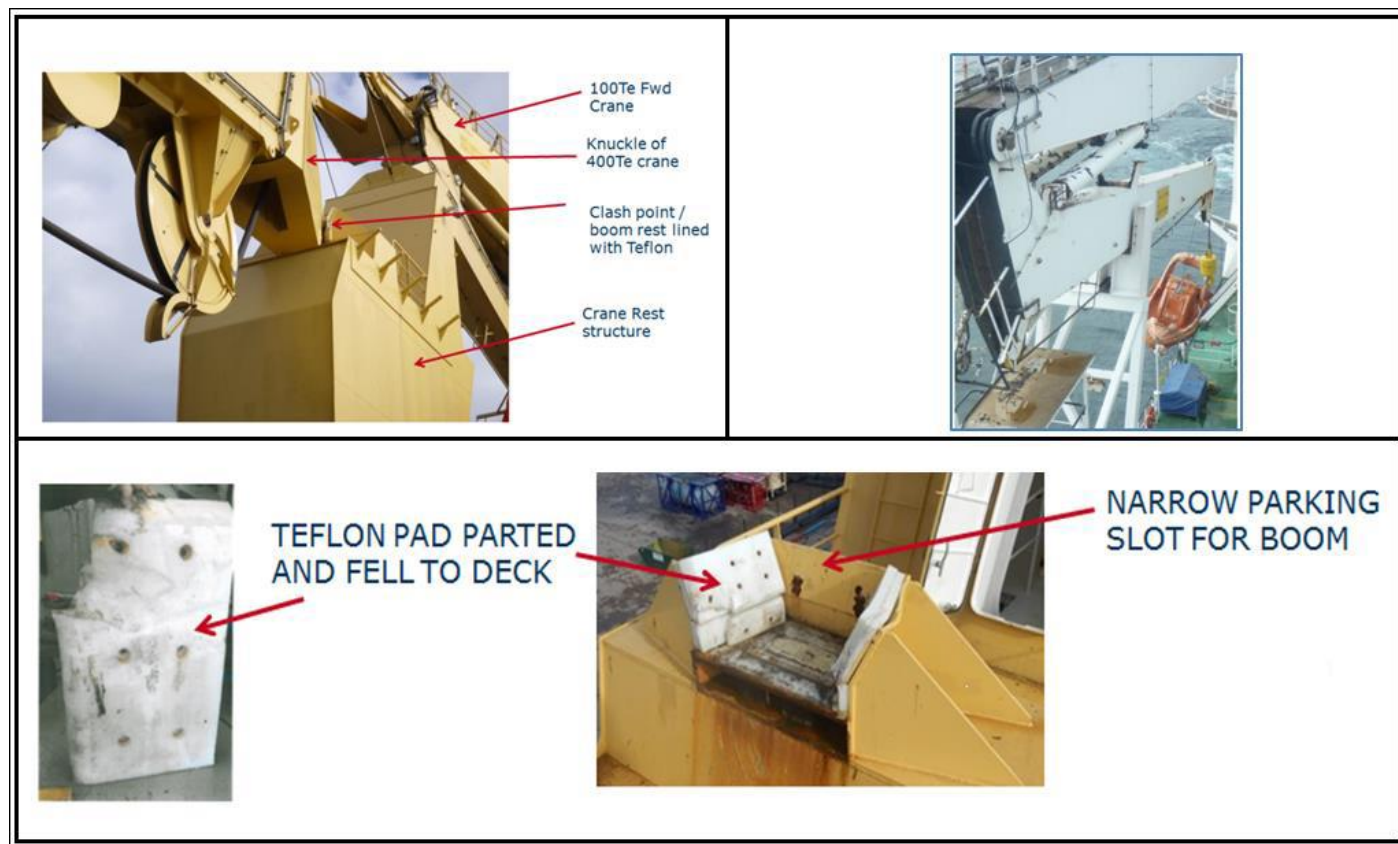
A member reported frequently dropped objects from crane rests during parking and when the crane boom was raised out of the crane rest. The falling objects had been Teflon or wooden landing pads, rubber protection, steel cover plates and nuts/bolts. An example is highlighted below:

- ◆ The crane rest had a tight fit/narrow parking slot for the crane boom;
- ◆ The crane rest protection cracked and although bolted dislodged as a result of everyday contact from the crane boom;

- ◆ Additionally it was difficult to monitor the landing/raising of the crane boom from the crane cabin.

- ◆ Teflon pads have been re-secured using larger washers on the bolts to prevent the bolts from being pulled through the Teflon/rubber, and a secondary chain has been attached to prevent the Teflon/rubber from falling to deck;
- ◆ Area around boom rest barriered off before parking/raising the crane boom;
- ◆ A dedicated spotter has been used to monitor the crane parking/raising operation;
- ◆ Cameras installed to aid inspection of the crane boom rest and assist parking/raising.

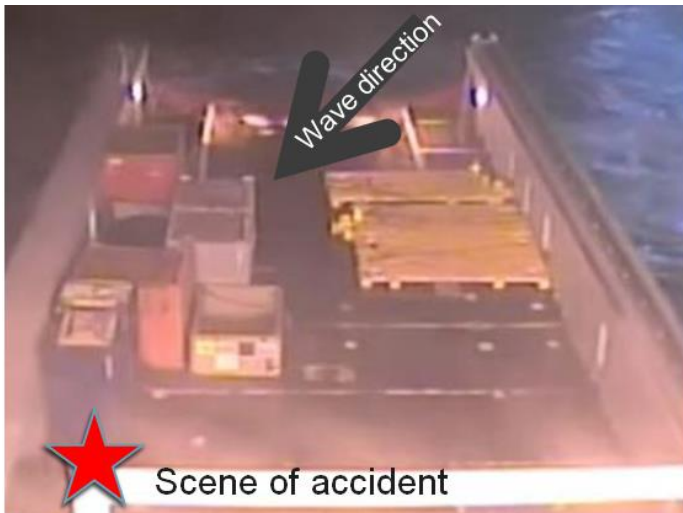
During this time the deck crew continued work on securing the cargo. Two Able Seamen (ABs) working on the deck decided that the sea fastening arrangement was not adequate to restrain the two mini containers located at the forward end of the deck. Additional rigging was required to rectify this, and one of the ABs left the deck to go to the nearby rigging store. The tension on the tugger winch was released to facilitate installation of the new rigging. A large wave crashed over the back deck of the vessel and travelled along the length of the deck, with the force of the wave causing movement of some of the landed cargo. The movement of this cargo resulted in the ABs becoming trapped between a mini container and a skip bin, with fatal consequences.

Scene of accident

- ◆ Working in and around unsecured cargo had become part of a familiar routine;
- ◆ A vessel with an open stern being used for cargo operations;
- ◆ Wave struck cargo;
- ◆ Cargo shifted 3-4 m on deck aft to forward;
- ◆ The crewman involved did not get out of the "line of fire" or hear the bridge warning over UHF radio.

- ◆ Further detailed risk assessment for AHTS conducting cargo operations. Risk assessment should include consideration of engineering controls to minimize excessive water on the vessel back deck (stern door or use of other vessel type);
- ◆ A review and update of company adverse weather working guidelines;

- ◆ A review of company cargo loading procedure to include cargo lashing arrangements, and further risk assessment for securing cargo;
- ◆ A review and update of company cargo securing procedure and risk assessment to include the requirement for a lashing plan and load sequence planning with rig before entering the 500m zone.

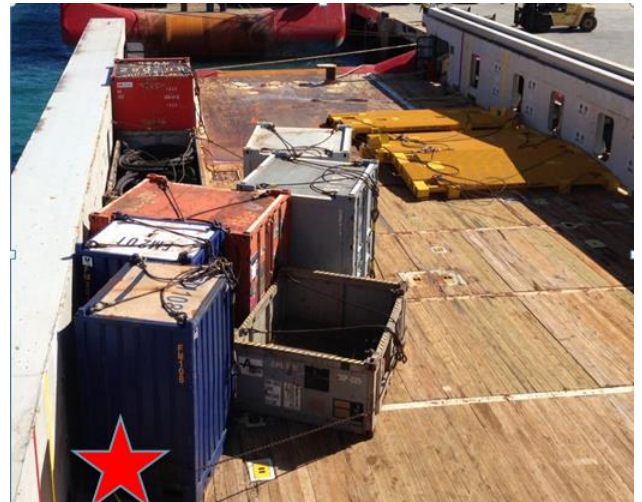
Photographs showing scene of incident.

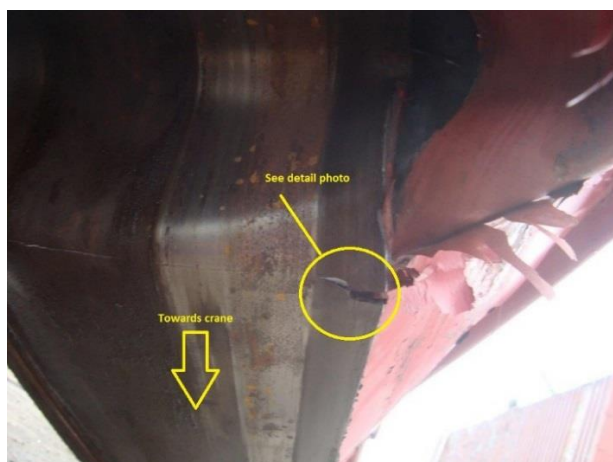
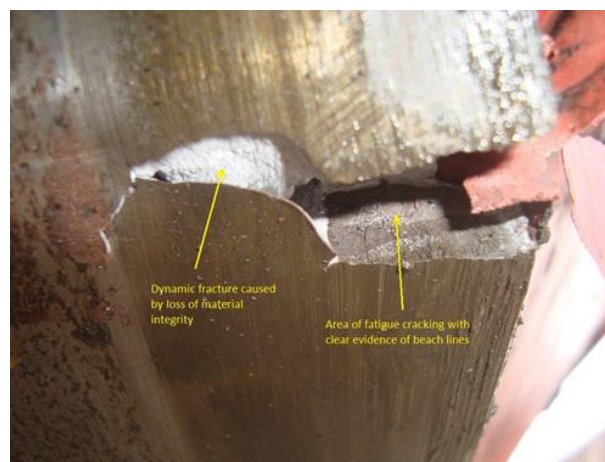
On investigation, it was found that the boom had buckled and cracked. The load was de-rigged safely; there were no injuries, nor was there any secondary damage to the load being lifted, or to the vessel.

- ◆ A large crack along the welded boom section was discovered which appeared to be old fatigue cracking and internal corrosion of the boom which evolved into a catastrophic materials failure;
- ◆ The crane had undergone recent testing by a third party, which did not discover the cracking;
- ◆ Testing/certification of the crane did not include Non-Destructive Examination (NDE) of critical areas;
- ◆ Several management failings were reported but none of these directly contributed to the incident.

The main cause of the incident was found to be material failure.

- ◆ Reviewed the crane planned maintenance system;
- ◆ Researched capability and cost of NDE to determine an appropriate amount of inspection versus risk.

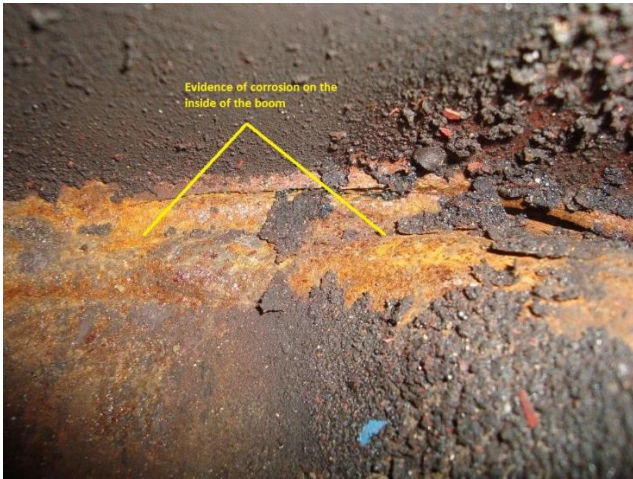
Showing close-up of corrosion

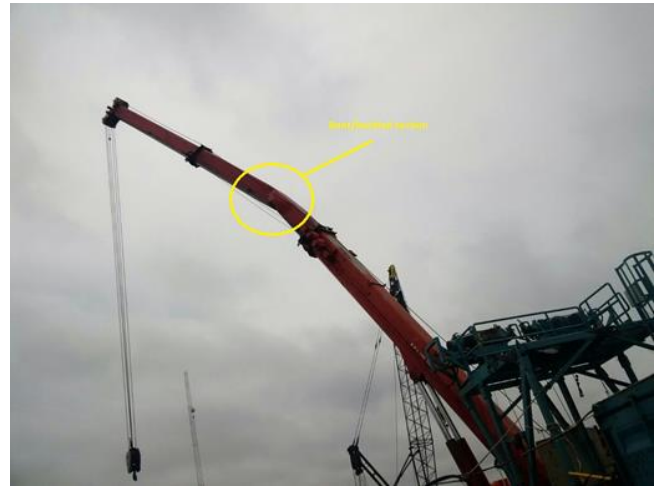
Showing point at which crane boom buckled (marked)
