## IMCA Safety Flash 21/16

August 2016

### Focus: Equipment Failure

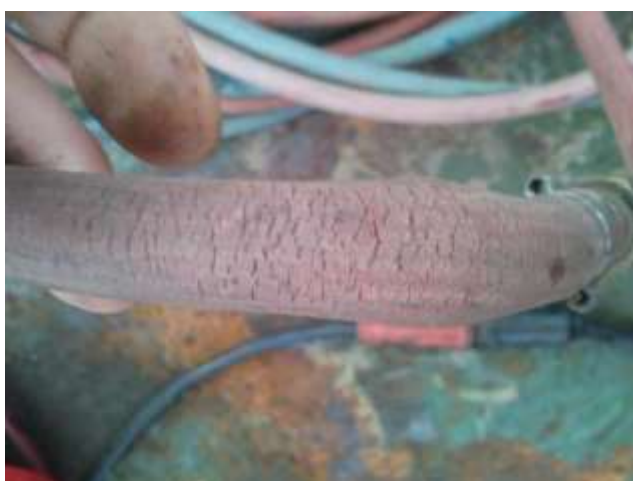
*Left: work-hardened and perished hoses*

- ◆ Repair or replace leaking components immediately;
- ◆ Remove damaged or leaking sections of hose, do not attempt to repair;
- ◆ Refit hose tails using crimp clips designed for that task;

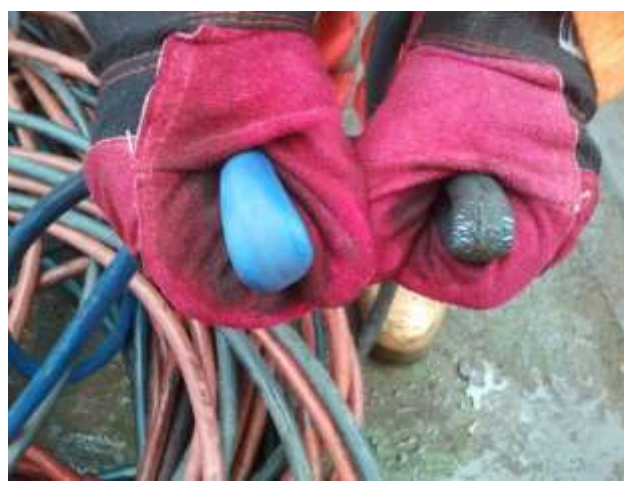
*Right: difference between new and old hoses*

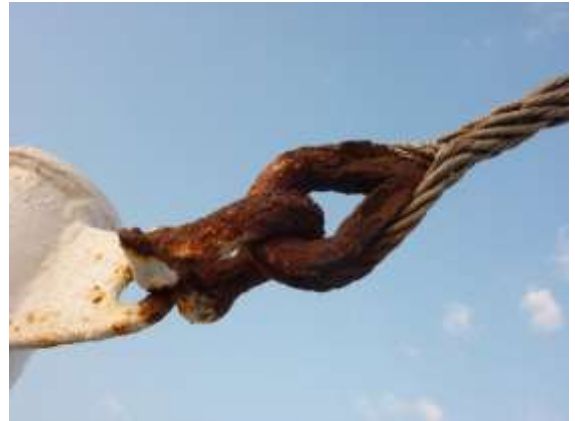
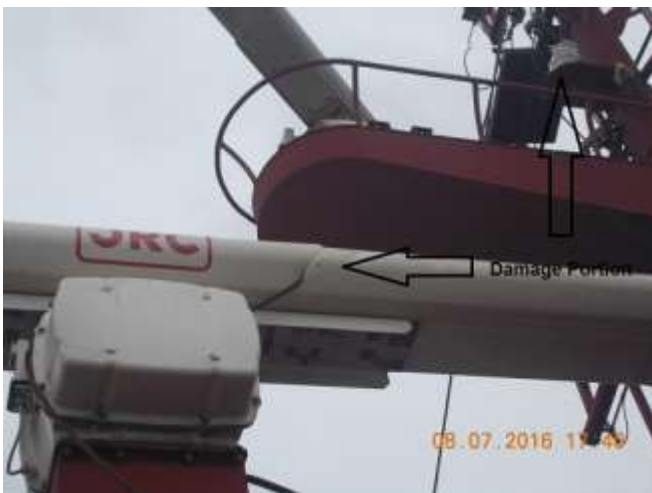
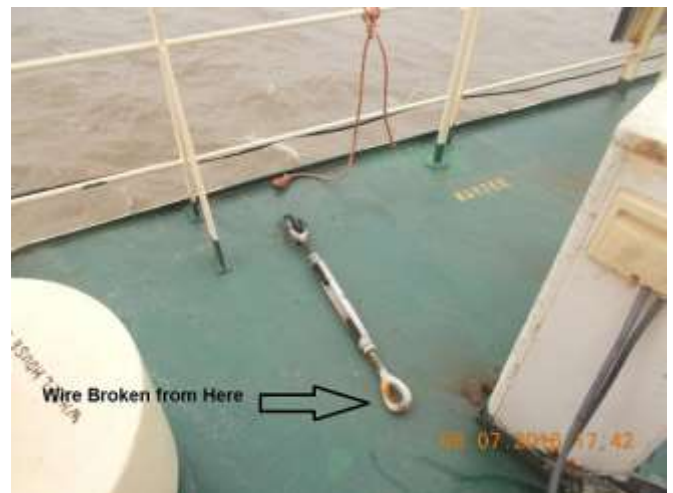
A member has reported an incident in which one of the wire stays securing a mast head, parted. A deck officer on watch heard a loud metal banging sound on the monkey island deck. Immediately both the radars switched off and someone was sent to investigate. One set of mast head securing wires (the port side) had parted from the long bottle screw and the strop had become entangled with a radar scanner. As a result, there was damage to the front side (radiation side) of the radar scanner cover, and the lower lamp assembly for the main mast head lights was damaged. The entangled strop was cleared away; temporary repairs were made to the radar scanner, and both radars tried out again.

The root cause of the incident was inadequate maintenance and inspection – failure to notice corrosion and impending failure.

Our member suggested that all similar securing arrangements should be inspected and tightened periodically and renewed or replaced, as necessary. Extra attention should be paid to all lashing and securing arrangement when heavy weather is prevalent.

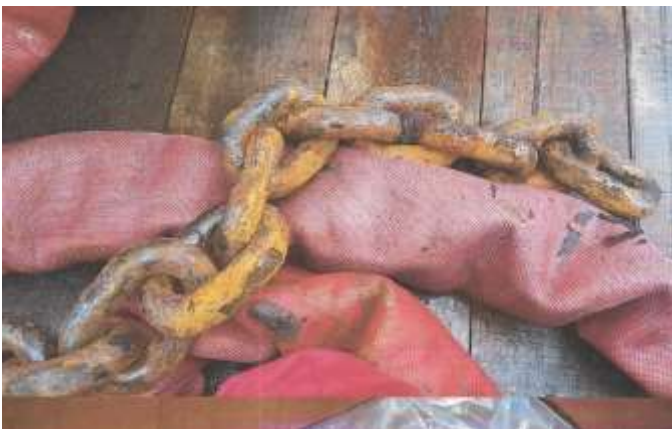
*Chain link and protective cover*

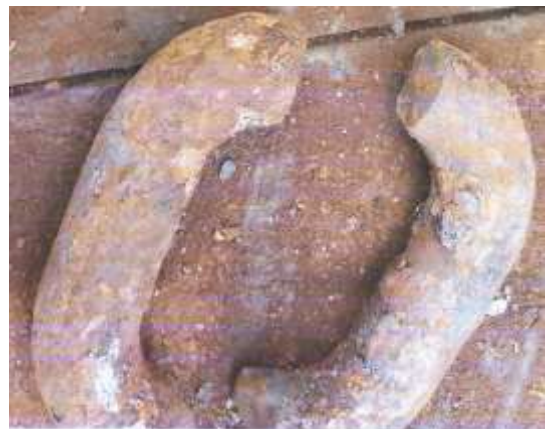
A member has reported an incident in which a chain parted during the recovery of a hyperbaric lifeboat (HLB) during routine testing and maintenance. On recovery of the HLB the vessel crane started the lift and when the weight on the crane load readout was approximately 7 tonnes, one leg of the chain set parted when two links split through their link ends. Since the HLB had not yet been fully lifted out of the water the drop was minimal and the parted chain dropped back onto the top of the HLB. There was no damage to the HLB shell due to the soft covering over the chain links.

*Chain link failure*

- ◆ Stopped the job;
- ◆ Lifted the HLB back in its original position using the davit system;
- ◆ The chain set was removed and quarantined.

- ◆ All HLB lifting chain sets should be re-inspected by full removal of the protective covering to gain complete access to each link for a thorough visual inspection;
- ◆ The inspection should be conducted by an authorised authority against an acceptable industry standard of acceptance criteria with emphasis on wear, cracks, pitting and corrosion.

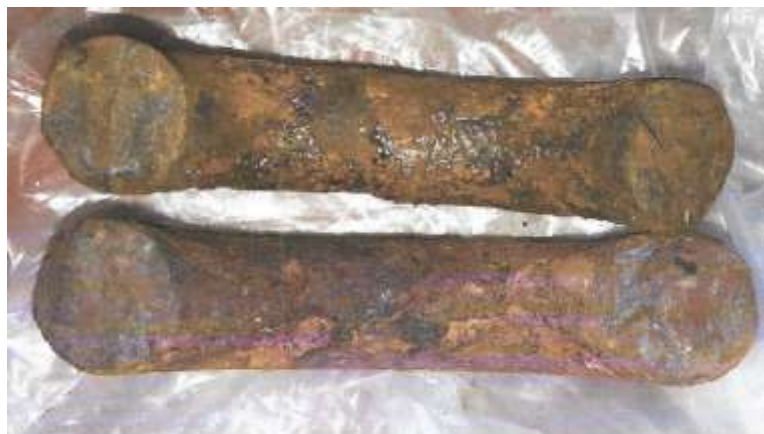
*Corrosion on cross section of failure zones*

- ◆ Periodic inspections of the chain were in date and on record;
- ◆ Significant corrosion was discovered on the chain, raising concern about the pass/fail criteria used on the previous visual inspection;
- ◆ The cross section of the failure locations revealed corrosion indicating the presence of cracks prior to failure;
- ◆ The protective covering is a potential obstruction to thorough and effective inspection of the individual chain links;
- ◆ Environmental conditions at the time of the incident were stable and could not have contributed to high impact loads;
- ◆ The chain set has been returned to the manufacturer for mechanical testing and analysis. The results of this testing are pending.
