IMCA Safety Flash 21/17

August 2017

Theme: Dropped Objects, Lifting and Cargo Handling

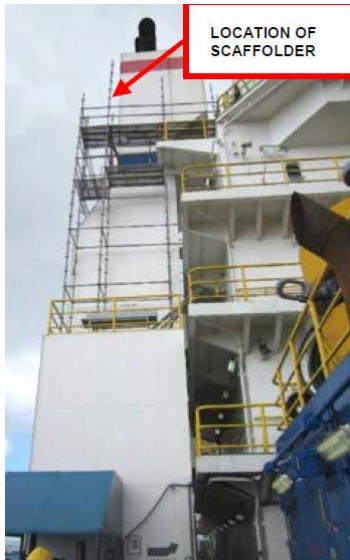
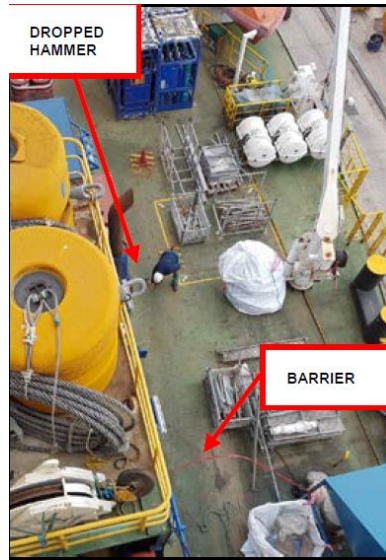
A hammer weighing 1.1kg was inadvertently dropped from height and fell over 12m to the deck. Third party scaffolders were erecting scaffolding along the funnel of a vessel. At the time of the incident, the decks below where the scaffolders were working were barriered off as required by the risk assessment. When moving from one level to the next, a hammer caught on the floor plate and was tipped out of the scaffolder's belt loop. The hammer slipped free from the attached lanyard (see photo), fell and bounced off the handrail of one of the lower decks and came to rest *outside the barriered area* on the forecastle deck. No-one was harmed.

- ◆ The lanyard and hammer were not suitable to be used together;
- ◆ Due to the inexperience of the scaffolding contractors with working at height tooling, the scaffolder and supervisor did not identify the issue;
- ◆ **The barriers were insufficient** – they were not wide enough and were not in line with the “cone of exposure” guidance provided in the dropped object prevention procedure.

- ◆ Although aware of the requirements for lanyards, the scaffolders were not skilled/trained in their use to the same level as the company personnel. When dealing with subcontractors who have different custom and practice, it is important to take a more active supervisory role to ensure things are done correctly and safely;

- ◆ Company requirements were communicated to the yard and scaffolding supervisor verbally at the site. There was no documented transmission of procedures. All documentation should be formally transmitted to all subcontractor's management to ensure that requirements are rolled out from the top down;

- ◆ Members may wish to reiterate:
 - the importance of the “cone of exposure” when dealing with dropped object protection, and ensure that this is discussed and given careful consideration

- the importance of ensuring lanyards and tool tethers are applied correctly when working at height.

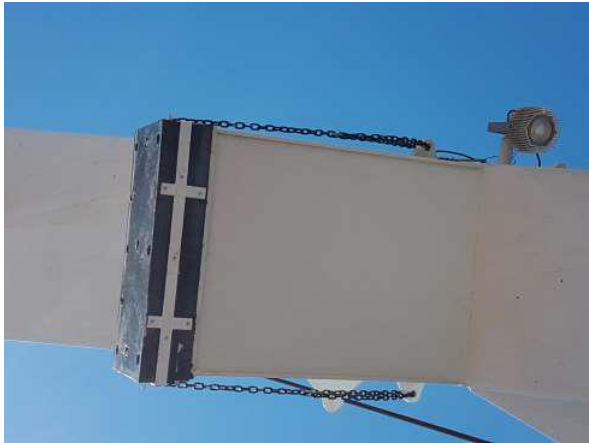
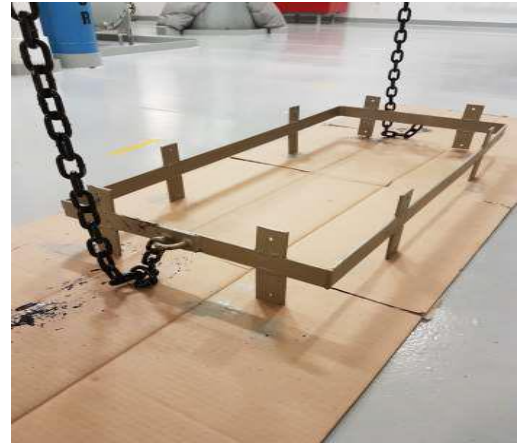
During lifting operations with the main crane, a buffer plate fell from the crane boom. It fell approximately 10m, weighing 70 kg and was 90cm x 40cm. It landed inside the barriered off area on the back deck; there were no personnel nearby. Clearly this could have been a potential fatality had someone been struck by the plate. The purpose of the buffer plate is to be a buffer between the jib and the boom so the steel is not damaged.

- ◆ The **immediate cause** was found to be that the bolts holding the buffer broke due to metal fatigue;
- ◆ The **root cause** was found to be inadequate or insufficient planned maintenance/inspection. Fatigue in the bolts had been allowed to develop over several years in operation as there had been no proper inspection of the bolts. It was not possible to see damage to the bolts during the visual inspections of the crane which were regularly carried out.

Showing buffer plate and subsequent secondary securing chains

- ◆ The bolts used subsequently to re-attach the buffer plate were increased in size from M12 to M14;
- ◆ Secondary securing of the buffer plate was installed to prevent it from falling;
- ◆ On all the members' vessels with similar cranes, the planned maintenance system was modified to include maintenance/inspection of the buffer plate including bolts;
- ◆ A DROPS check of all cranes was made in order to assess for potential dropped objects during operation.

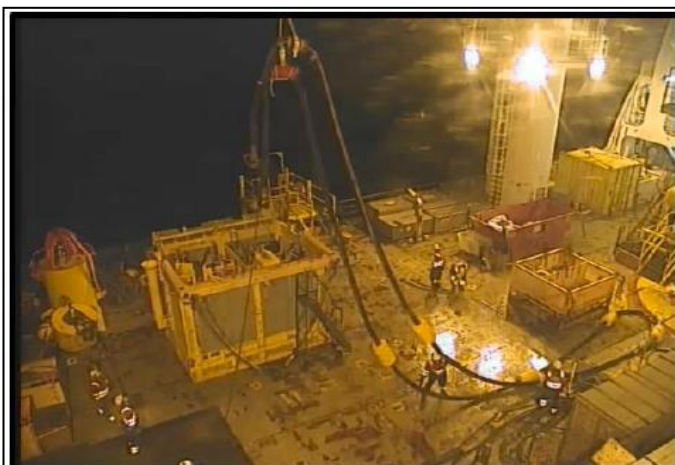
Rigging crew positioning during lift

Although no-one was harmed, and no-one was stood directly under the load, CCTV footage shows the deck crew being in “at risk” positions during the lifting operation and handling the load for no apparent reason.

- ◆ Safe positioning of lifting crew during crane operations – active supervision at all times;
- ◆ Thorough inspection – before use – of all pre-rigged lifting equipment coming from external parties;
- ◆ Reiteration of the importance and the correct use of Lift plans;
- ◆ Stop the job when exposed to unfamiliar equipment!

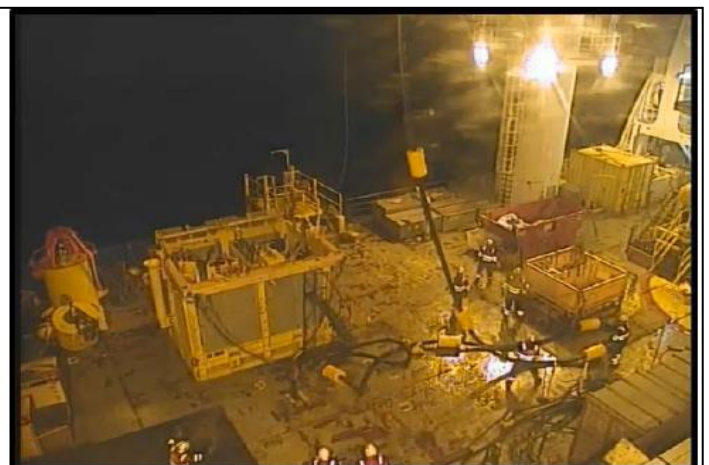
Dropped fuel hose on deck

On inspection, it was identified that the lifting sling had been incorrectly installed onto the hose saddle. The sling should have been choked around the saddle and fuel hose but instead, was found choked around the non-load bearing urethane sling guide.

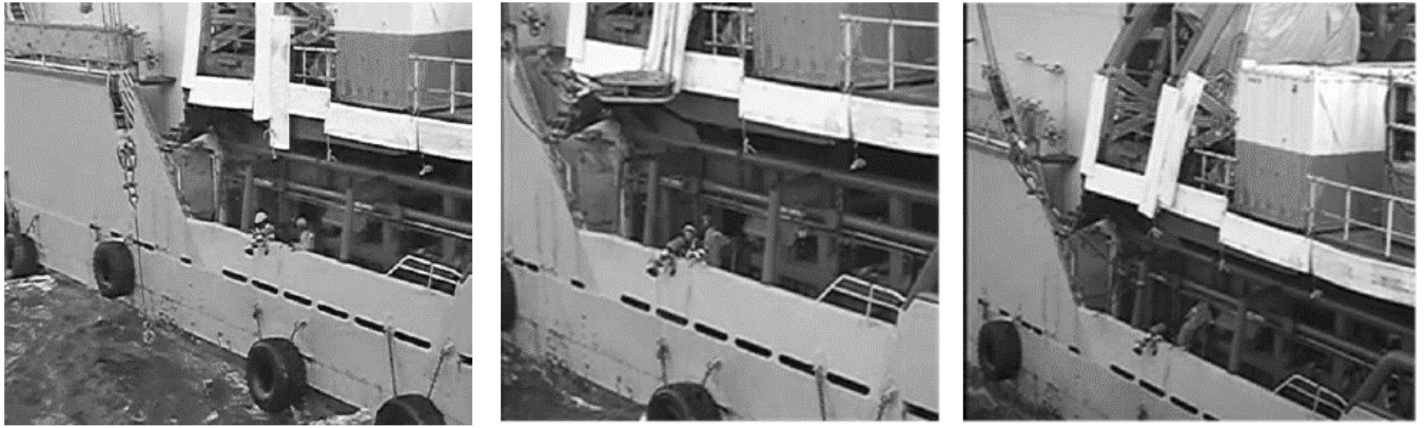
During bunkering operations between two vessels at sea, there was an uncontrolled movement of a crane block, resulting in a pennant striking a supply vessel, placing personnel in the line of fire. The receiving vessel’s crane was positioned along the supply vessel’s port side where deck crew were waiting to secure and connect the hose to the rigging. The supply vessel rolled to Port due to sea swell. This caused the crane’s auxiliary hoist block to make contact with the supply vessel’s ROV launch and recovery system platform, which in turn caused the hoist block and attached pennant to swing.

While swinging, the pennant and hook made contact with the work station close to where the supply vessel’s deck crew were stationed. Following the incident, an **All Stop** was called. After the task was reassessed, the supply vessel proceeded to re- route the hose along the main deck. The operation was successfully completed.

- ◆ Activities involving different departments should be jointly and thoroughly planned with clearly defined roles and responsibilities;
- ◆ Operations involving crews unfamiliar with one another (as on visiting supply vessels, etc.) should be fully planned in advance.
