IMCA Safety Flash 21/18

September 2018

Equipment failures

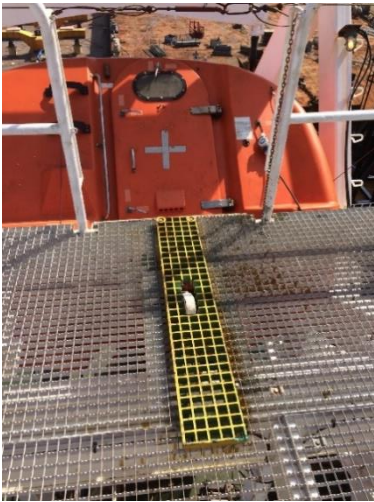
Normal stowage position

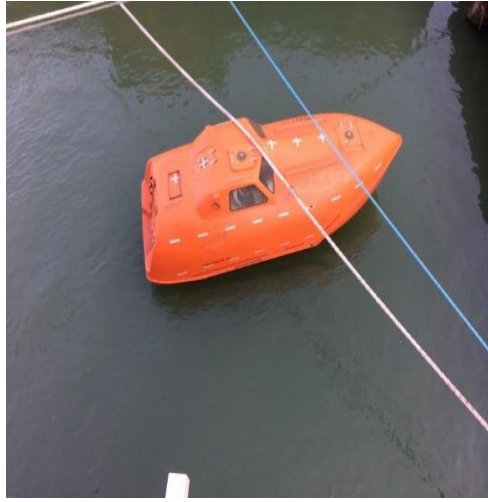
Location after accidental release

By eliminating the technical failures or human intervention, the only possible explanation is that the master link was not properly placed on the release hook, and gradually slipped out of the hook over time.

- ◆ Re-assessment and careful positioning of the master link when replacing the lifeboat;
- ◆ Temporary downgrade of lifeboat safety certificate (fewer POB);
- ◆ Assessment of risk for maintenance (securing) hook to be permanently on the lifeboat when the vessel was at sea (there was no objection from Class). However, it was decided not to do so. The reason for this was the risk following from a more complicated emergency procedure for the crew in emergency was considered too high;
- ◆ The maintenance hook to be used always when in port, or during maintenance at sea.

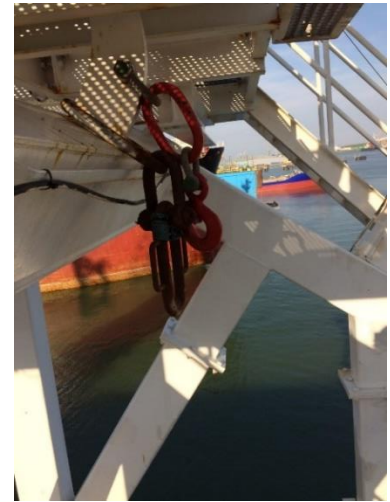
Master Link and maintenance hook (red painted) after release

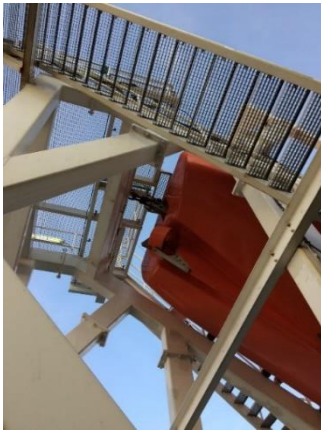
Lifeboat retrieved back in cradle

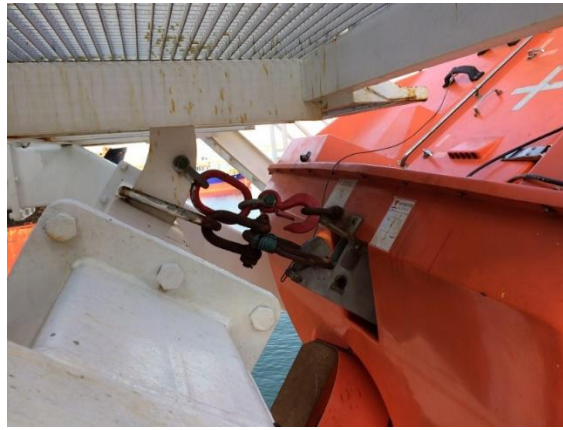
Close up of connection after retrieving back (maintenance hook applied for security)

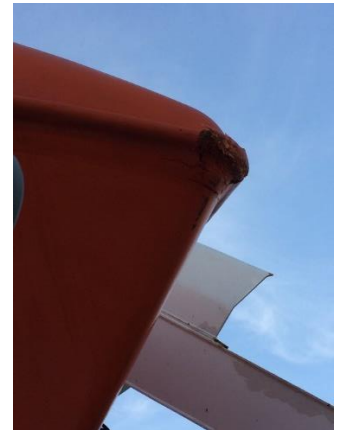
A crew member noticed the boat in the water and investigation began. Crew boarded the lifeboat and it was found that the release hook was still in the locked position and safety pin was in position. Also, the master link in the hook was in good condition. It was not understood how it could have happened. The bow of the lifeboat sustained damage, coming from collision with a barge moored about 20m behind the vessel. The barge was undamaged.

Damage to the bow

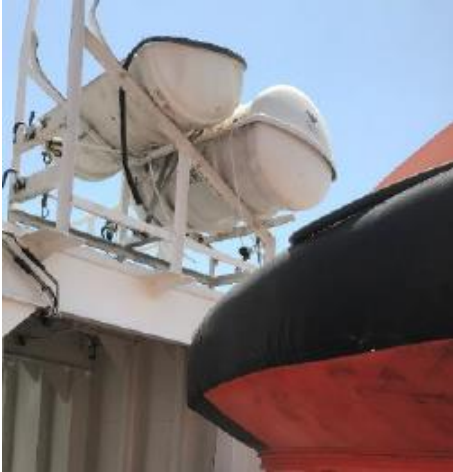
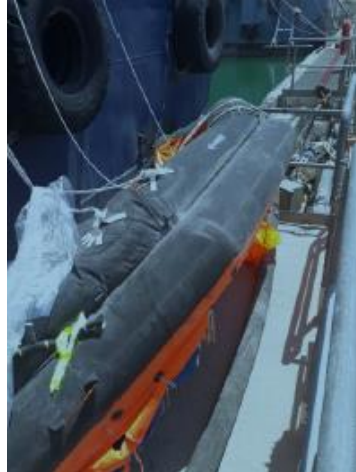
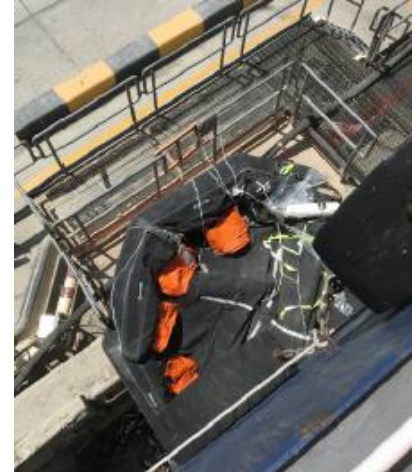
A life raft self-activated and fell from its cradle from the vessel deck, 8m down onto the barriered quayside bollard area. The weather temperature at the time was 44°C.

The life raft securing straps, pennant line and life raft station security belts were inspected, and no signs of external impact observed. Investigation identified that the life raft self-inflated following sudden release of gas from the gas cylinder. Further inspection of the cylinder by a third-party showed no damage or corrosion to the bushing disc or the circular piece cut; internal inspection of the cylinder found no excessive surface corrosion.

- ◆ The gas cylinder was not properly serviced by a third-party service provider;
 - investigation identified that improper torque force was applied to cylinder valve disc bushing
 - the disc was not wound back while the cylinder was being filled. This bent the disc towards the anvil and pushed it hard against it. This could have damaged the disc and then failed as the pressure rises on a hot day
 - potential damage to diaphragm and overfilling of cylinder, added to build-up of pressure due to the extreme heat over a sustained period, could have led to the diaphragm failure.

- ◆ When servicing OEM supplied equipment, manufacturer's service manual requirements should be complied with at all times;
- ◆ When making use of third-party providers, ensure that there is proper communication and ensure an effective service provision assurance process is implemented.

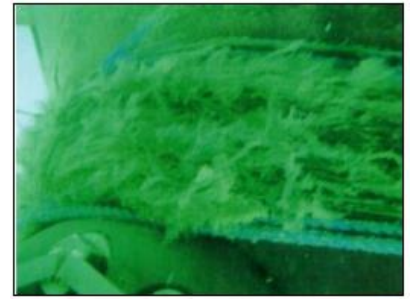
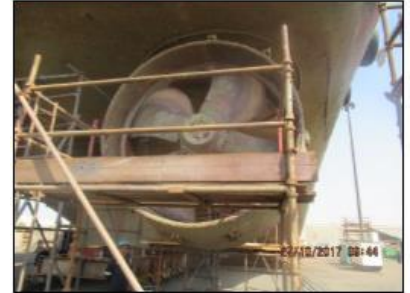
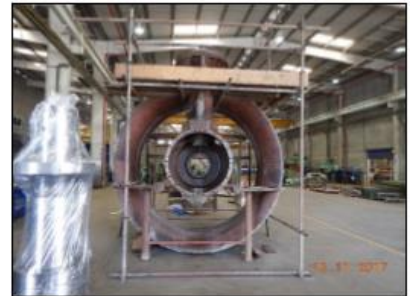
Investigation revealed the presence of seawater in the thruster oil system. The vessel left the platform using the port engine only and an underwater survey of the propellers was carried out on location. That underwater inspection showed rope and fishing nets fouling the starboard propeller and azimuth unit. The presence of oil around the propeller hub was also noted. The vessel had to go into dry dock, and the thruster assembly, including propeller blades and Kort nozzle, had to be removed for repair.

- ◆ Rope and fishing net fouling found on the starboard azimuth thruster;
- ◆ The seal was damaged by the fishing net;
- ◆ Seawater presence was observed in the hydraulic system;
- ◆ Reduced lubrication quality of the hydraulic oil caused damage to thruster components;
- ◆ Vibrations were noted on the hydraulic pump. Suction filters were found clogged with water and oil residues.

- ◆ Crew should check equipment manuals and ensure correct maintenance intervals have been added to the PMS;
- ◆ Manufacturer to study the possibility of installing a net cutter on the propeller shaft;
- ◆ In order to recognize water ingress caused by leakage quickly, equipment to facilitate random chemical sampling to determine water content should be installed.

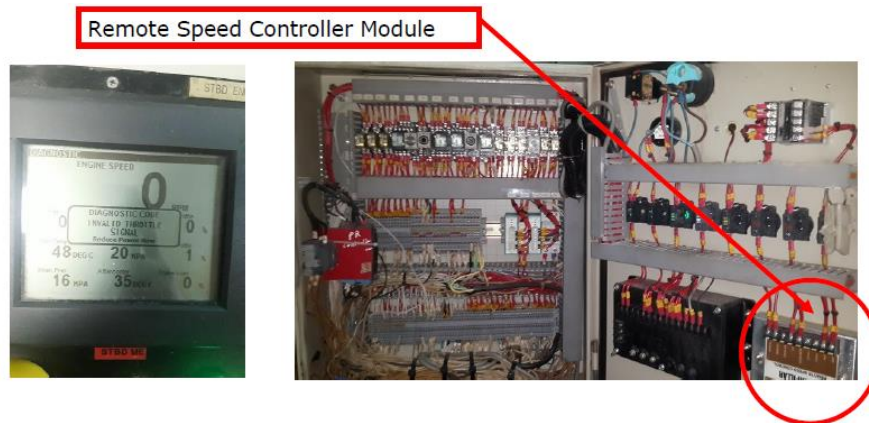
An offshore support vessel (OSV) was underway to field loaded with cargo when a sudden drop of starboard main engine RPM was observed. The main engine dialog screen gave the error message <invalid throttle signals>. The engineers informed the bridge immediately. Investigation began; the onshore office and the client were also informed. With the client, it was decided to take the vessel back into port as a quick fix was not available.

- ◆ The remote speed controller module had failed;
- ◆ The cause was overheating for a prolonged period;
- ◆ The root cause was assumed to be extremely unfavourable conditions (hot and humid) in the engine room, leading to unexpected and unpredictable failures of electronic components because of high temperatures.

- ◆ Crew should remain aware of and alert to the likelihood of unexpected equipment failure under extreme conditions of heat;
- ◆ Sufficient spares of potentially vulnerable electronic items should be carried and stored appropriately.

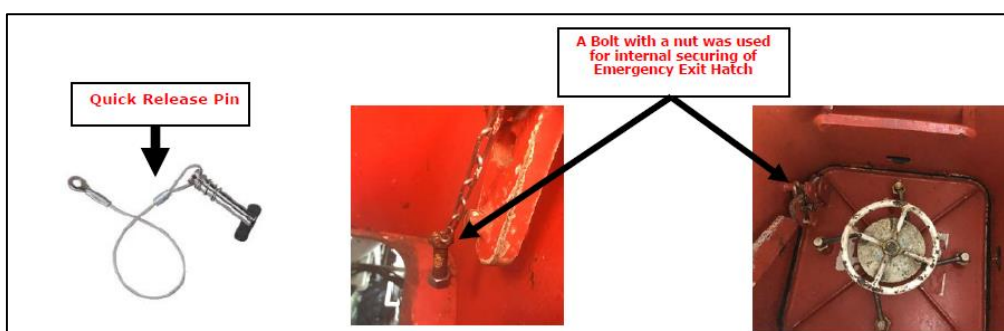
The port side emergency exit to deck from the steering gear room failed to open during an inspection by shore-side management. In addition, inappropriate locking arrangements (bolt with a nut) were found used for various emergency exit hatches located on both sides of the main deck.

- ◆ There were inappropriate locking arrangements for emergency exit hatches – these should not be used. This practice could have led to a potentially hazardous situation where the hatch could not be opened.

- ◆ As per company planned maintenance schedule, the correct and full operation of all watertight doors and escape hatches should be checked on a weekly basis;
- ◆ Safety inspections and maintenance of critical equipment should be conducted in an effective manner.
