IMCA Safety Flash 22/15

December 2015

I Near Miss: Corrosion-Related Failure of Bolts Used To Secure Lifeboat Winches

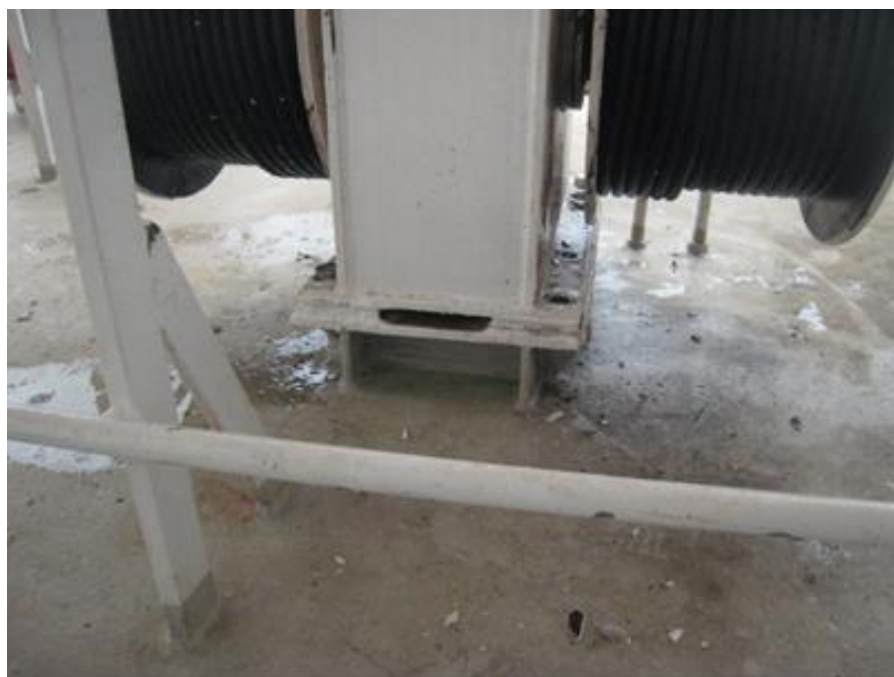
There are four lifeboats on board the vessel, each with a similar winch and foundation arrangement. Further investigation of the first winch foundation plate detected an additional four bolts that were severed but still retained within the foundation assembly – in summary, a total of five out of eight bolts had failed. This prompted an inspection of all the winch foundation units on the remaining lifeboats. On a second lifeboat three out of eight bolts were detected as being severed while still being retained in place on the assembly by the paint coating. The remaining two lifeboat winch foundation assemblies were found to have no bolt failures.

Winch foundation plate assembly (with some failed bolts removed).

- ◆ The bolts failed as a consequence of intergranular corrosion;
- ◆ The chromium-manganese alloy from which these bolts were manufactured was not considered a suitable material for bolting in the marine environment;
- ◆ The carbon content of the alloy used would make the material highly susceptible to grain boundary sensitisation and consequently to intergranular corrosion.

In short, the bolts supplied and installed (which had been in place for approximately eight years) were not suitable for use and had failed through corrosion.

- ◆ A safety flash was issued to all company vessels instructing them to thoroughly examine similar lifeboat foundation plate hold down bolts;
- ◆ The vessel on which this incident took place, all foundation hold down bolts on all four lifeboat winch foundations were replaced;
- ◆ The severed bolts were taken onshore for metallurgical investigation to determine the root cause of the failure;
- ◆ The ship builder and the supplier of the lifeboats were notified of the incident and invited to participate in the investigation.

- ◆ All fleet vessels with similar winch foundation arrangements were to replace the existing bolts with grade 8.8 – Hot Dip Galvanized bolts and nuts as soon as possible;
- ◆ All fleet vessels with similar winch foundation arrangements were to ensure that the bolts are replaced every five years with grade 8.8 Hot Dip Galvanized bolts and nuts immediately before the 110% load testing of lifeboats. This will become part of the five-yearly lifeboat routine;
- ◆ Maintenance routines were revised to include the above changes;
- ◆ The ship builder was asked to investigate their own quality control procedures for nuts and bolts used in critical areas;
- ◆ The ship builder was asked to liaise with other ship owners for whom they had supplied similar davit foundation assemblies, to inform them of the situation and to ask them to check the condition of hold down bolts.

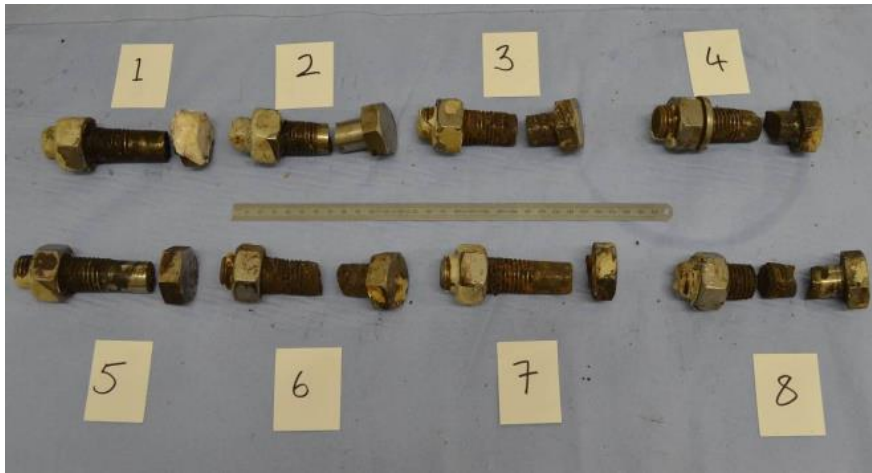
The condition of the severed bolts.

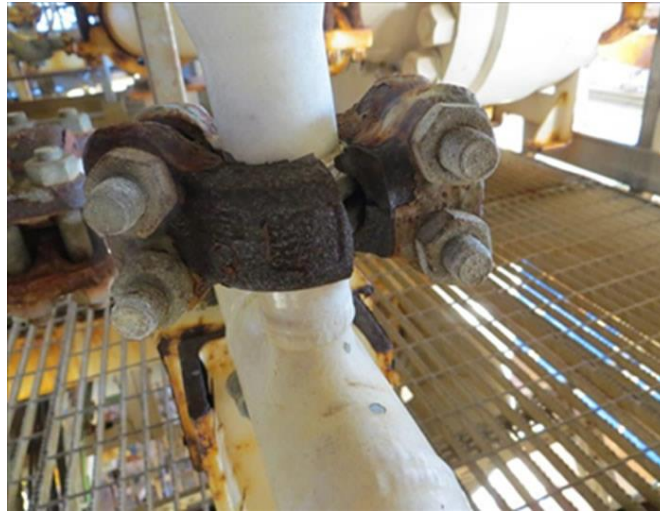
The UK Health and Safety Executive (HSE) has published a safety alert regarding an incident in which there was a catastrophic failure of a pipework clamp connector. The incident occurred on an offshore production platform where a 1" diameter Vector 'Techlok' pipework clamp connector catastrophically failed causing a gas release. The failure was caused by poor heat treatment during the manufacturing process, which led to failure by cracking.

Cracking caused by poor heat treatment during manufacturing process.
