## IMCA Safety Flash 22/16

September 2016

### Summary

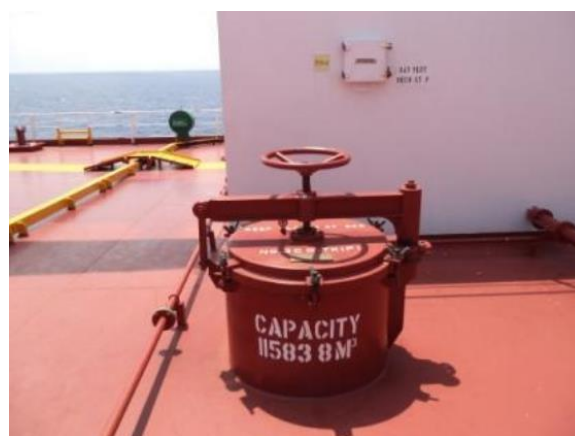
The Chief Officer and Cadet entered the cargo tank after an enclosed space work permit and risk assessment had been completed. When the Chief Officer and Cadet reached the bottom of the cargo tank they felt debilitating effects of hydrocarbon vapour present at the lower level of the cargo tank. Both the Chief Officer and Cadet attempted to activate their Emergency Escape Breathing Devices (EEBD) and exit the cargo tank.

The Master observed the Cadet in difficulty and quickly entered the tank, ignoring the advice of a fellow crew member. The Chief Officer successfully exited the cargo tank but the Cadet had collapsed unconscious on the tank bottom. When the Master reached the tank bottom to aid the Cadet he was overcome by hydrocarbon vapour and collapsed.

The alarm was raised and a rescue was quickly initiated. The Master and Cadet were retrieved from the bottom of the cargo tank and brought to the main deck where first aid was administered. The report concludes that the Master died and the Cadet was injured as a result of entering the cargo tank containing a concentration of hydrocarbon vapour at the bottom of the cargo tank. The ship's safety procedures for enclosed space were not

fully complied with and the risk posed by the hydrocarbon vapour measured in the cargo tank was not appreciated by those involved in the tank entry preparations.

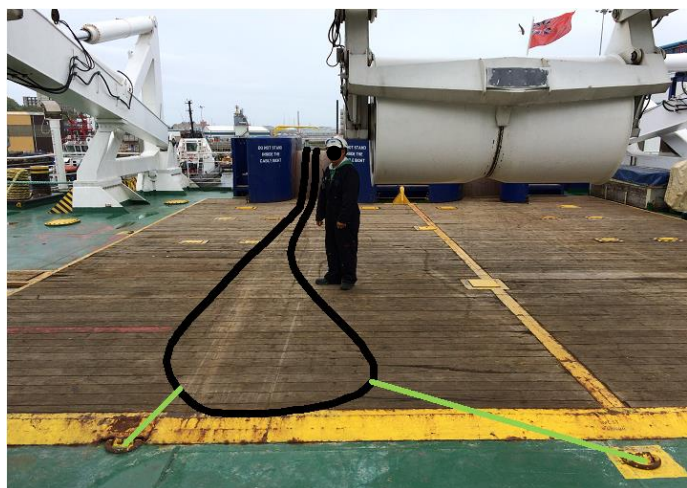
A member has reported a near miss potential “line of fire” incident during cable handling operations in which a member of the deck crew stood close to a heavy duty cable that was about to come under tension. With the recovered cable bight secured to a deck stopper, one of the deck crew was working in the vicinity of the cable just prior to cutting the bight. The Master observed the crew member’s unsafe position and exercised a “stop work” to prevent potential injury.

*Diagram outlining positions at the time “Stop Work” was exercised;*

A Safety Observation was raised and discussed at the Safety Committee meeting, and all deck crew were reminded of “lines of fire” and to keep clear of “snap back zones” in the vicinity of cable, wires and ropes.

The incident serves to reiterate the need for awareness of the “line of fire” and “snap back zones”. Whenever working with cables, wires and ropes, be aware of the surroundings and any actual or potential hazards. Watch out for team mates – keep an eye on all colleagues to ensure they are safe at all times. Never be afraid to “stop work” – whenever unsafe acts or conditions are encountered, stop the job and do not restart until you are safe to do so.

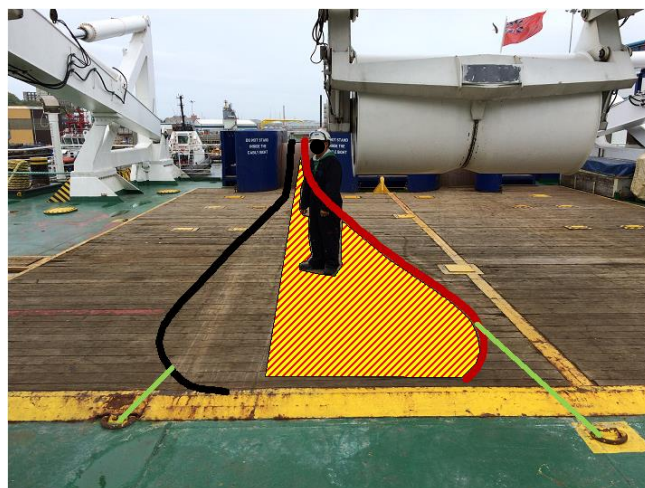
*Diagram outlining the crewman’s position – directly in the “Line of Fire” - if the cable had been cut. The hatched area indicates the “Snap Back” zone and the red line, the possible path of the cable*

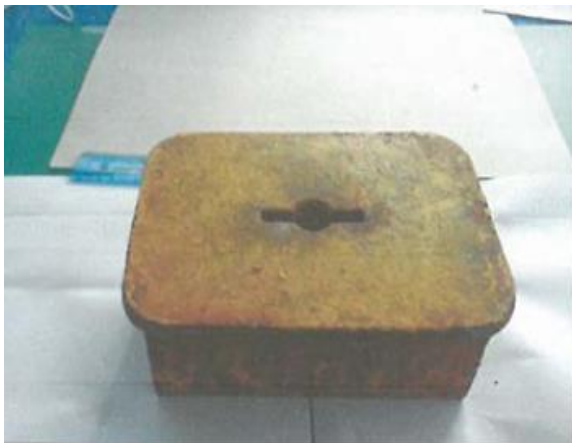
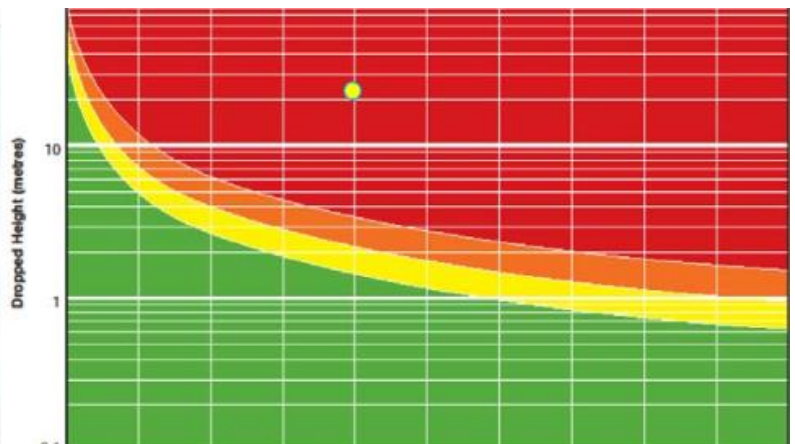
The MSF has published a safety alert regarding a potential dropped object. Following cargo offloading operations from a vessel to an offshore platform, the platform crew notified the vessel that a post cover had been found on top of a mud skip that had been received from the vessel. The post cover had the potential to be a dropped object of major consequence. The post cover weighed approximately 4kg.

The post cover had been removed while lashings were fitted to cargo. The post cover was placed on top of the mud skip and not been removed before the oncoming shift hooking the off-going mud skip onto the crane. The post cover had gone unnoticed and the mud skip was offloaded to the platform. Post covers are known to come free during adverse weather and previous incidents have involved the lodging of post covers in forklift pockets of containers.

- ♦ **Immediate Cause** – Crew member left post cover on top of mud skip during cargo operations;
- ♦ **Root Cause** – No process in place for managing the removal and replacement of post covers during cargo operations.

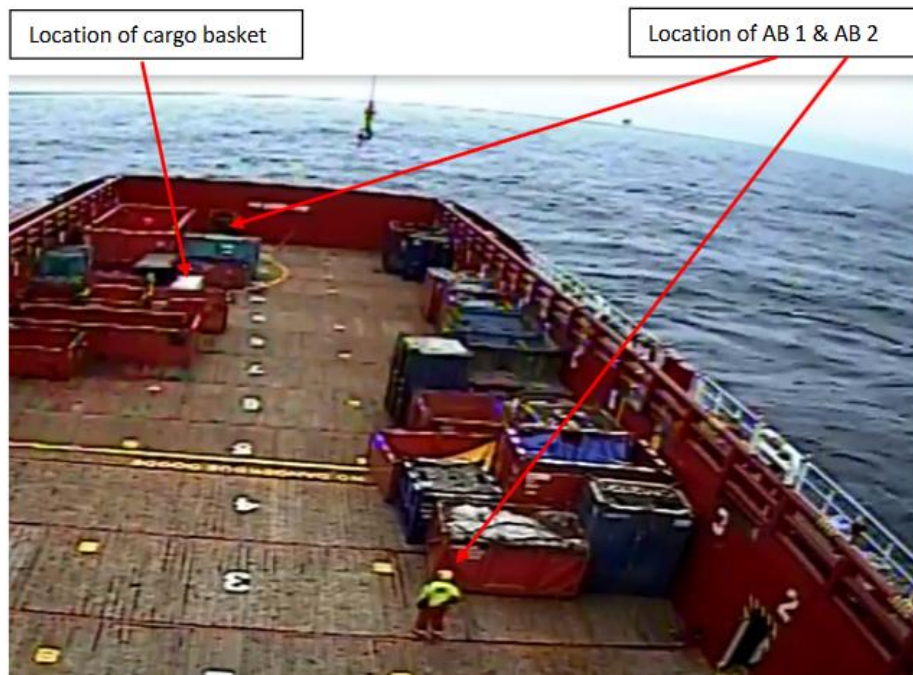
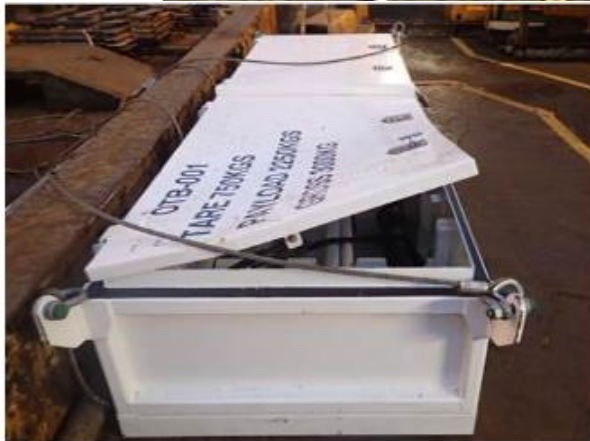
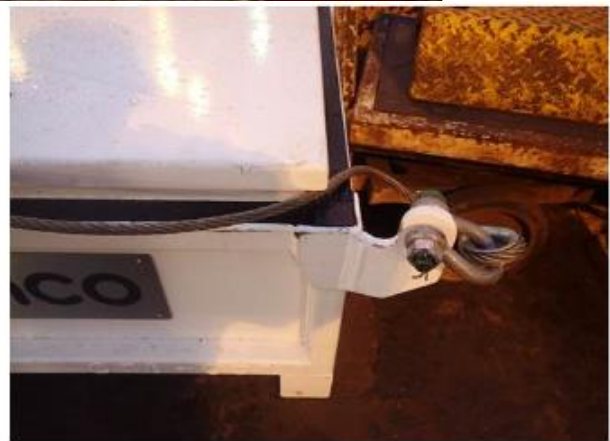
The MSF has published the following safety alert regarding lifting during cargo operations. A Platform Supply Vessel (PSV) was working alongside an offshore installation carrying out cargo operations, which included the discharge of a small cargo basket. After unhooking the previous back loaded cargo carrying unit (CCU), crewmen ‘walked the crane’ approximately 15 metres and hooked on a cargo basket – they then left the area and the crane began to take the strain. As the slack was being taken up, the lifting bridle caught under the lid of the basket. Fortunately, the crane driver noticed the lifting bridle snagging and lowered the load. Both the crewmen had walked away from the basket in different directions neither observing the basket being lifted, and so neither were aware that the lifting bridle had snagged, nor could they see each other to highlight the problem.

After a short time both crewmen made their way back to the basket and cleared the lifting bridles. They then stood clear in a safe haven nearby while the crane took up the slack but once again the lifting bridle caught on the lid, this time buckling the lid exposing the cargo inside.

- ◆ All involved (both on the vessel & on the installation) were reported as experienced in PSV operations;
- ◆ The crewmen on board the vessel routinely carried radios to maintain contact with the bridge and crane. All were reported as fully operational although they did not routinely talk to the crane driver during every lift;
- ◆ As the incident progressed there was minimal communication between the crane operator and the crewmen regarding what problems were being encountered and how they would proceed;
- ◆ The full operation and difficulties encountered were witnessed by at least three persons, none of whom “stopped the job”.

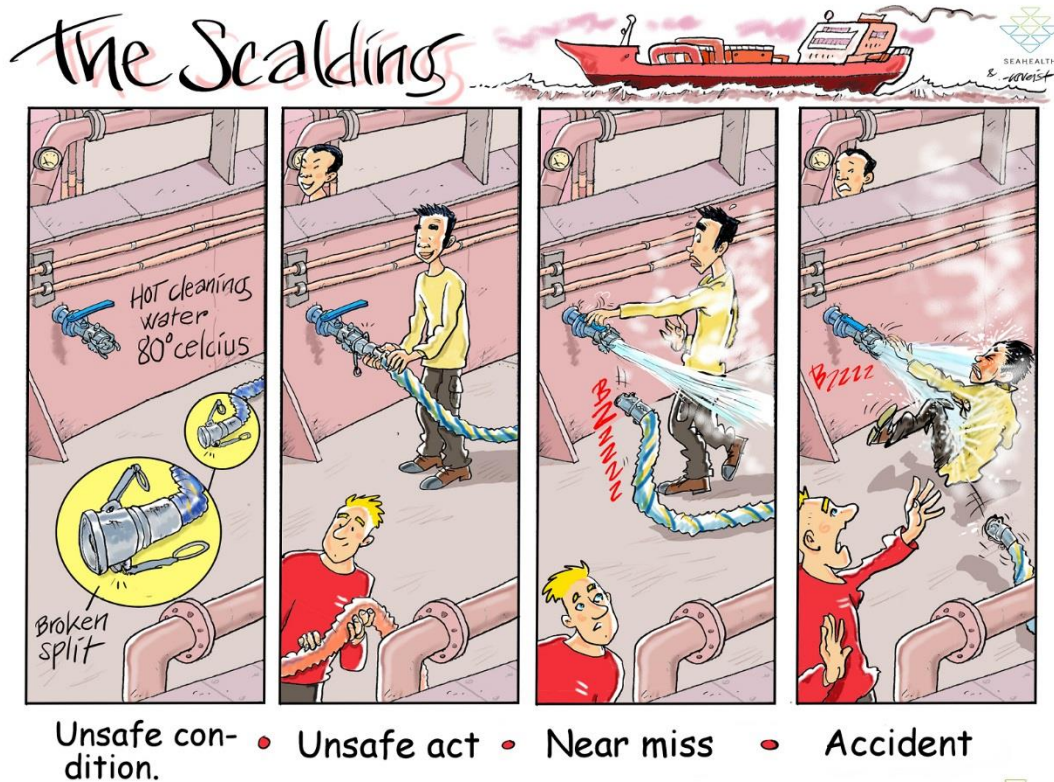
Seahealth.DK (<http://www.seahealth.dk>) has circulated a report of an incident during tank cleaning in which a crewman was badly scalded, receiving first and second degree burns over a third of his body. The incident occurred during hot water cleaning on lube oil tanks, when cleaning machines were exchanged between sequences of cargo tanks. When changing sequence, the tank cleaning hose, when pressurized, opened up and hot sea water released freely from the line. The injured party was positioned alone right in front of the hydrant

and not expecting the failure. None of the crew saw what caused the failure, but they noticed steam clouds from hot water coming off the hydrant and the injured person next to the hydrant.

Investigation revealed that the most likely cause was that the securing mechanism/locking mechanism for the camlock coupling was either defective or not properly locked, leading to the coupling to break off when pressure was applied. When the hose was found, after it had gone off the connection point, one of the locking handles was found broken off; the shaft missing and the gasket was found on the deck.
