## IMCA Safety Flash 22/18

September 2018

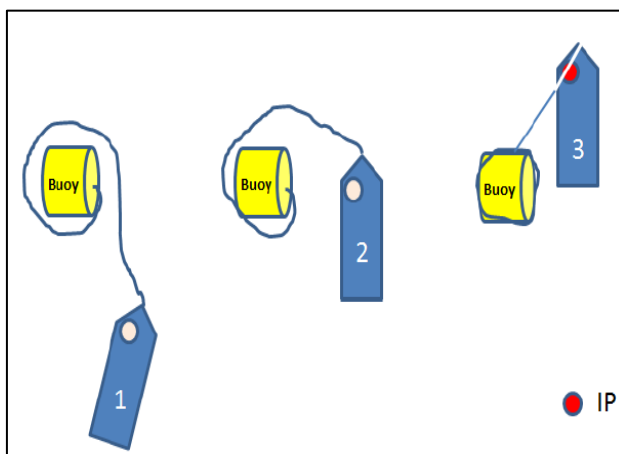
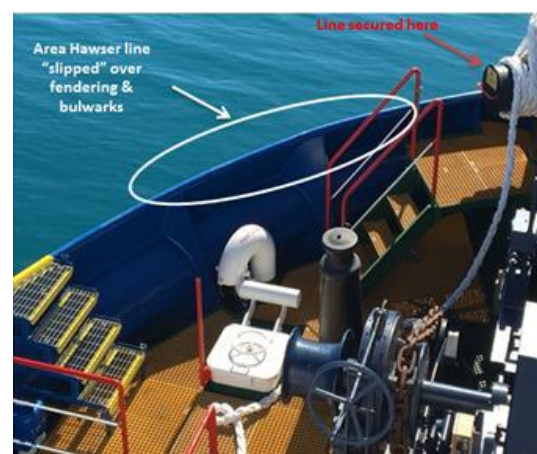
A seafarer was caught in the line of fire and temporarily trapped by a mooring line, but fortunately escaped without serious injury.

As the vessel was manoeuvring around the buoy, the swell and sea state affected the vessel's rate of turn, causing it to move ahead rather than turn as planned. This subsequently resulted in the direction of the mooring buoy to lead aft of the vessel's port beam and place the hawser line under tension; the taut line slipped over the bow fender and bulwarks arrangement and pinned the seafarer against the handrail of the stairs for approximately 4-5 seconds. The vessel moved in the seaway; the line tension subsided, and the seafarer was freed. He escaped serious injury but experienced some post-event shock and localised bruising and pain.

- ◆ The design of the sea buoy allowed the floating hawser and messenger to become fouled when floating free;
- ◆ The location of the sea mooring was subject to strong and fluctuating currents (a replacement low profile sea buoy was ready to be deployed upon the vessel's next arrival in port);
- ◆ The chief officer believed the foredeck to be clear of personnel immediately before starting his manoeuvre around the sea buoy to clear the hawser;

- ◆ A new low profile sea buoy has been deployed that is more suitable to areas experiencing strong and fluctuating currents;
- ◆ A strict clear deck policy has been enforced for future operations involving vessel manoeuvres while attached to a mooring hawser, including VHF communications confirming that the deck is clear prior to commencing the manoeuvre;
- ◆ A toolbox talk (TBT)/job safety analysis (JSA) review will be held prior to manoeuvring the vessel around a sea buoy that emphasises the clear deck policy and VHF confirmation;
- ◆ An alternative method, used by other persons performing the manoeuvre in previous occasions, involved using the azimuth drives to 'side walk' around the buoy, while keeping the buoy facing the bow and not under tension. This method would be used henceforth.

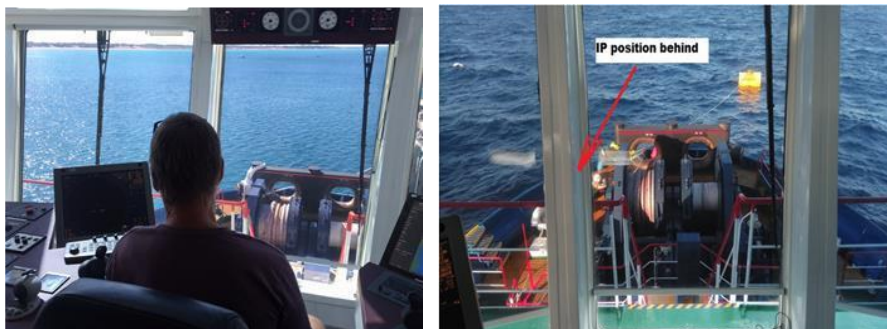
- ◆ The conning position at the forward console has inherent blind spots, caused by vertical window stanchions, which prevent an uninterrupted view of the foredeck area unless the person manoeuvring the vessel moves his field of view;

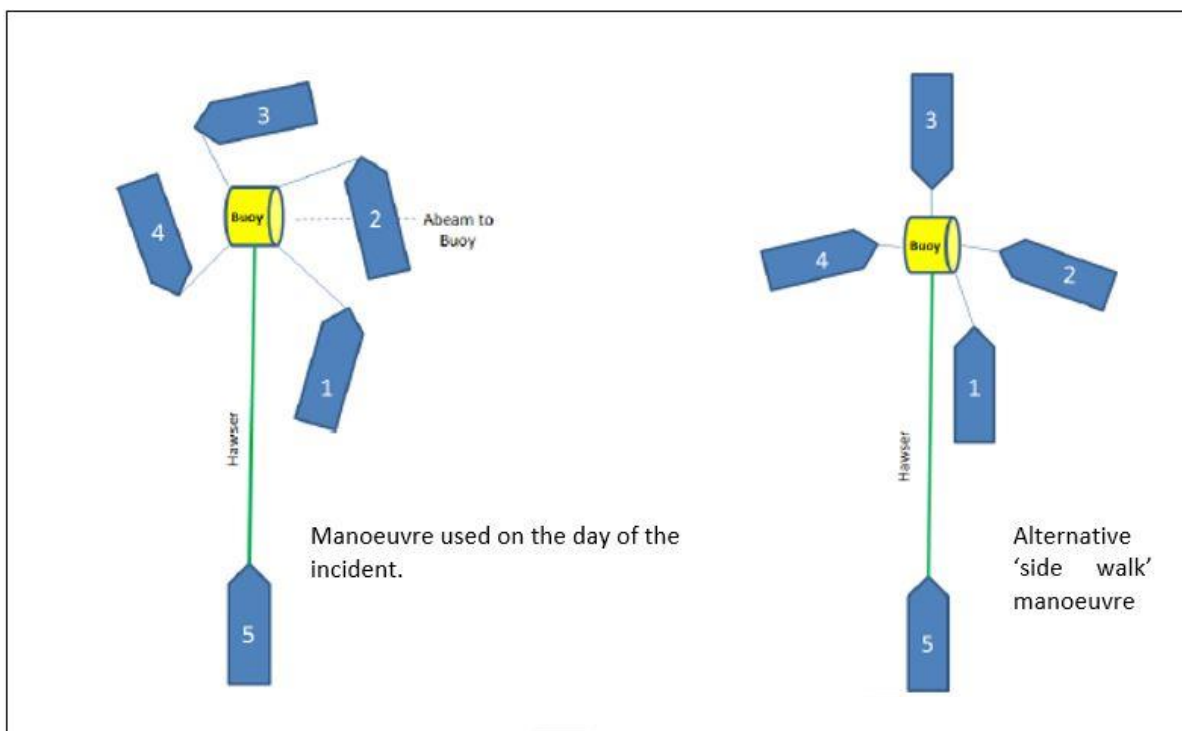
- ◆ Confirmation by very high frequency (VHF) radio that the deck was clear, was not obtained;
- ◆ The vessel manoeuvre used to un-wrap the hawser from the sea buoy had the potential to place sudden tension on the hawser line as the vessel rotated around the sea buoy. It also had the potential to place an adverse lead on the line from the vessel's central panama lead.

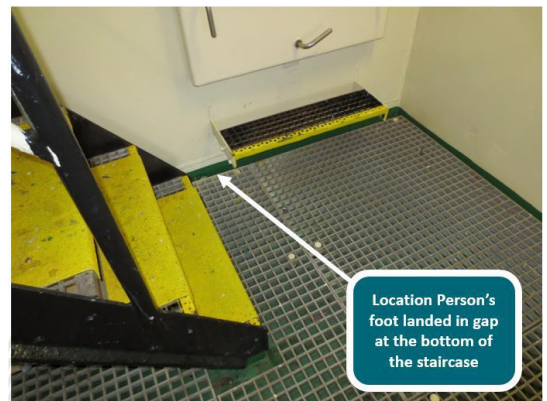
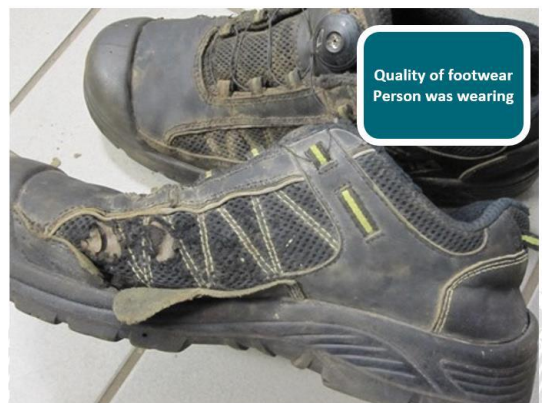
A crewman on a vessel lost his balance going down some stairs and fell, resulting in a fractured ankle. His foot got caught in a gap as he landed at the bottom of the stairs. He suffered 3 broken bones and his foot was dislocated. He was evacuated by helicopter to hospital, where surgery was performed a number of days after the event.

- ◆ Immediate causes:
  - person lost footing and fell forward
  - complacency/lack of situational awareness
  - potentially poor standard of footwear, however soles of shoes were not excessively worn;
- ◆ Underlying causes:
  - potential for tiredness/fatigue – the incident occurred on a nightshift
  - failure to identify that the gap at the bottom of the staircase may present a hazard. Although it should be noted that the stairs were classified in accordance with local regulatory standards.

- ◆ Additional warning signage was placed at top of the staircase;

- ◆ Review of instructions/expectations regarding company standard of safety footwear;
- ◆ Improvement modification was added to staircase in order to prevent a person's foot from becoming caught between the single protruding step and the staircase.

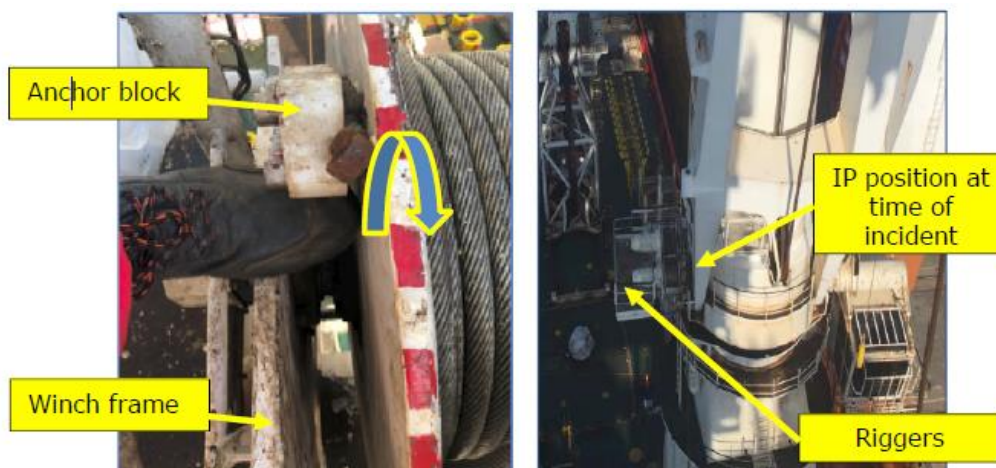
A person involved in spooling a wire onto the main crane forward tugger winch drum suffered a serious foot injury. To facilitate the operation, he positioned himself in a restricted space inboard of the winch and opposite to the supporting riggers on the crane tugger platform. When he decided to leave this location, he placed his left foot on the winch frame to help step over a protrusion. This resulted in his foot being placed directly into a line of fire position, extending beyond the handrail. The anchor block, fitted to the outside of the still rotating winch drum, struck the extended boot which resulted in all five toes being amputated.

- ◆ The task risk assessment (TRA) was inadequate for the work and did not recognise hazards associated with rotating equipment during the spooling operation;
- ◆ The TBT did not discuss positioning for the personnel involved in the task, and did not emphasise the rotating block as a hazard;
- ◆ The rotating anchor block was unguarded as it was thought to be safe and barriered by the handrail;
- ◆ Safer options were available to the work team but not taken;
- ◆ There had been no time pressure to complete the task.

- ◆ Conducted a 'hazard hunt' on winches to identify further potential line of fire hazards;
- ◆ Re-assessed the effectiveness of the existing safety controls (safe use of work equipment), barriers, implemented required improvements and reporting findings back to shore-side management;

- ◆ Reinforced importance of specific risk assessments, effective TBT preparation and delivery for every activity, and the importance of last-minute risk assessment at work-site to ensure that all hazards have been identified prior to work starting;
- ◆ Reiterated importance of 'Stop Work Authority'.

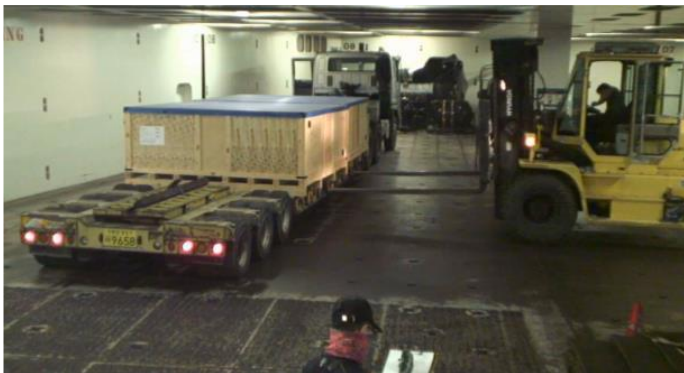
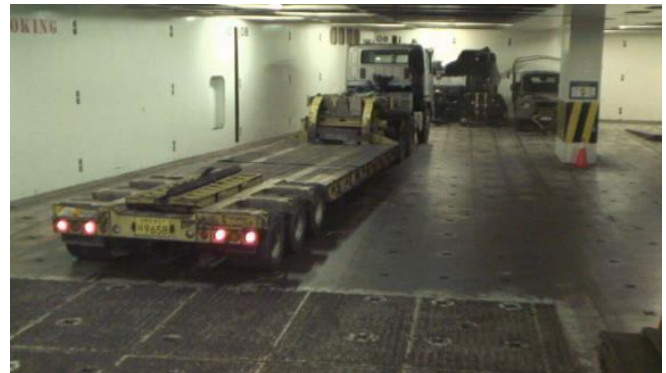
A member reported a fatal incident which occurred on a large Ro-Ro vessel during loading operations. A trailer loaded with two large wooden boxes drove down the ramp to deck number one and parked shortly after clearing the ramp on the port side of the cargo hold. With guidance from the stevedore foreman, the wooden boxes were unloaded by a forklift. When the unloading was finalised, the trailer reversed back up the ramp to deck two and hit the duty officer currently observing the cargo operations. The duty officer received medical assistance from shore very quickly, but unfortunately died in the ambulance on the way to hospital.

- ◆ No one witnessed the trailer hitting the duty officer;
- ◆ The site of the accident is in a blind spot for the CCTV cameras;
- ◆ The noise level on the cargo decks on this kind of large vessel during loading and discharging is rather high, particularly on cargo deck one. It is not clear that an audible reversing alarm would have changed the outcome in this case;
- ◆ There was no indication that the duty officer was standing outside the yellow safety zone on the ramp when he was hit by the trailer;
- ◆ The duty officer was not wearing his safety helmet as was required. Based on his injuries, the assumption was made that he was hit by the trailer when he was looking up towards deck two;
- ◆ The driver of the trailer did not use any signal man/reversing assistant, nor did he look backward through his trailer window before starting to reverse;

- ◆ The immediate causes were found to be:
  - the trailer driver failed to ensure that there were no obstructions when starting to reverse
  - driver did not use a signal man/reversing assistant when reversing, even though he was driving a heavy vehicle;
- ◆ A causal factor was inadequate supervision/planning – the requirement to use a signal man/reversing assistant when reversing larger vehicles and trailers on board was not followed;
- ◆ The **root cause** of the incident was found to be an inadequate management system, which was not strict enough. The sub-contracted stevedore company did not ensure that the owners' cargo handling instructions were followed.

- ◆ Better situational awareness is required, particularly in the cargo holds, during cargo operations, and anywhere where vehicles are working;
- ◆ A strengthening of PPE requirements particularly for high visibility clothing. Vessel management teams to ensure that existing requirements for hard hat or safety helmet is always complied with;
- ◆ A better awareness should be developed of control measures for non-routine operations.

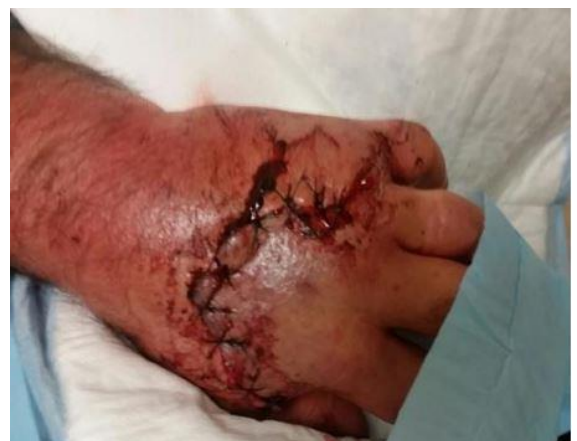
During a slow lifting process to remove a rubbish bag from a storage container, the storage container itself also began to lift. The crane operator was unable to see the lifting operation due to a blind spot, and therefore had another employee guiding him through the lift. The employee placed his hand on the container in order to free the bag. As the container began to lift, the metal frame began to part, which caused the container to fall onto the production deck and the individual.

The employee was left with a large laceration (see image) on his left hand, which required 8 stitches.

- ◆ The storage container was removed from service and discarded.
