IMCA Safety Flash 24/19

October 2019

1 Update to SF 11/19: Fatality and multiple injuries - flash fire onboard pipe-lay barge

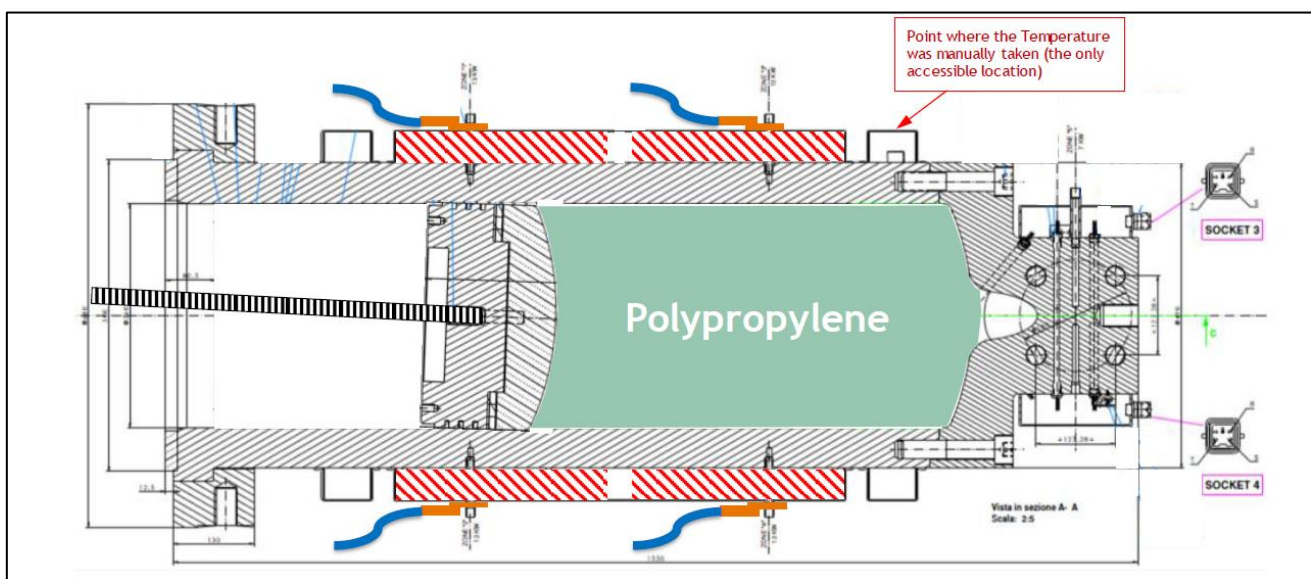
During pipelaying activities, Injection Moulded Polypropylene (IMPP) equipment used for field joint coating got stuck. Pipelaying activities were stopped and repair operations were started. The crew started to dismantle the machine to investigate the problem. It was discovered that the piston was stuck (i.e. seen tilted from the open flange) inside the accumulator chamber (Figure 1). While trying to pull out the stuck piston using a threaded bar, the heating elements were energized in order to avoid the solidification of the polypropylene contained in the accumulator chamber, and thus to ease the pulling operations.

Figure 1 – Known configuration of the accumulator chamber while starting repair activities

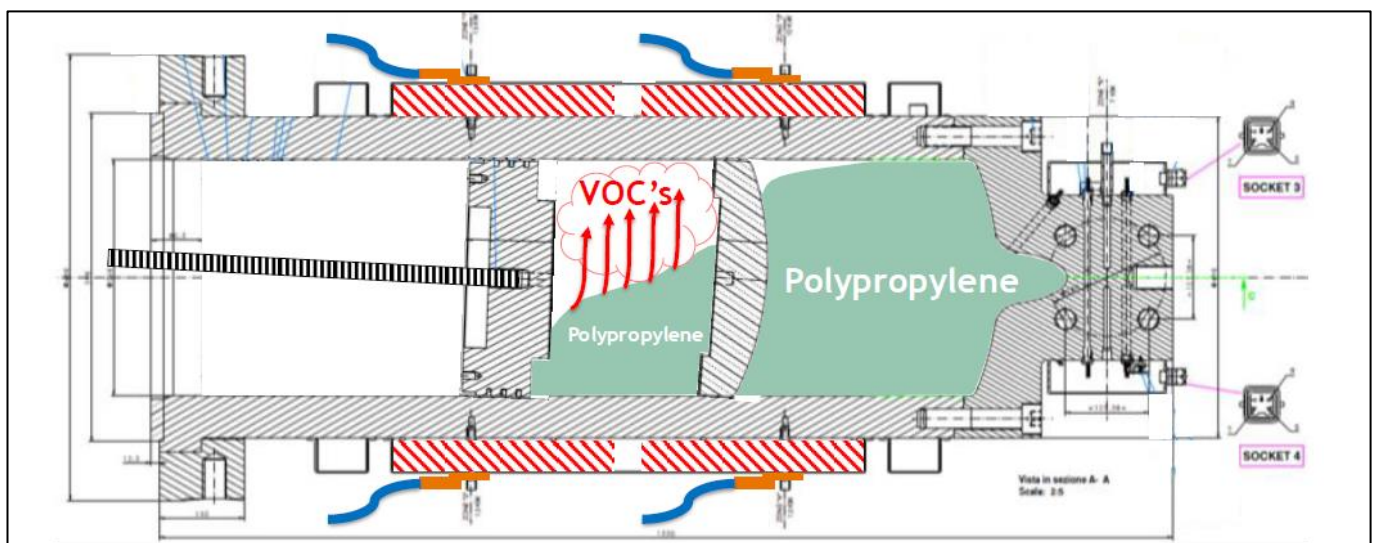
Whilst at the final stage of extracting the piston, a cloud of flammable vapour and fine polypropylene droplets blew out from the accumulator chamber. The cloud ignited, resulting in a so called “flash-fire” in which fourteen persons were injured. The fire was extinguished by the barge crew.

The crew connected the IMPP equipment built-in heating system to an external power supply (i.e. replacing the temperature and pressure control system with manual temperature control) to ease the extraction of the melt piston. This resulted in loss of control of the temperature inside the accumulator and, ultimately in overheating the polypropylene accumulated inside (Figure 2).

Figure 2 – Real configuration of the accumulator chamber during the repair activities, where the bimetallic piston had split into 2 pieces, causing a partial dam effect and thus an uneven distribution of polypropylene.

- ◆ Custom-made production equipment should be always provided with a comprehensive operation and maintenance manual, including ordinary repair operation and definition of battery limits, beyond which shore approval should be required (MoC process);

- ◆ The behaviour of chemicals and fluids processed by the equipment should be fully analysed against undesired deviations from operating conditions. This information should be assessed and reviewed during the relevant safety studies (i.e. HAZOP, FMECA, etc.), as well as part of the operators' training package.
- ◆ For custom-made production equipment, ensure the availability of hand-over report between the supplier/developer (i.e. vendor, engineering, etc.) and the final owner (i.e. Asset and Operations), including the formal transfer of all documentation (i.e. Manuals, Safety Studies, FAT, SIT, etc.);
- ◆ The Control of Work package (i.e. task plan, permit to work, risk assessment, etc.) should always be consistent with the real situation and revised every time a change occurs, or inconsistencies are identified.
