## IMCA Safety Flash 25/19

October 2019

### 1 Battery fire with subsequent gas explosion: warning about lithium-ion power following ferry fire

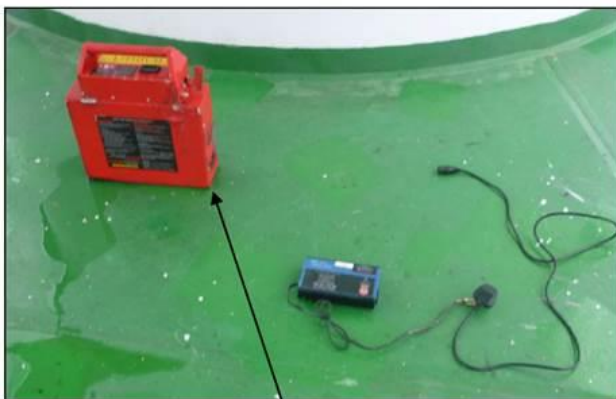
This was identified as a Portable Helicopter Start Power Unit (Lithium battery) which was located in the corner of the office and connected to a charging pack. The unit and charger were safely removed and doused with fire hoses until cooled and deemed safe. A quick and professional response from crew prevented any further escalation and the incident resulted in no injuries to personnel.

Failed unit and charging cable

A suspected failure of unit or charger caused overheating and potential fire hazard. Our member has been in contact with the manufacturer and they suspect a component in the charger failed.

- ◆ Failed unit was quarantined for safe disposal or returned to manufacturer for investigation;
- ◆ The vessel has now established a clearly marked external storage area for old batteries;
- ◆ All operators using similar units should ensure they are serviceable and show no signs of defect or deterioration.

Devices fitted with Lithium batteries such as this should not be left unattended whilst charging. This also applies to personal devices such as laptops, tablets and mobile phones.

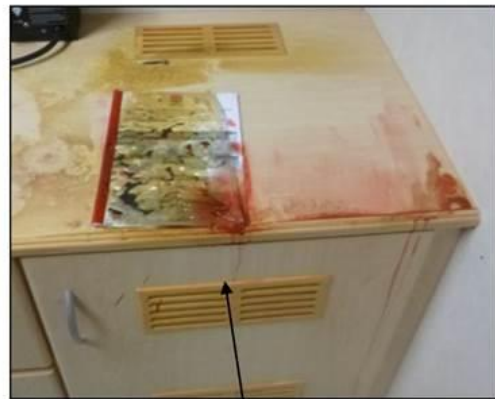
Location in Heli-admin

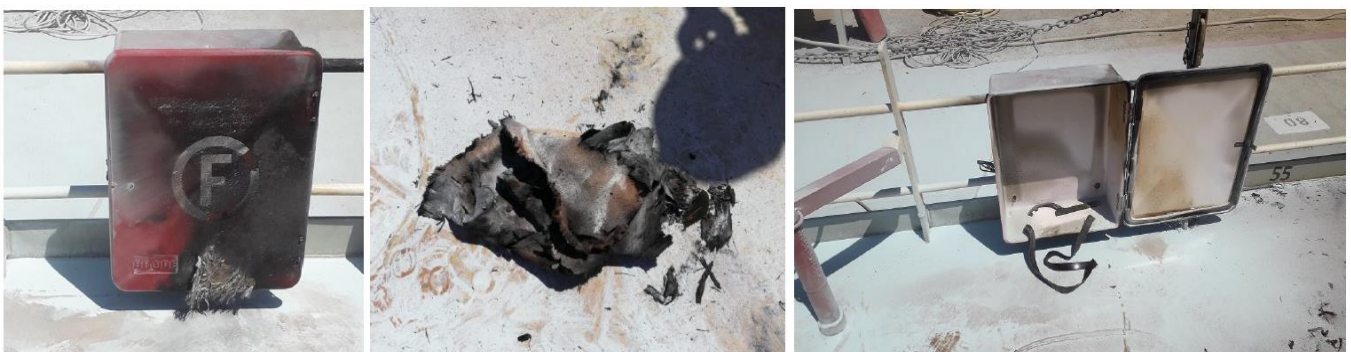
While conducting a fire watch round on a vessel in port, a 2nd mate noticed that a fire blanket on the midships fire hose box had caught fire. He immediately reported this to the Bridge and used an extinguisher to put the fire out.

The fire started after a third-party team (hired to remove sea-fastenings) had left the job to have lunch after cleaning the grillages on deck. There were no injuries to personnel, no harm to the environment and only slight damage to the fire hose box.

- ◆ There was incomplete recognition of all possible and likely hazards associated with the hot work activity – such as potential embers or residue that could ignite;
- ◆ The third-party fire watch did not ensure that the area was clear of embers or residue that could ignite before leaving for a lunch break;
- ◆ Potential poor quality of the fire blanket.

- ◆ Review risk assessments related to sea fastening preparation and removal operations to ensure that all hazards associated with hot work are contained in the risk assessment – hazards associated with embers and/or residue that could ignite;
- ◆ Full and thorough discussion of fire watch responsibilities;
- ◆ Better and more continuous supervision of third-party contractors and their equipment.
