## IMCA Safety Flash 26/18

2018

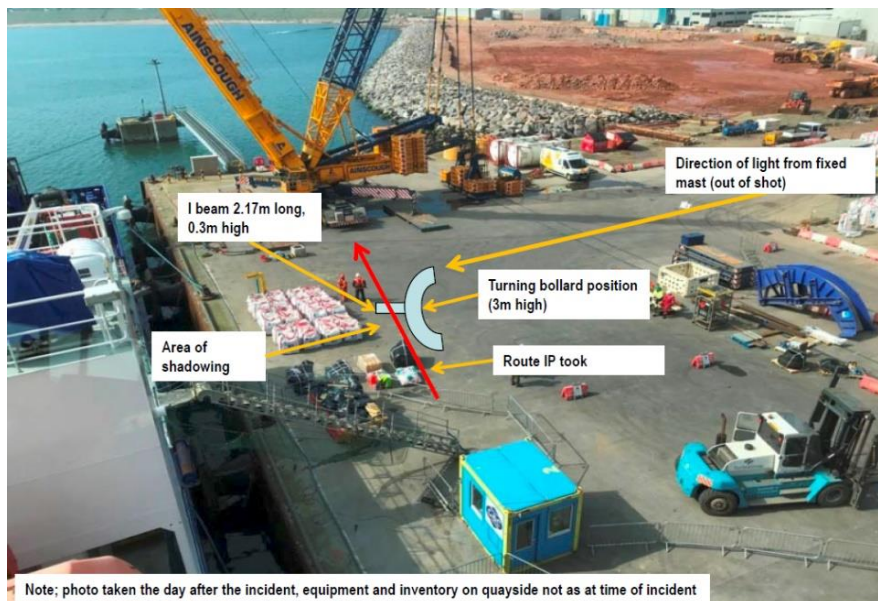
A rigger walking along the quayside tripped over an obstacle, and in the resulting fall suffered fractures to both wrists, a bone in his hand and his elbow. The incident occurred at night during a project mobilisation. The rigger walked down the gangway and onto the quayside to help the deck foreman. He tripped over a grillage I-beam fabricated to the turning bollard that was awaiting lift onto the vessel.

- ♦ The rigger did not take sufficient care or recognise the hazards and risks associated with walking through an area where equipment had been stored for loading;
- ♦ Other personnel involved in quayside operations and handling of equipment did not intervene or fully recognise all hazards and risks associated with activities and equipment;
- ♦ Identified control measures for slips, trips and falls were not applied to quayside operations;
- ♦ The QA/QC checks performed were not fully effective as they focused on dimensional and integrity checks rather than occupational safety hazards;
- ♦ The grillage 'I' beam was not identified as a potential tripping hazard during inspection or handling activities;
- ♦ The grillage 'I' beam was in shadow and there had been no consideration of additional onsite lighting;

- ◆ Responsibility for management and control of quayside operations was not clearly defined.

- ◆ Ensure that shift handovers clearly identify who has responsibility for operations on the Quayside. Before starting work, at the start of each shift the Quayside should be checked by those responsible for hazards and to ensure it provides a safe place of work;
- ◆ Consider provision of further portable lighting as required during mobilisation;
- ◆ Ensure principles of dynamic risk assessment are applied to day-to-day routine operations; this provides opportunity to continually assess the surrounding environment for hazards and adapt to change throughout the shift.

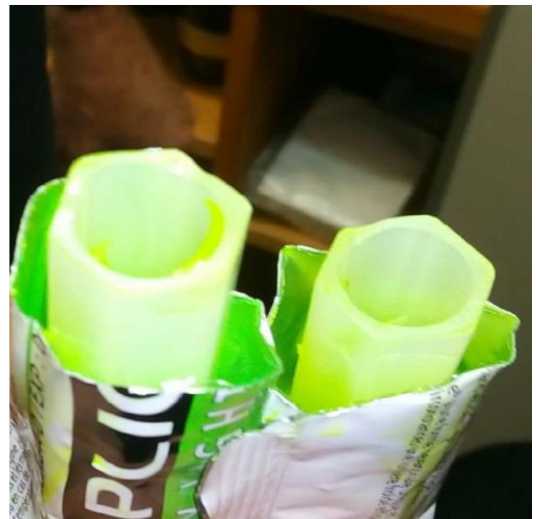
While activating a 'glow stick' the casing snapped releasing the glow dye. Our member noted that a number of sticks from the same batch broke open, releasing the chemical dye contents.

- ◆ Storage – the plastic from which these are made is known to be brittle if exposed to extreme temperatures. This may be a probable cause considering warehousing locations of the item;
- ◆ Issues with manufacture – the manufacturer speculated that *“during the injection when we make the tube a small piece of dust [may have] prevented the tube from forming properly which can cause this type of phenomenon.”*

- ◆ Ensure long-term storage in appropriate air-conditioned environment;
- ◆ When opening such light sticks, do so well away from your eyes, and wearing protective gloves;
- ◆ Check expiry date and/or authenticity of existing stock of such materials.

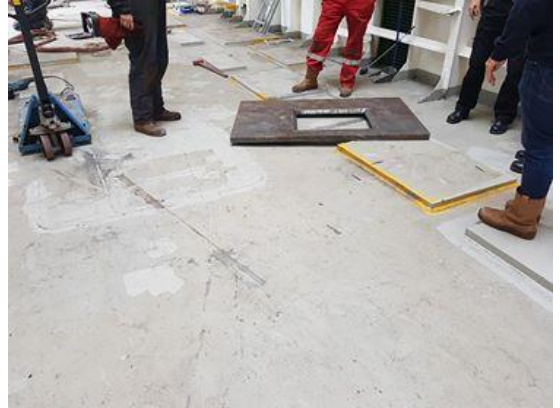
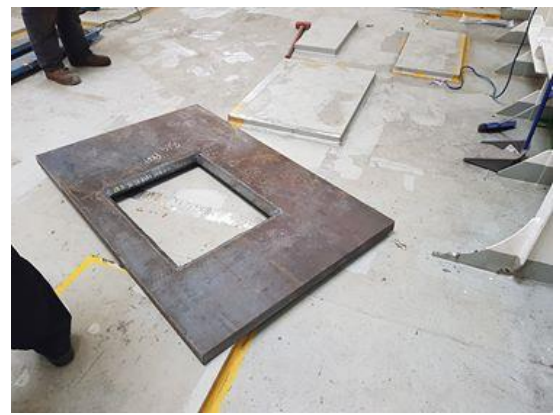
A crewman was hit by a steel plate bouncing off the deck after it fell 14m from a load after a magnet failed. The incident occurred when shaped steel plates for reinforcing were being lifted from the main deck to the ROV hangar through a hatch. The lifting equipment was a 25T crane, two connected soft slings and a heavy-duty magnet. As a lift was swung into position over the hatch opening, one steel plate (sized roughly 1.5m x 1m and weighing approx. 450 kg) came loose from the magnet and fell approximately 14 meters down into the ROV hangar.

- ◆ The plate was so shaped that the magnet could not hold it properly: it was noted that 8 or 9 rectangular plates without cut outs had been lifted successfully with the magnet. The plate that fell was shaped differently, having a rectangle 68 cm x 54 cm cut from it (see photographs). As this plate was to be lifted, no one took into consideration that this plate had a large cut out, limiting the connection area for the magnet;
- ◆ Clear instructions were not followed: investigation also shows that the lifting operation was planned with clear instructions **NOT** to use magnet for lifting into ROV hangar. Pallets were to be used to lift plates into hangar, and magnet to distribute only, not above 300mm off deck.

- ◆ Lifting plans should be followed and should also cover all aspects, as in this case, where there are differences in object properties. This short cut could easily have resulted in major injury and, more than likely, a fatality if the plate had struck directly;
- ◆ The importance of following plans and also focus on identifying increased risk cannot be stressed enough.

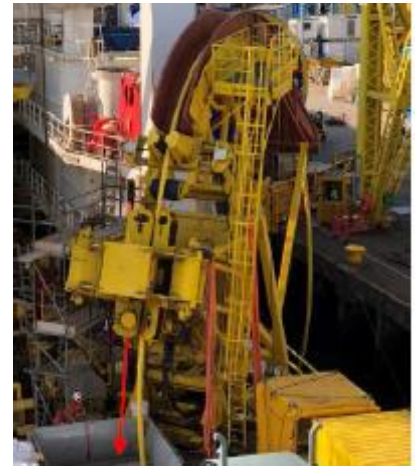
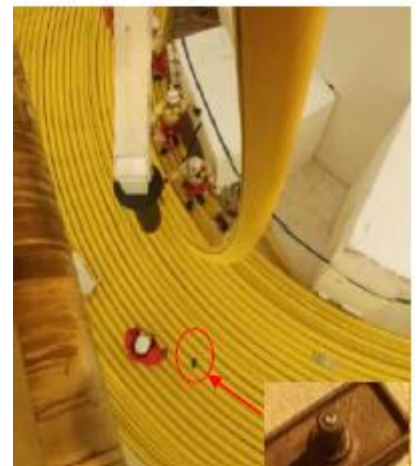
During the trans-spooling of an umbilical, a tensioner pad retaining bolt sheared, resulting in a 1.5kg tensioner pad dislodging and falling 11m to the under-deck carousel, where it struck the already trans-spooled umbilical. The dropped pad then bounced towards the starboard side, narrowly missing the deck supervisor, and landed on a salt sack approximately 1 metre from him.

- ◆ A decision had been taken not to change the grade 8.8 bolts with the 10.9 bolts, due to resources, timescale and difficulty of access;
- ◆ The retaining bolt was not subject to an inspection, nor were the torque values checked due to the difficulty in accessing the tensioner;
- ◆ Risk assessments had not been conducted prior to the work activity, therefore there had been no consideration of potential dropped objects or mitigation thereof.

Direction of travel and landing area of tensioner pad from 20te Tri-Cat tensioner

- ◆ Replace M10 x 25mm grade 8.8 retaining bolts with M10 x 25mm grade 10.9 on all equipment prior to mobilisation to vessels;
- ◆ Corrective work orders to be fully completed inclusive of inspection of tensioner pad retaining bolts and torque value checks, prior to mobilising equipment to vessels;
- ◆ Risk assessment of this type of work should take place before it starts.
