IMCA Safety Flash 27/19

November 2019

1 High Potential Near Miss Guide Cone Funnel Dropped

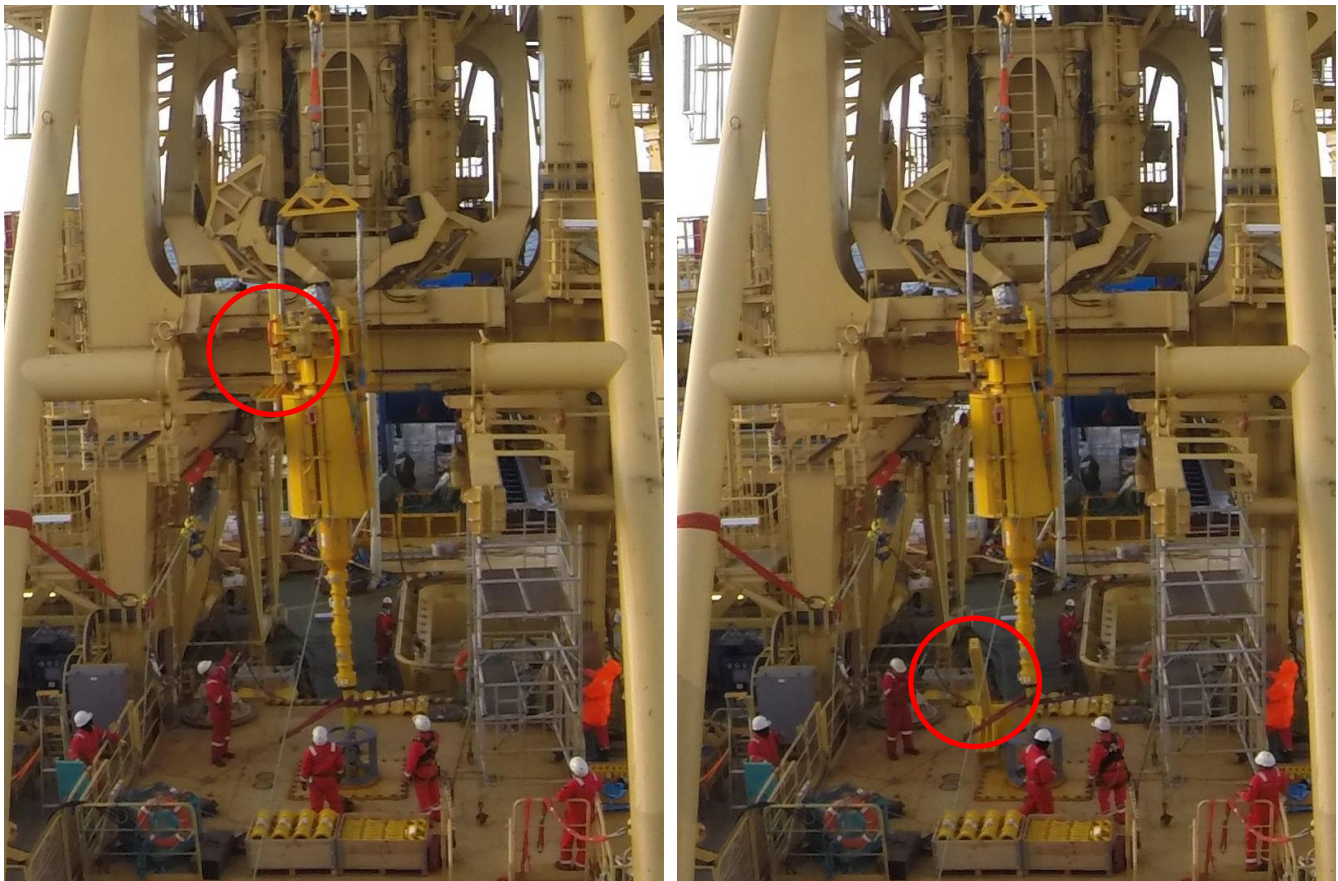
An umbilical termination head (UTH) guide cone funnel fell from its sleeve connected to the UTH body. The UTH was the 2nd end of the umbilical. It had been lifted over the vertical lay system (VLS) tower and was being prepared for deployment when the incident occurred. The UTH guide cone funnel weighed approx. 500kg and fell more than 4m towards the moonpool doors.

The next step prior to deployment was to fit the bend restrictors under the UTH. While lifting the UTH from the hang-off collar to fit bend restrictors the guide cone funnel fell off.

- ◆ The guide funnel locking mechanism failed to secure the guide funnel in vertical orientation, due to too small locking protrusion.

- ◆ Design:
 - the locking mechanism on guide funnel was not suitable for the vertical orientation. The locking mechanism was secured with a cable tie, and there was no designed-in secondary securing for the locking mechanism or the guide funnel

- the outboard connection c/w guide funnel was an existing design used for installation in horizontal orientation
 - supplier design review may not have covered change in use in a proper way. This is being investigated by the supplier

- ◆ Risk assessment and/or design review or re-assessment highlighting using an existing design in a new way;
- ◆ All guide funnels from this supplier with this design should be modified with a secondary securing/locking mechanism designed to withstand installation forces;
- ◆ Revision of umbilical termination head manual to further highlight risk factors (e.g. loose items and locking system etc);
- ◆ All parties involved in engineering, fabrication and installation should be included in design reviews, HAZOP, HAZIDs etc.

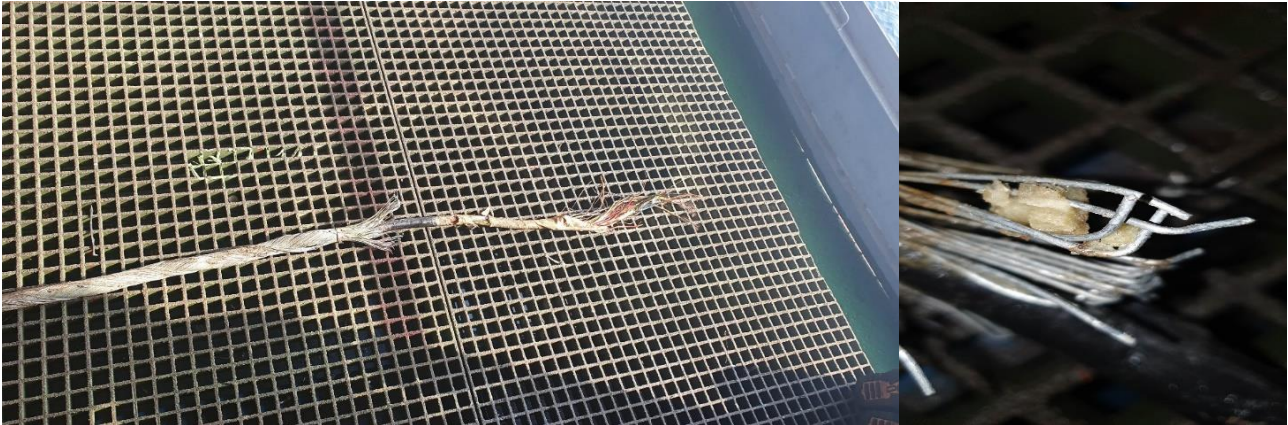
- ◆ The TMS main lift wire and bullet parted. Further inspection identified a failure in the armour wire shield which was found to be dry with no signs of grease or any oil contaminations;
- ◆ It was noted that the 'Wirelock®' potting compound inside the socket was scattered into small pieces. The armour wire end bends appeared to be existing and no deformation noticed. Exposed armour wire length was 89cm.

- ◆ The evidence presented post-incident indicated a failure of the system main lift umbilical at the connecting bullet termination point which was secured via a chemical potting compound (Wirelock®);

- ◆ The technician who conducted the re-termination commented that the volume of product used was approximately 30% less than he had anticipated, and the compound did appear to be slightly more glutinous or viscous than usual. This is believed to be due to higher than normal ambient temperatures. The inspection

- ◆ The **immediate cause** of the parting of the main lift umbilical from the TMS connection bullet, was seen to be failure to follow correct procedures;
- ◆ The **root causes** were
 - failure of the potting compound inside the TMS bullet
 - failure to take into account high ambient temperatures when working with the potting compound.

- ◆ Amend procedure for potting sockets whilst in high temperature environment and where possible conduct work only within set temperature guidelines given by manufacturers;
- ◆ Consider alternative supplier for better temperature range product;
- ◆ Changes in procedures to indicate:
 - temperature of environment in which work is conducted
 - volume by weight or volume of compound used
 - compound batch number and storage details.

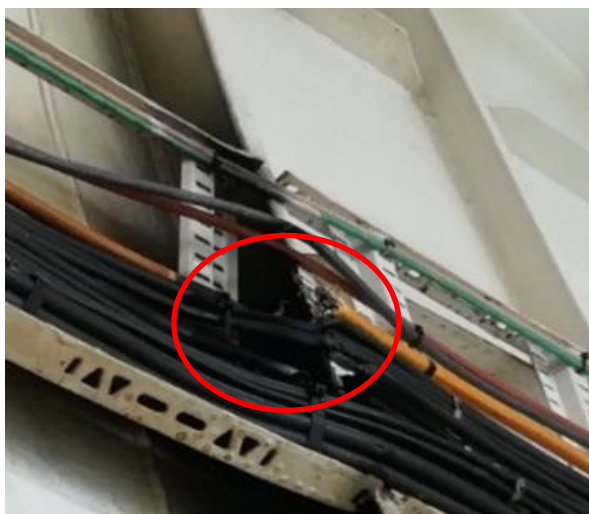
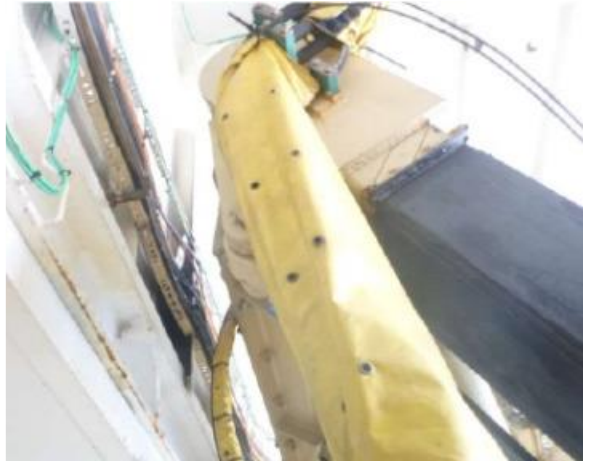
Initial investigations identified that the electrical cables and hydraulic hoses serving the equipment had been severed. Further investigation established that the cables and hoses in the ROV hanger had been inadvertently severed by the ROV launch and recovery (LARS) frame which had come into contact with the bulkhead cable tray (yellow structure in second photo).

The impact between the LARS and the bulkhead cable tray was not reported immediately after it happened, possibly because it was not noticed by those involved in the operation of the launch and recovery system.

- ◆ Review of launch and recovery operations and documented risk assessments/operating procedures:
 - documents amended where necessary
 - one of the ROV crew assigned to monitor the ROV recovery process with particular reference to the proximity of the launch and recovery system frame to the vessel structure;
- ◆ Incident and required actions discussed with those involved in the ROV operations. Employees reminded of their responsibility to speak up if they identify an unsafe act or condition, e.g. damaged equipment and/or services;
- ◆ Installation is in progress of a permanent engineered solution to prevent contact between the LARS frame and the vessel structure.

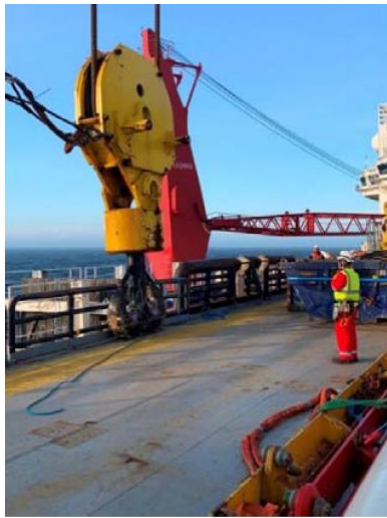
Hook and handrail

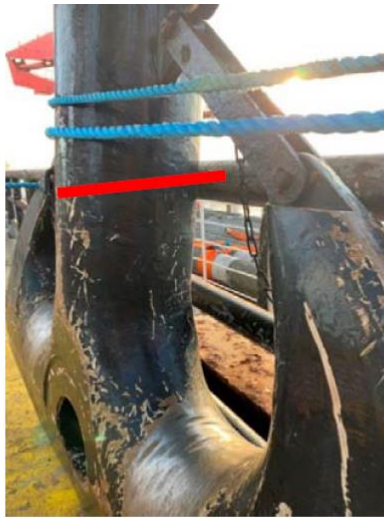
Close up of hook with intended position of rope indicated with red line

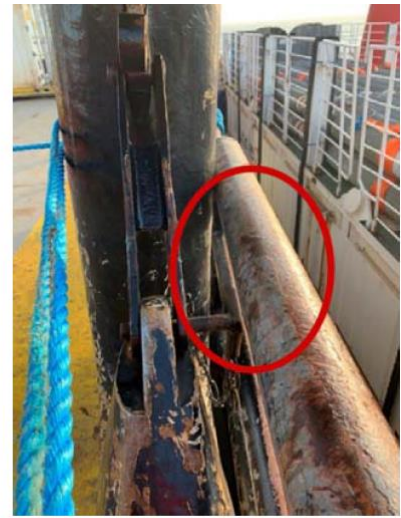
Pinch point between hook shank and handrail

- ◆ The method chosen to stabilise the hook was not correctly evaluated or safely engineered and the hook was still moving; this placed the rigger **in the line of fire**.
- ◆ The crane block was not sufficiently stabilised;
- ◆ The rigger moved in to secure the block before a clear signal was given from the Banksman;
- ◆ The banksman did not stop or call back the rigger when he approached the load prior to clear signal.

- ◆ Ensure all high-risk sub-activities are risk assessed prior to start of work;
- ◆ Ensure that loads are stabilised before starting to work on them;
- ◆ Ensure rigging team members comply with their roles and responsibilities.

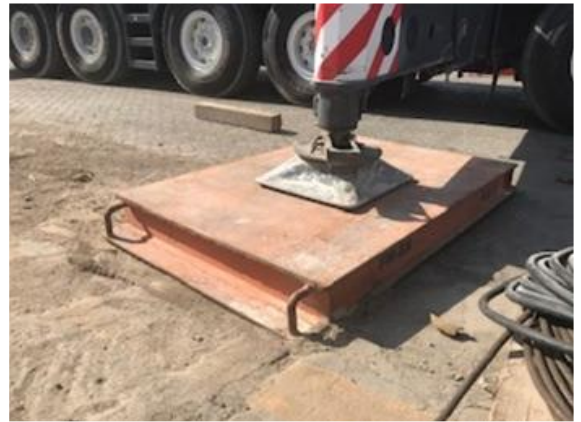
To remove the timber block from beneath the outrigger pad, the pad was attached to the elevated FLT forks/tines using two webbing slings. As the pad was being raised off the timber block, it caught on the front left tyre (FLT) causing the pad to jerk/swing.

This resulted in one of the two slings releasing, enabling the pad to drop back onto the timber block. The employee who was in the process of retrieving the timber block from underneath the suspended pad sustained hand injuries when the pad fell.

The investigation established that the activity was not adequately planned, assessed or supervised, and this resulted in the improper use of a forklift truck.

- ◆ Banned the practice 'free rigging' – that is, attaching ropes, chains or slings to FLT forks/tines for the purpose of below tine lifting and moving;
- ◆ **In progress/pending:**
 - can a removable attachment be used when there is the need to move a suspended load using an FLT? Is the FLT itself appropriate?
 - review the existing processes, procedures, risk assessments and operator competency to ensure the safety of FLT and lifting operations
 - re-evaluate the behavioural safety aspects of routine operations, including individual responsibilities to work safely and speak up to identify an unsafe act or condition.

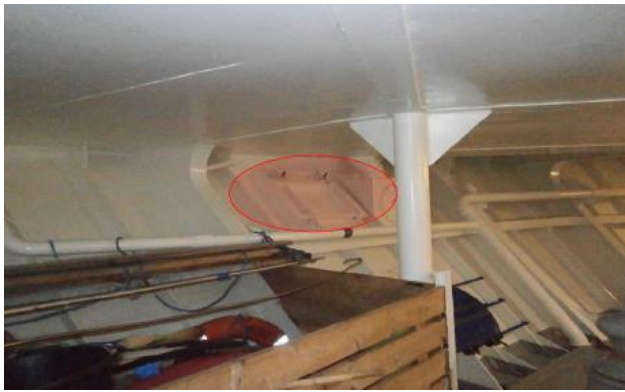
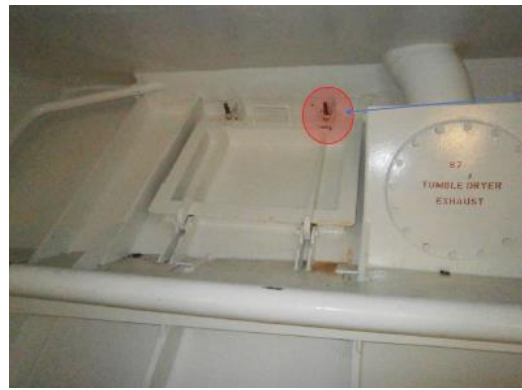
When closing this hatch the IP caught his finger between butterfly nut and the hatch

The hatch being secured was heavy and in such a position that it required the AB to reach or climb up to open, close and secure it; this awkward arrangement resulted in finger entrapment.

Our member made the decision that due to the weight, arrangement and position of the hatch being unsafe for handling, it would not be used for mooring operations and a temporary alternative arrangement put in place for running lines. Engineering solutions available:

- Fitting a motion damping strut, such as a fluid-filled gas strut;
- Or, fitting a hatch in a different position that allows for safer handling and improved safety and ergonomics for passing lines.
