IMCA Safety Flash 28/17

November 2017

This flash covers three separate issues. Firstly, we have prioritised a near miss relating to pull pins in diving helmets. Secondly, several incidents relating to personnel safety, traffic management and traffic separation zones in the yard environment, and thirdly, three hand/finger injuries.

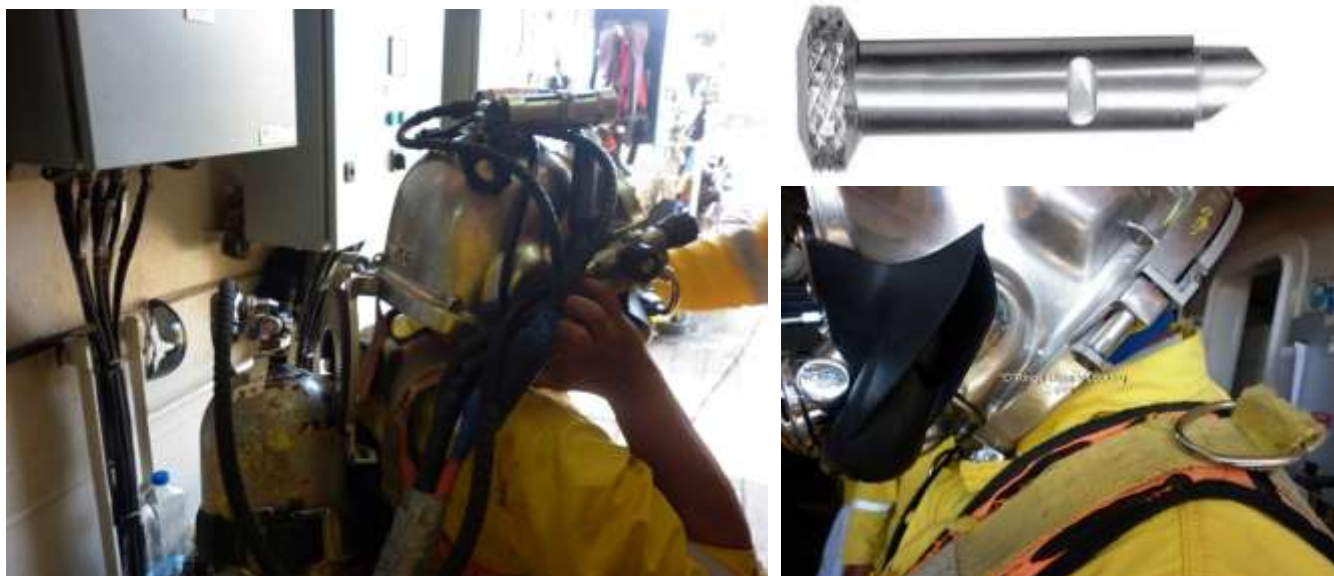
Photo indicates the open locking collar assembly in open position, behind diver's shoulders

Upon investigation of the dive video and audio recordings, it was identified that at some point during diving operations the knurled end of both helmet locking pull pins, used to secure the locking collar assembly (*see photo*) had caught on top of the R-Vest shoulder harness at the attachment D-ring “where the inspection equipment (CP-UT meter) are secured via a rope lanyard”. This had pulled the locking pins, thus resulting in the locking mechanism coming open. As a result, the locking collar assembly opened and dropped past the diver’s shoulders removing the primary guard that holds the helmet on the diver’s head.

- ◆ The **direct cause** was found to be:
 - The knurled end of both helmet locking pull pins that secure the hinged locking collar assembly (*see above photo*) had caught on top of the R-Vest shoulder harness and pulled to open position;

- ◆ The underlying **root causes** were found to be:
 - The swing hinged locking collar assembly dropped to an open position whilst the diver was working, without him noticing, and passed the top of his shoulders as he leaned forward to conduct tasks

- Activation of helmet free flow to help demist the visor caused a slight over-pressurisation inside the helmet resulting in the neck dam O-ring popping open. This allowed water to enter the helmet when free flow was turned off;

- ◆ **Root causal factors** identified were:
 - Design failure of the locking pull pins was not addressed during helmet maintenance which recommended fitting of KM *Pull Pin Sleeve Kit* part #525-112.

- ◆ All helmets returned to workshop for fitting of KM *Pull Pin Sleeve Kits*;
- ◆ Divers given familiarisation brief of with potential hazard;
- ◆ Dive tenders reminded of the need to follow pre-dive dressing procedures, ensuring the neck dam is locked and secure and recording that this check has taken place;
- ◆ To prevent recurrence, divers and tenders were instructed to be vigilant regarding items that could cause or interfere with the pull pins;
- ◆ The practice of hanging work tools on the upper part of D-ring on recovery harness will be stopped.

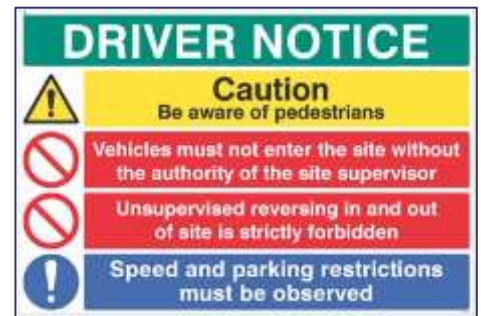
The UK Health & Safety Executive (HSE) has prosecuted a road haulage firm after an employee was crushed between two articulated vehicles and subsequently died from his injuries. A driver suffered fatal injuries when his vehicle rolled forward out of control whilst he was coupling the HGV (heavy goods vehicle) tractor unit to a trailer. See [here](#) for original press release.

UK HSE investigation found that the company had failed to implement safe systems of work or monitoring arrangements to ensure that its drivers were consistently undertaking coupling and uncoupling operations safely, in line with widely available industry guidance. As a result of this, a culture developed whereby its drivers were not always applying trailer parking brakes.

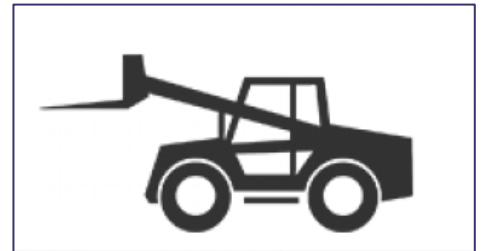
A worker was struck by a reversing telehandler when crossing the work yard. The worker sustained multiple injuries and later died in hospital. See [here](#) for original press release.

- ◆ The company had failed to address the management of large vehicle movements on its site;
- ◆ The company had not carried out an on-site health and safety inspection;
- ◆ The driver of the telehandler involved in the incident had not received any training in operating this vehicle.

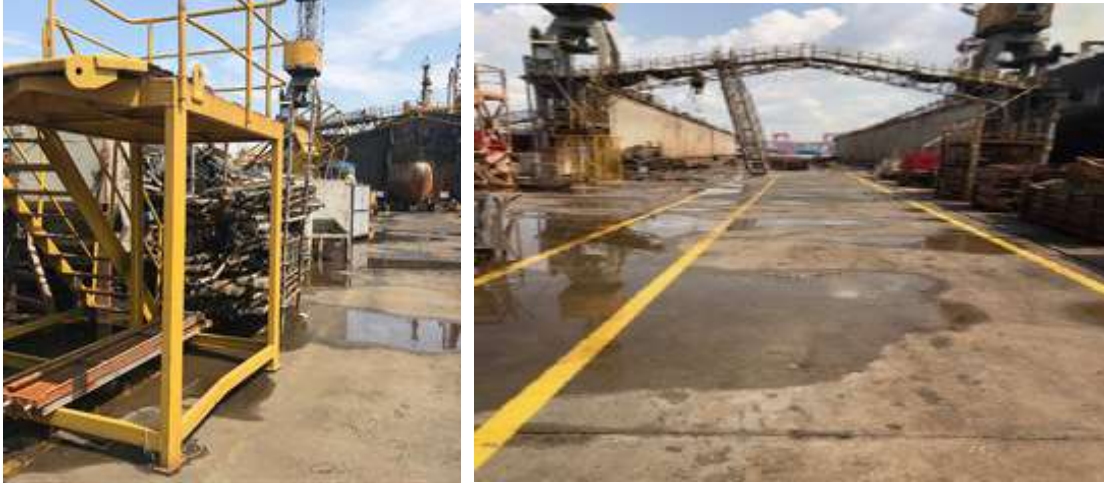
A member reports a near miss incident in which a worker was almost hit by a 'cherry picker' mobile crane. Whilst walking to a dry dock, a shipyard visitor was almost struck by the vehicle when it suddenly reversed driving direction.

- ◆ The cherry picker operator did not look first before reversing;
- ◆ There was inadequate traffic management or separation zones: the pedestrian walkways were not clearly visible as the paint markings had faded away;
- ◆ The traffic separation scheme for equipment and pedestrians had been blocked off with the storage of materials.

- ◆ Further toolbox talks for all equipment operators to address safe work practices;
- ◆ All materials blocking the pedestrian walkway were removed;
- ◆ Traffic separation scheme marking were refreshed with a new coat of paint.

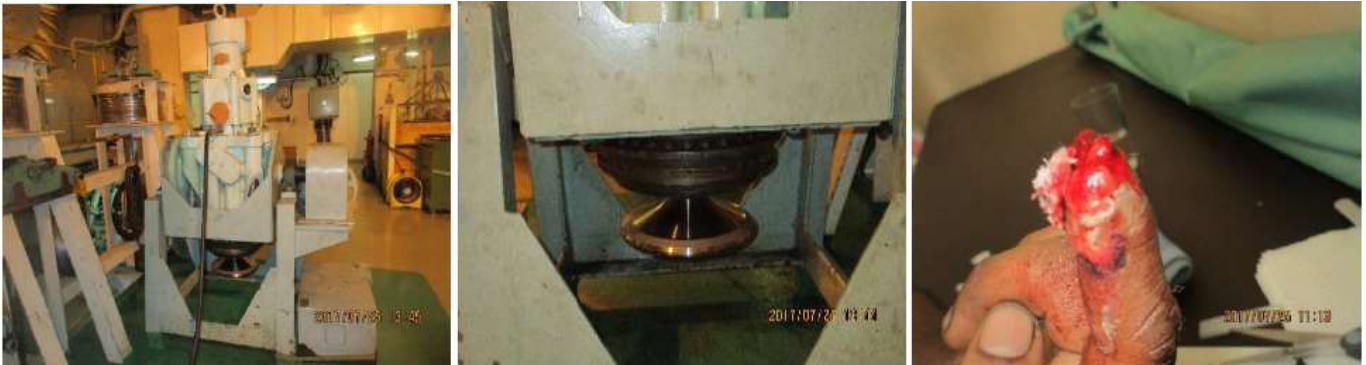
An engineer suffered a crushed finger when there was an unplanned movement of a main engine exhaust valve during maintenance. The second engineer and a fitter were working together on the overhaul of a main engine exhaust valve. After completion, the valve was tested with compressed air. Once the air was shut off and the seat descended, the second engineer noticed some dirt on the face of the seat. He instructed the fitter to stand clear using hand signals, and attempted to clean the dirt with a rag. At that moment, the fitter opened the air and the seat face moved upwards, crushing the second engineer's finger as he attempted to remove his hand.

- ◆ Some of the **immediate causes** were found to be:
 - Poor communication: Although in plain sight of each other, the noise of the engine room meant that verbal communication was not possible between the second engineer and the fitter. The fitter didn't see or understand the hand signals from the second engineer, and the reopening of the valve was not communicated to the second engineer

- Hand placed in dangerous position "in the line of fire"
 - Following the successful test of the overhauled valve, the compressed air was not disconnected prior to second engineer cleaning the face – crew were servicing equipment that was still in operation

- Inadequate planning – there was a failure to disconnect the compressed air prior to cleaning the face
 - Hazardous environmental condition – noisy engine room;

- ◆ The **root causes** were found to be:
 - There was no adequate system of communication and confirmation during operations in noisy environment was not identified during risk assessment neither discussed in toolbox talk

- There was no isolation (lockout/tagout)
 - Inadequate compliance – the risk in this routine, recurring task was seen as tolerable.

- ◆ Develop method of communications in noisy work environment and ensure this is included in risk assessment;
- ◆ Review/familiarisation of crew on company lockout/tagout procedures.

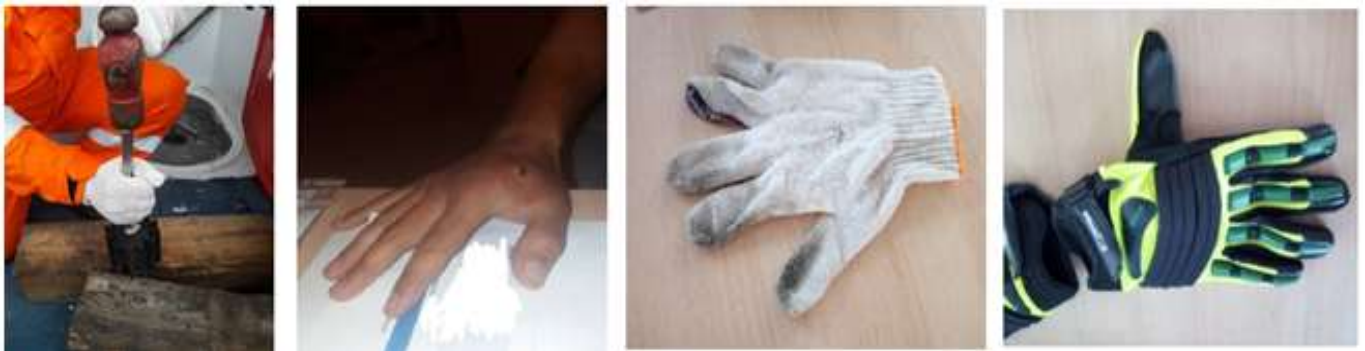
A crewman attempted to remove the impeller from a fire pump using a hammer and punching rod. While he was hammering, a steel splinter of the punching rod (3-4 mm) chipped off and punctured his right hand.

The incident happened during corrective maintenance to a fire pump. The injured person was tasked by the Chief Engineer to disassemble the pump, as the Chief was busy with other work. The injured person observed that the impeller was stuck on its shaft due to misaligned splines between impeller and shaft. He started to attempt removal of the impeller by knocking out the shaft using a hammer and a steel punching rod. The punching rod splintered and the splinter went through the injured person's glove and entered the soft tissues between thumb and index finger.

- ◆ The tools selected for the job were inadequate;
- ◆ An adequate and correct gear puller specially designed for the task was not available on board;
- ◆ Inadequate hand protection equipment was used for the task; cotton gloves were used instead of mechanical impact protection gloves, which were available onboard.

- ◆ Ensure the right tools to do the job are available;
- ◆ Proper PPE, whilst a last line of defence, can minimise consequences or prevent injuries from happening.
