IMCA Safety Flash 28/18

December 2018

1 LTI: Severe Burn from Short Circuited Li-Ion Battery

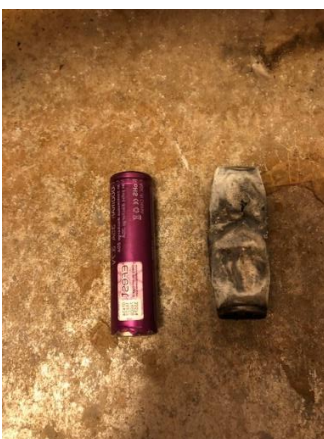
The metal keys created a short circuit with the battery. Carrying the battery in his pocket with the keys enabled the keys to provoke a 'thermal runaway' by either puncturing the outer shield or by making a connection between the plus and minus layers; the exact cause could not be determined conclusively.

The exploded battery and the one it was supposed to replace if required.

Our member prohibited the carrying of loose Lithium-Ion batteries whilst at work, added appropriate issues and precautions to the vessel induction information displayed onboard, and ensured that a check was made by stewards during cleaning of cabins in order to identify batteries being charged unattended.

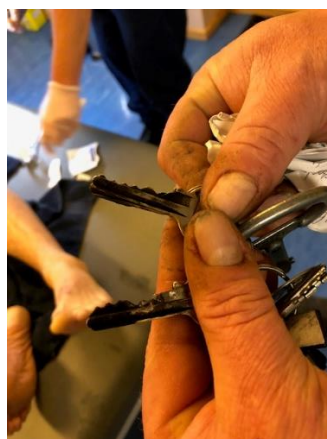
The keys that caused the short circuit

The crewman was carrying the Li-Ion battery loose in his pocket together with metal keys. This caused a short circuit of the battery and initiated a 'thermal runaway', which caused the battery to burst and explode into flames.

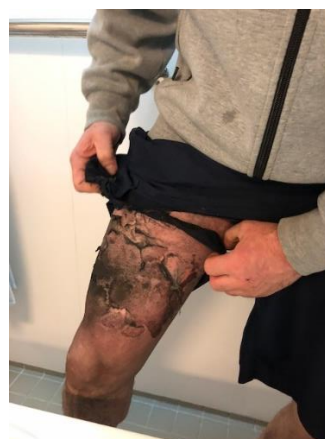
The burn – which was classed both 2nd and 3rd degree – temperatures estimated at approximately 1000 °C

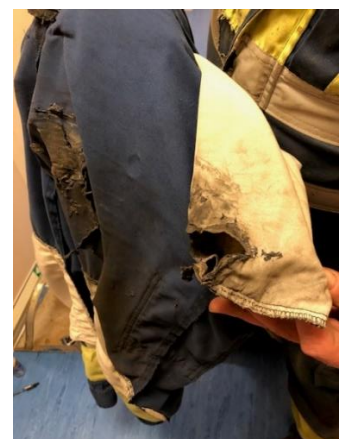
The pocket – burnt through

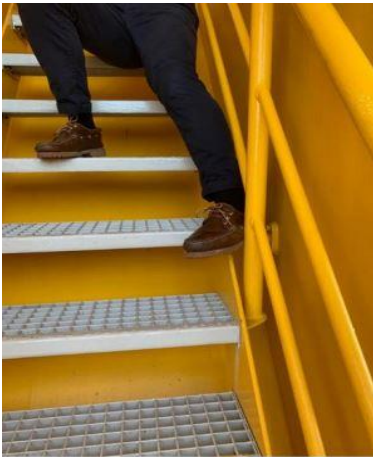
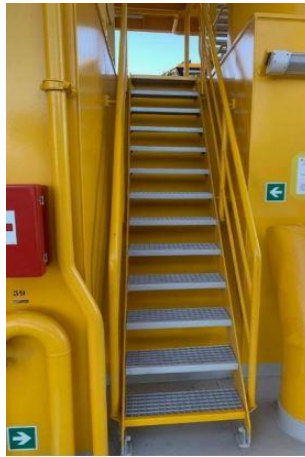
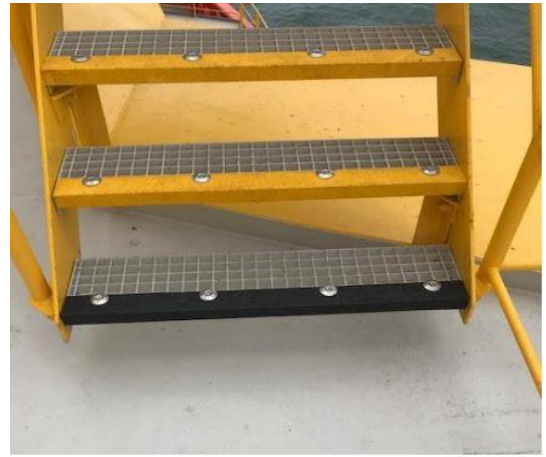
A crew member was going to a lower deck using an external stairway. He was holding a bucket in one hand and holding the handrail with the other. As he descended the staircase, his foot slipped off the step, causing him to fall. In order to prevent further slipping down the remaining steps, he put his left foot in the space between the upright stanchions to break the falling motion, and as a result broke his toe.

The MSF notes that the only potential problem could have been an ineffective grip on the steps; the vessel had the standard perforated steps found on many vessels, however, there was no additional anti-slip grip strip.

- ◆ Check that the anti-slip design or measures remain fit for purpose, and that they have not been painted over or worn – check it is still effective;
- ◆ During wet weather or when decks and surfaces are wet, particular care should be taken to use the 'trailing hand' technique or the 'one hand for the ship and one for yourself';
- ◆ Always wear appropriate personal protective equipment (PPE).

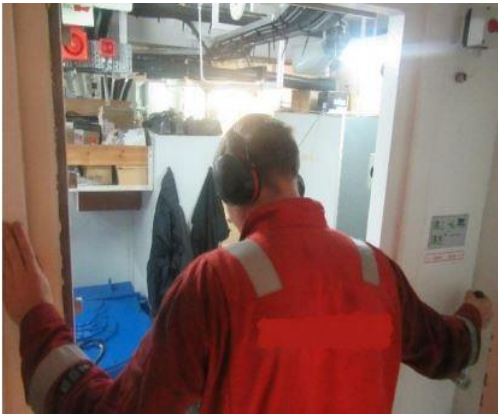
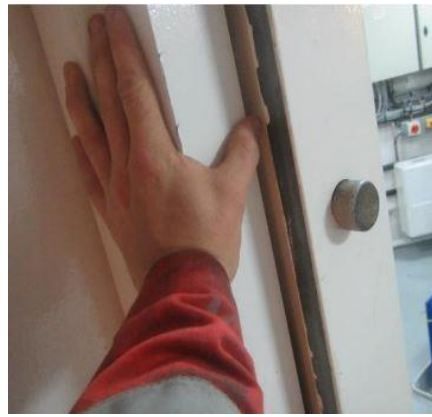
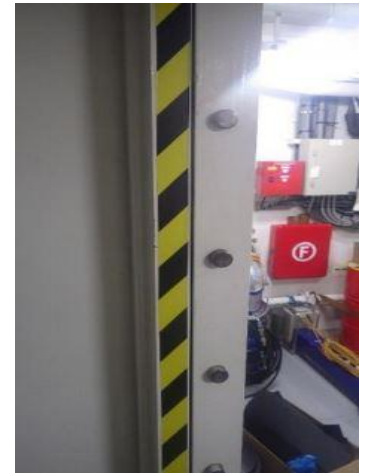
A crew member was opening a watertight door into the bow thruster room. As he placed his hand on the operating handle, he placed the other hand on the watertight door framework opposite. As the door opened, his thumb was squeezed between the frame plating and the door housing.

The injured person placed his hand on the opposite side of the door to steady himself, just in case of vessel movement. However, the framework provides a flat surface and is easily mistaken as a 'safe spot' to place a hand when operating the operating lever.

- ◆ Ensure all new crew members undertake a familiarisation tour of the vessel, effectively highlighting potential hazards (particularly, moving machinery, stored energy situations and equipment etc.);
- ◆ Encourage crew members to ask questions if any task or part of their role is not understood;
- ◆ All new crewmembers onboard should be supervised – this is key in providing trainees with a safe working environment. All supervisors are encouraged to ensure close mentoring and supervision;
- ◆ Highlight hazards surrounding the weather tight and watertight doors onboard;
- ◆ Add hazard markings to the door frame (as demonstrated in the above photos);
- ◆ Concentrate on the task at hand – concentration is vital in ensuring every crew member departs the vessel in the same condition they joined.

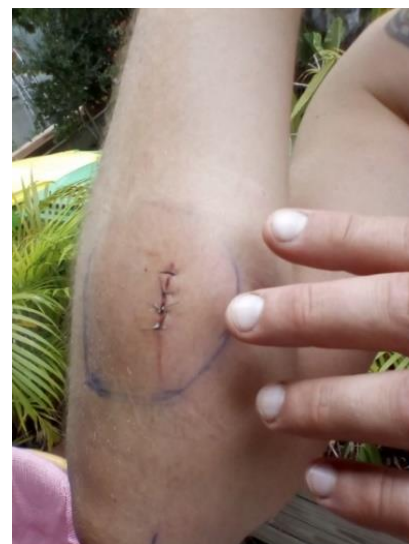
Whilst conducting routine engine maintenance a seafarer caught his arm on a sharp piece of wire, causing the need for medical treatment. The seafarer was using a spanner to tighten bolts connected to the main engine exhaust system where a piece of sharp reinforcing wire was protruding from some nearby flexible hose. The spanner slipped, causing the seafarers arm to forcefully come into contact with the wire resulting in a cut requiring medical treatment.

The sharp reinforcing wire was sticking out and should not have been.

Before conducting the routine maintenance, a simple check would have highlighted the sharp wire. The seafarer could then have either removed the wire or, if not possible, bent it back or covered it so as not to cause any harm.
