## IMCA Safety Flash 28/19

December 2019

### 1 Man Overboard – Fall from Pilot Ladder

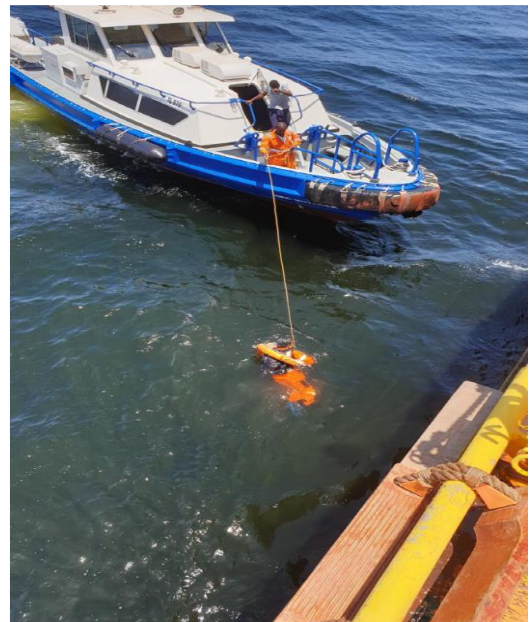
While he was climbing the pilot ladder with his right foot on the 2nd step of the ladder and his left foot just off the service boat deck, the boat lurched backwards, causing the bottom part of the ladder to sway slightly.

This resulted in the IT service technician losing his balance and he fell into the water from a height of approximately 1.0 to 1.2 meters. He was not wearing a lifejacket.

- ◆ Ensure that ALL persons embarking or disembarking through the pilot ladder wear SOLAS approved lifejackets;
- ◆ No bags, back packs or any other luggage should be carried – all luggage should be sent on-board separately;
- ◆ Brief all crew on ‘**stop work authority**’ – this should have been stopped before it happened.

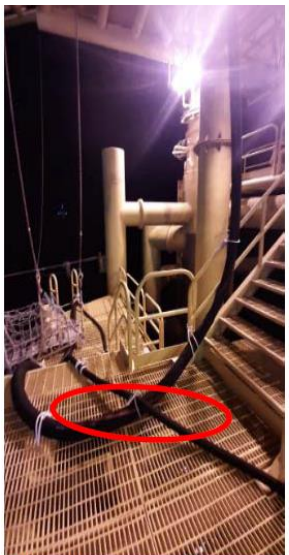
Position of temporary hoses at incident scene

- ◆ The incident was the result of poor/inadequate hose management practices; Hoses were laid across the platform boat-landing causing a trip hazard;
- ◆ Control measures as per the approved risk assessment were not implemented; specifically, the requirement to route hoses in a safe manner. This resulted in poor worksite preparation and insufficient inspection;
- ◆ Poor custom and practice – laying hoses on platform walkways had been common practice during the current campaign; they had been temporarily set up four days prior to incident and they were not identified or highlighted as causing a trip hazard;
- ◆ Failure to recognise and report hazards – individuals involved in the operations at the time of the incident had previously accessed the platform's boat landing and had failed to recognise and report the hazards presented from hoses laid across walkways.

- ◆ Ensure all work tasks are adequately planned and risk assessed before starting work activities, including review of access, egress and escape routes;
- ◆ Where temporary hoses are placed at access ways/work areas always, consider additional controls to eliminate the possibility for trip hazards, such as use of cable racks or hose covers;

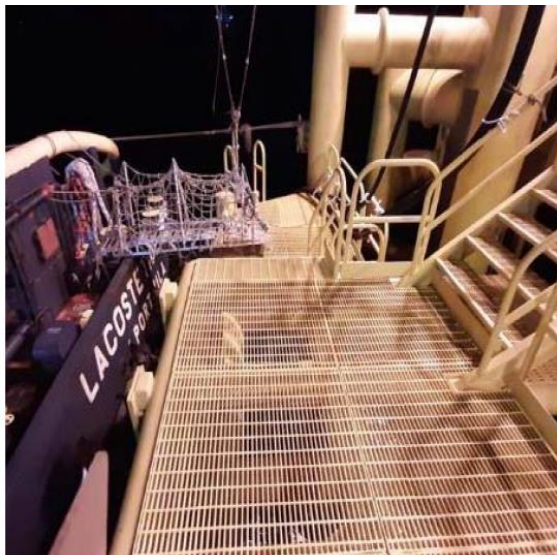
Reinstated work area, free of trip hazards - post incident event

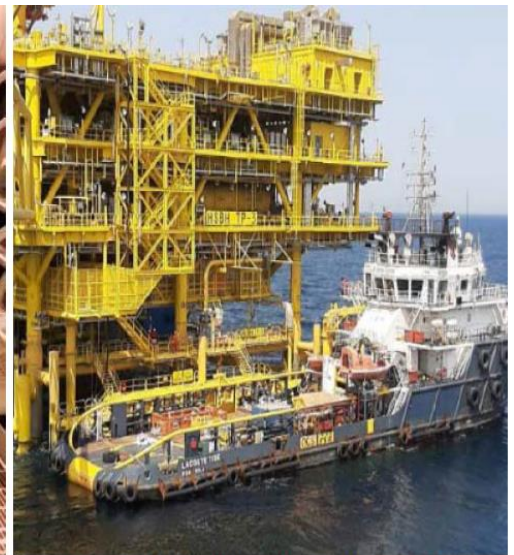
Offshore platform where incident occurred, with workboat alongside (moored to boat-landing)

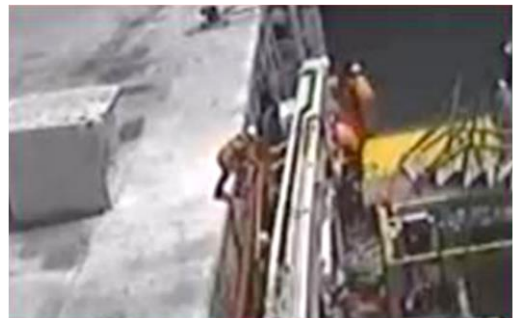
A vessel was departing from port when crew found it necessary to remove the mooring lines from the shoreside bollards with no safe un-boarding/boarding arrangements in place – instead clambering over the side (CCTV capture shown adjacent). A standard unmooring process (using shore-based support) had been discussed with the team involved during the pre-task briefing/toolbox talk.

Immediately before starting the unmooring operation, the port authorities informed the vessel that the ‘shoreside linesmen’ were not available. As a further consequence, the mooring lines were not recovered quickly enough, resulting in an entanglement into a stern thruster.

- ◆ The fouled mooring line was removed/cleared from the thruster;
- ◆ Reinforcement and raising awareness of:
  - existing company rules on safety including the obligation of all employees to ‘speak up/step in’ if they see an unsafe act and/or condition
  - the importance of dynamic risk assessment and management of change (MoC)
  - the relevant sections of Code of Safe Working Practices for Merchant Seafarers (COSWP)
  - fleet level risk assessment and management procedures
  - fleet level vessel mooring/unmooring procedures;
- ◆ There was a visit by senior management and discussion with the team involved.

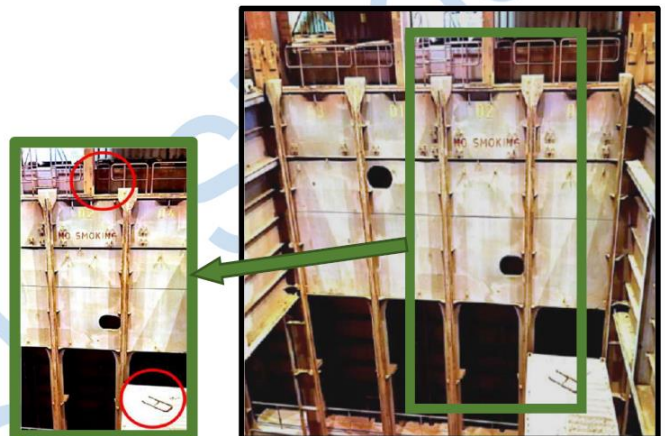
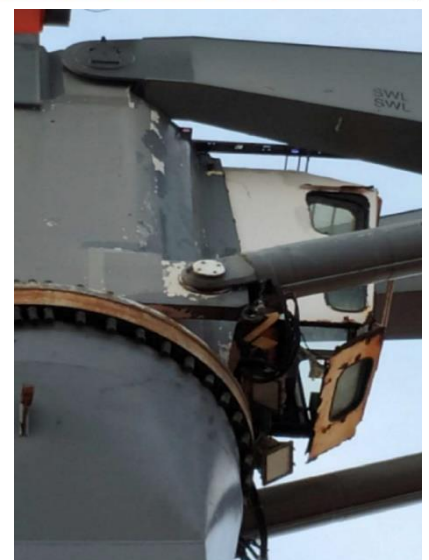
- ♦ **A stevedore was fatally injured** by falling into the cargo hold of a container ship; investigation revealed that a safety railing, which was in poor condition and badly corroded, could have contributed to the fall of the stevedore from a height of about 20 metres. Although the corroded safety railing had been identified to be one of the tasks to be carried out on-board, there were no safeguards or warning signs put in place to warn personnel in the vicinity of its condition.
- ♦ **A crew member of a container ship had a fatal fall from a height of almost 20 metres**, when the base plate of the crane cabin he had just entered gave way, and he died at the hospital.

- ♦ A comprehensive inspection regime of areas which could pose a threat to the safety of personnel should be in place so as to facilitate appropriate intervention and priority for carrying out appropriate repairs in a timely manner;

- ◆ Safety barriers/gratings are meant to protect personnel from potential hazards, such as prevention of falling from height. Where safety barriers/gratings are found to be corroded such that their main role of providing functions could be compromised and pose a threat to personnel, shipboard staff should take appropriate mitigating measures by putting up warning signs and cordoning off such areas to the extent practicable and make such observations known to the company;
- ◆ Inspections of areas which are covered by anti-slip mats or any other similar concealments of metallic surfaces, should be carried out in detail especially where the chance of moisture being trapped is high.
