IMCA Safety Flash 29/17

November 2017

Summary

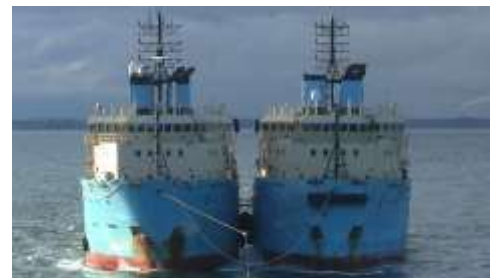
The Danish Maritime Accident Investigation Board (DMAIB) published a Marine accident report on *Mærsk Battler's* loss of tow and the foundering of *Mærsk Searcher* and *Mærsk Shipper* in the Bay of Biscay on the night between 21 and 22 December 2016. *Mærsk Searcher* and *Mærsk Shipper* were configured in a side-by-side towing setup. During the passage, the fenders between the vessels on tow failed, and the vessels started to interact. This caused damage to the superstructure, which eventually compromised the watertight integrity of *Mærsk Searcher* and led to water ingress. She capsized and sank, and subsequently *Mærsk Shipper* was pulled under also. The crew of the towing vessel *Mærsk Battler* carried out a controlled breakage of the towing wire and came loose of the foundered towage.

It is concluded in the report that the loss of fenders, collision and flooding of the unmanned ships under tow had been addressed in the risk assessment carried out, and that risk mitigating initiatives were in place for each risk item. However, these initiatives were ineffective. The DMAIB concludes that the risk mitigating strategies were mainly focused on preventing risk factors in isolation and left little or no contingency for acute interaction between the risk factors.

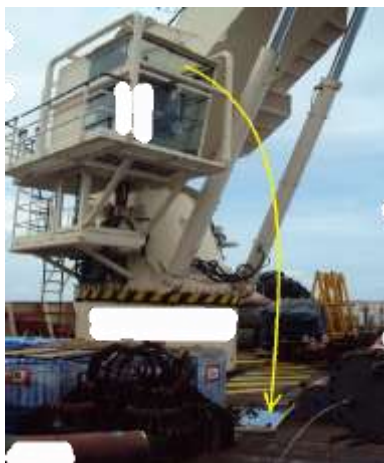
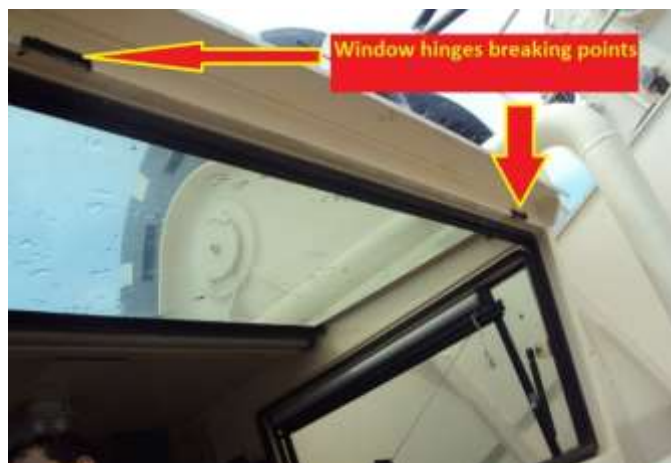
A window came loose from the crane operator's cabin on a DSV, and fell approximately 4m to deck. No one was injured. It happened when, during a pause in crane operations, the crane boom was slewed away from personnel working on deck, and the crane operator asked to stand by for further instructions.

While waiting, he noticed a grease stain on the outside of the cabin wind shield. He opened the cabin upper window from the inside, in order to make it easier to clean the stain, when the hinges failed and the window fell out and down to the main deck. The crane operator immediately shouted to deck personnel to watch themselves as the window was falling down. Everyone got clear; no one was hurt as no one was under the crane cabin at that time. Our member held a “safety stand down” and a dropped object hazard hunt was conducted on the main deck.

The hinges on the crane window failed, and the window fell out. Causal factors include:

- ◆ Inadequate design/construction of window/crane cabin;
- ◆ Inadequate maintenance/inspection of the crane window/crane cabin;
- ◆ Awareness of working at height, or of dropped object risks, may not extend to commonly unnoticed parts of the infrastructure of the vessel, platform or even of buildings, for example, windows.

- ◆ Review, design and propose a new upper window hinge connection. This will apply to any other window hinge connections that are identical or similar;
- ◆ Develop checklist to address the inspection of windows, doors and hinge connections elsewhere;
- ◆ Correspond with the window/hinge manufacturer on the deeper causes of the hinges failing.

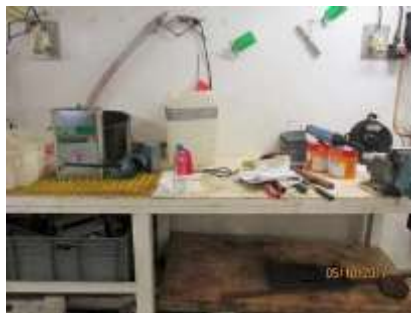
One of our members has noted a trend of chemicals being decanted into unlabelled clear plastic water bottles of the sort commonly used for drinking water, and persons have assumed the chemicals to be water and taken a drink from the bottle. Our member noted two recent cases; in one case, a person ingested a small amount of the chemical; in the other, a person took a sip from the bottle but did not swallow any chemical.

Water bottle in the position at the time of incident (NB there was no red tag on it at the time)

Storing chemicals in unlabelled containers presents an avoidable risk, especially when chemicals are placed into containers such as water bottles or soft drinks bottles. Accidental poisoning could result in serious harm. If unidentified chemicals are accidentally ingested, medical staff may not be able to administer the appropriate treatment in a timely manner, with potentially fatal consequences.

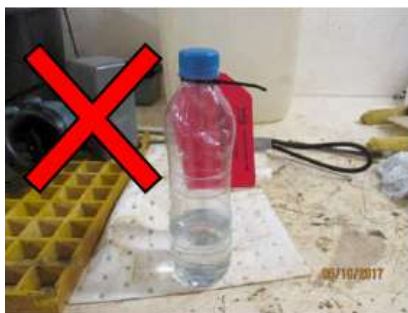
Close up of the bottle showing that the contents (Loctite SF7063) looked like water

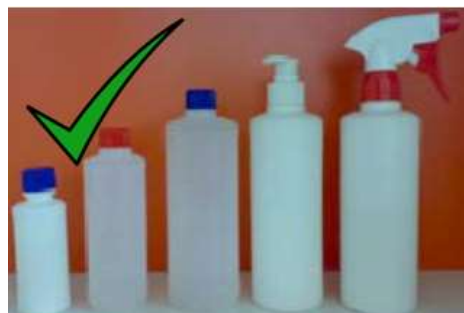
Examples of appropriate containers for decanting chemicals

- ◆ If it is necessary to decant chemicals from their original containers:
 - Always decant the chemicals in the chemical storage area
 - Use a container in good condition, of type appropriate for the chemical

- Ensure that both containers are clearly labelled. The labels should be clean and legible and should include:
 - full product name
 - Manufacturer name

- safety data sheet (SDS) reference
 - **Do not use bottles normally used for, or associated with, drinking water**
 - Wear the correct personal protective equipment including gloves and protective eyewear;

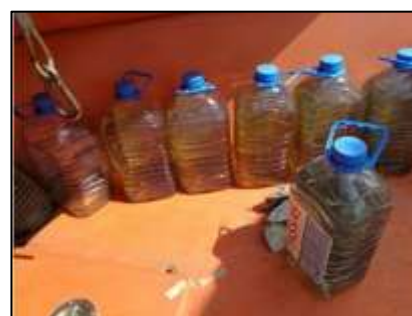
During a vessel inspection, plastic water bottles were discovered being reused to store diesel on board a fast rescue craft (FRC). There was no proper labelling or means of substance identification. The bottles were emptied subsequently and discarded accordingly. A safety stand down was held with the crew.

- ◆ Inappropriate management and handling of flammable liquid – water bottles used not for their intended purpose, but for storage of diesel fuel without any proper labelling;
- ◆ The storage of fuel oil or other chemical substances in drinking water containers was a ‘usual’ practice for the crew due to alleged unavailability of special containers on board;
- ◆ Lack of safety awareness: the potential risks of fire or spill, and the possible consequences to the crew members, environment and to the vessel, were not identified, nor properly assessed.

- ◆ All flammable and combustible liquids should be stored in a designated storage area in special containers with sufficient ventilation means in line with SDS indicated storage requirements;

- ◆ **Water bottles should not be reused.** There have been and are incidents in the industry of accidental consumption of fuel, thinners and other substances, due to water bottles being reused for other substances;
- ◆ Vessel management should identify requirements for appropriate and suitable containers for chemical storage, observing regulatory and operational requirements, and arrange delivery as necessary;
- ◆ Full crew discussion and review of risks associated with inadequate handling/storage of flammable and hazardous substances.
