## IMCA Safety Flash 29/18

December 2018

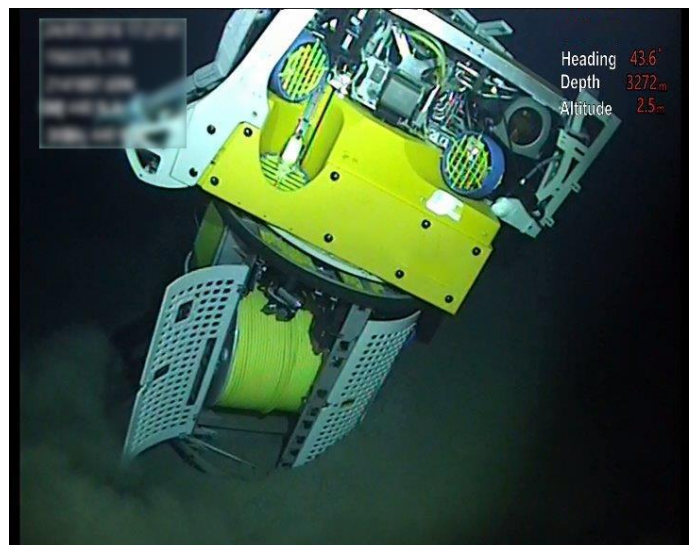
An ROV system had just completed a test dive to 3000m and was being returned to deck. Upon lifting the system out of the water, the umbilical became detached from the TMS bullet. The ROV and TMS fell to the seabed and landed upside down on a firm seabed at 3276m water depth. The vehicle was located by another ROV system from the same vessel. The system (ROV and TMS) was inspected on the seabed. Based on that information and the sea conditions (1.5m significant wave height), a risk assessment and a toolbox talk (TBT) were carried out which determined that recovery was both safe and possible. The spare bullet was terminated onto the ROV umbilical to allow it to be used to recover the system with the emergency recovery rigging on the TMS. The ROV, TMS and umbilical termination were damaged in the incident. No personnel were injured.

The parted umbilical termination was analysed by a third-party specialist laboratory. Following a detailed engineering examination and internal investigation, it was concluded that the umbilical failed because its termination had been conducted in a very poor fashion with a number of clear defects observed.

- ◆ It was noted that the subcontract technician doing the termination did not demonstrate appropriate skill in how to conduct such terminations, and it was clear that procedures were not followed;
- ◆ There was an over-reliance in each link of supply chain delivering a quality product, rather than following appropriate checking or verifying of quality.

- ◆ Umbilical re-termination procedures were revised to provide clearer instruction and now include requirement for photographic evidence showing completion of each main step;
- ◆ Umbilical termination considered a critical point of assembly therefore quality control processes should be followed to confirm appropriate surveillance is applied to sub-contractor.

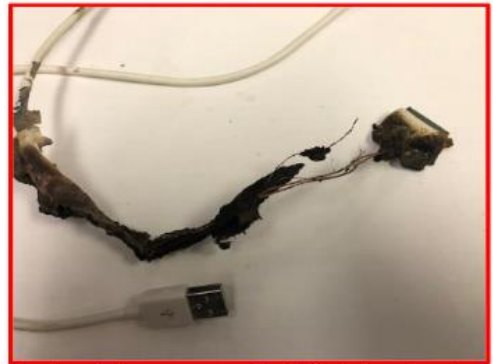
**March 2018:** A fire occurred in temporary living quarters after a contractor left a cell phone charging on his mattress while at work for the day. The charger wire apparently failed, creating enough heat to ignite the bed sheet and mattress (see photo, right). The fire team responded to the area and quickly extinguished the flames. No personnel were present at the time of the fire, and no injuries resulted from the incident.

*Wire insulation apparently failed, leading to fire.*

- ♦ Charger cords for all electronic devices should be in good working condition (with no exposed wiring) prior to being brought offshore;
- ♦ Charging devices should not be left on surfaces that are potentially flammable or that can promote heat build-up;
- ♦ Avoid leaving charging cables or portable electronic devices on bedding;
- ♦ Do not leave unattended devices connected to outlets found on lights in bunks;
- ♦ Remove electronic devices from chargers and outlets once fully charged;

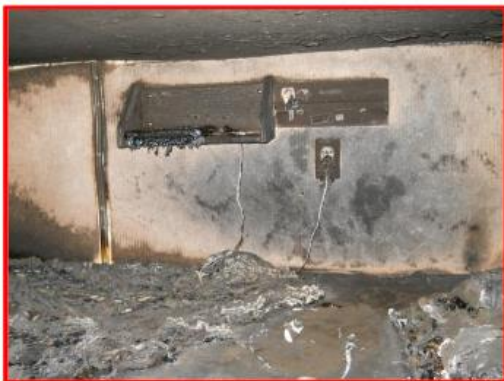
*Device was left charging on night stand.*

**May 2018:** Black soot was noticed above the entry door of rented living quarters. After power was isolated, personnel entered the building and found heat damage to the ceiling and lights, as well as multiple charred mattresses. A possible cause of the fire was a tablet being charged on a bottom bunk hanging night stand (see photo, left). The tablet and electrical receptacle were badly charred.

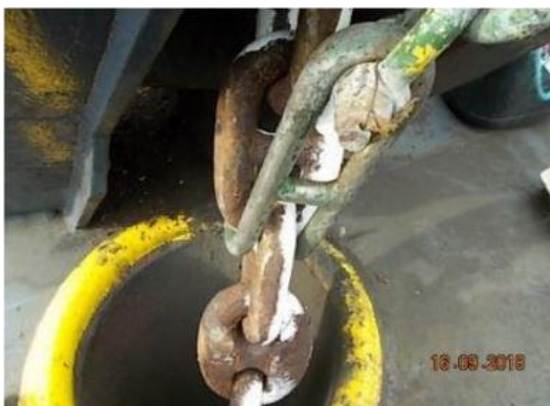
*Claw as intended*

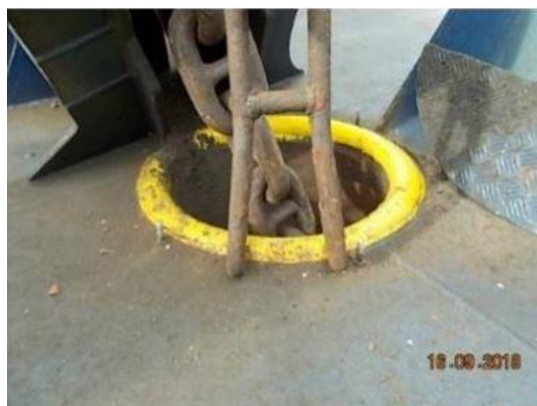
- ◆ Maintenance:
  - maintenance on the windlass and associated parts was conducted in line with requirements of planned maintenance system (PMS)
  - all parts of the windlass were greased regularly; however, as identified in other mechanical failures, grease from the greasing nipples had not penetrated every part of the equipment, leading to the linkages becoming seized;
- ◆ Claw:
  - the devils claw had been engaged on the anchor cable and tightened, leaving no gap or slack in the lashing
  - the two arms of the claw opened as the weight fell upon them, allowing the cable to pass through
  - there was no significant corrosion noted on the equipment;
- ◆ Guillotine:
  - the guillotine had not been secured in place when dropped across the cable when the break failed
  - because of this, it did not effectively stop the anchor cable running out when the claw failed.

*Claw post incident*

- ◆ Conduct thorough inspections of moving parts of the anchor windlass – particularly the brake band assembly. All moving parts should be confirmed operational;
- ◆ Routine greasing of parts to ensure proper lubrication. When greasing, moving parts should be moved to full extent of operation to ensure full functionality;
- ◆ Any seized or non-operational parts should be freed up at first opportunity;
- ◆ Devils claws of the design shown were replaced with wire strops of appropriate safe working load (SWL). Alternative designs are to be reviewed by vessels;
- ◆ All anchoring operations should include a check of the area to ensure no other part is placed at risk by the job; check over the side for any small craft at sea or in port. Exclusion zone in the proximity of the anchor during dry dock.

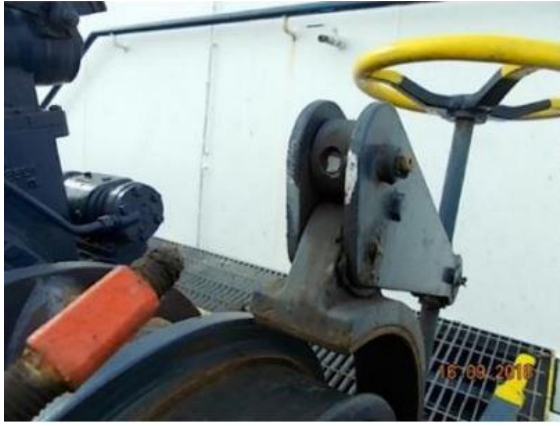
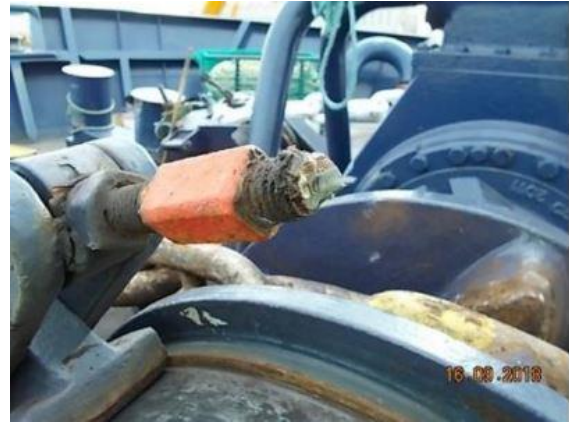
Stripping the brake assembly for investigation revealed that both linkages housing the failed threaded spindle were seized. Lack of rotation in the linkages caused a 'bending force' to be applied to the spindle upon tightening the break. Over time, this has caused stress within the spindle, resulting in complete failure.

*Failed section of brake assembly*

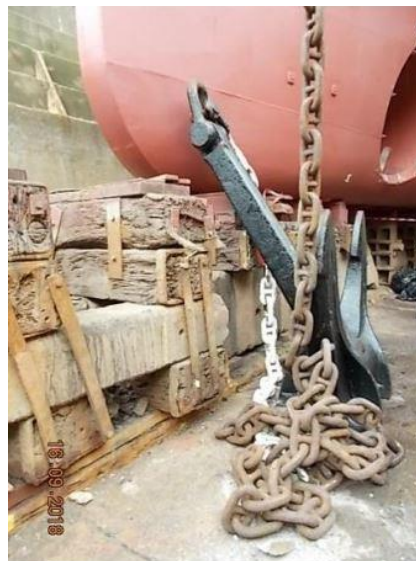
A vessel's anchors were ranged on the dock bottom for inspection and painting. With the work complete and the vessel due to depart from the dock, the anchors were recovered. Once recovered, the brakes were applied, guillotines on both anchors dropped across, and devils' claws were engaged. The clutch was disengaged and the brake on the port anchor was tightened to ensure that it was properly applied before finishing the maintenance. At tightening the break, the threaded spindle sheared, completely releasing the break band, meaning that the full weight of the anchor was taken on by the devils' claw. The weight of the anchor forced the arms of the claw open, allowing the chain to run freely and the anchor and chair to run out to the dock bottom unrestricted.

*Anchor post incident*

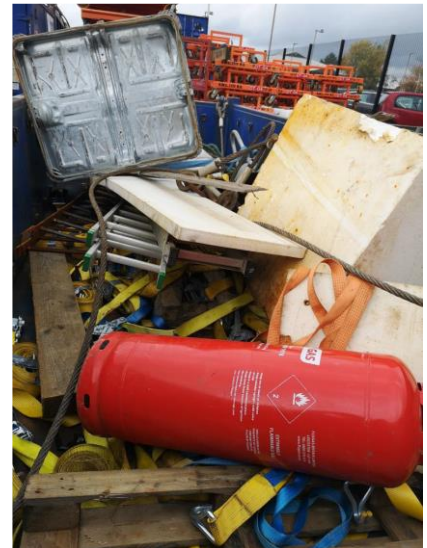
As the half-height container was unloaded from the truck, it became obvious that the equipment inside was inadequately packed and secured. The contents of the container included an empty intermediate bulk container (IBC) and a full propane gas cylinder.

- ◆ Inadequate active supervision during the demobilisation;
- ◆ Low risk perception and rushing to get the job finished;
- ◆ Failure to acknowledge or understand hazardous acts/conditions and the importance of intervention.

- ◆ Personnel to call an 'All Stop' if an unsafe act or condition is observed;
- ◆ Vessel management should ensure all equipment is backloaded in a safe and secure manner.

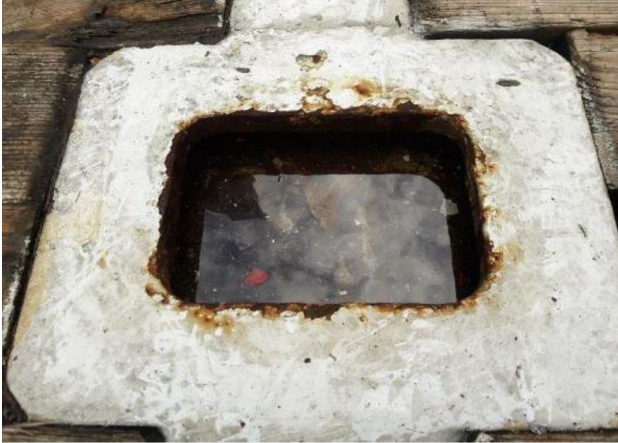
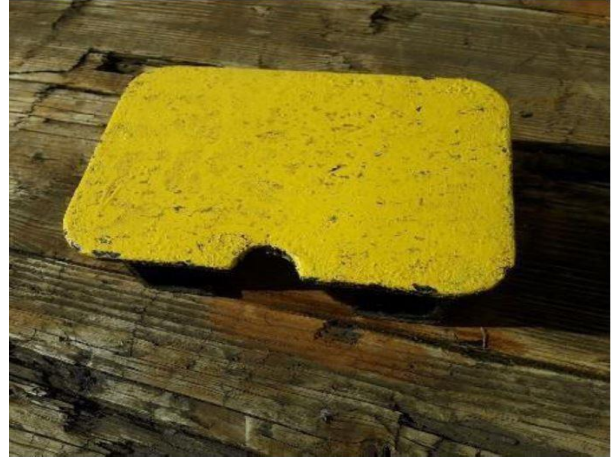
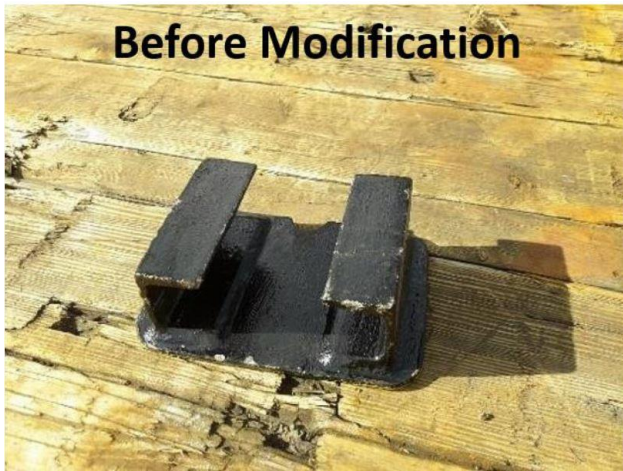
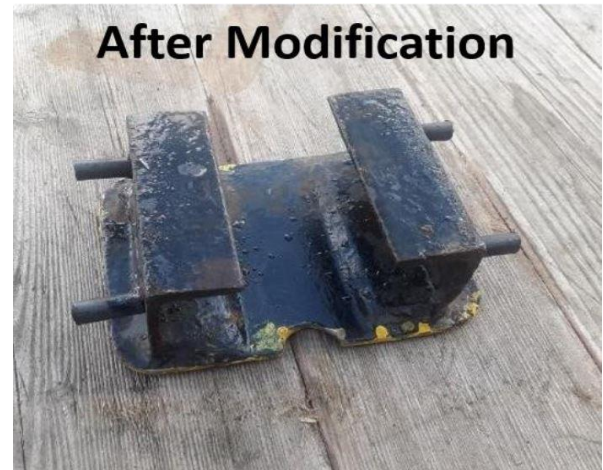
The Marine Safety Forum (MSF) has published [Safety Alert 18-23](#), in which a 20ft basket was lifted during offshore cargo operations. The bridge team were later informed by the installation crew that a yellow metal plate had been found trapped inside the forklift pocket of the basket; the plate was used to protect a potential trip hazard (stanchion mounting holes).

However, the control measures listed did not include pre-inspection of the deck; the control measure requiring a pre-inspection of the container failed as it did not identify the potential dropped object. The MSF does note, however, that the ability to conduct a full, detailed inspection of a container prior to lifting deck can be impaired and may not always identify potential dropped objects. This can be due to:

- ◆ The cover plate was replaced, and the trip hazard was removed.
- ◆ Vessel crew were able to come up with a solution to prevent the plate from accidentally being moved again – additional pins had been added which will hold the plate in place in the future (unless removed intentionally);
