# IMCA Safety Flash 30/19

December 2019

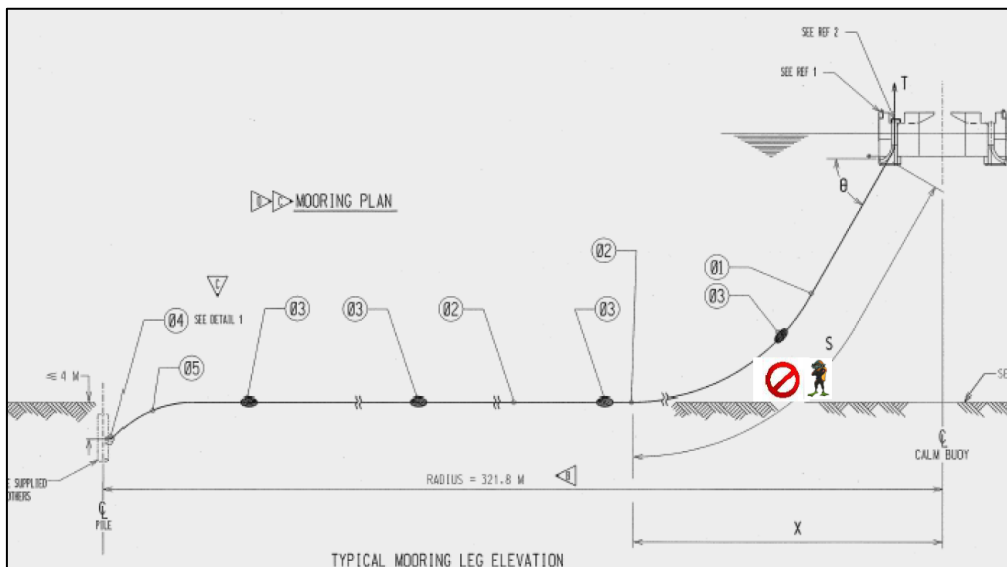
During diving operations to locate a pipeline end manifold (PLEM) near a single point mooring (SPM), a diver was trapped by an anchor chain. The incident occurred when Diver 1, searching for the PLEM, went underneath the anchor chain without realising it. His umbilical got caught and he turned back to find that it was trapped between the chain and the seabed. He tried without success to free it, and then tried to pass back under the chain, which moved at that moment, trapping the diver at the chest and left shoulder. Diver 2 was deployed to rescue Diver 1; he cut the umbilical and assisted Diver 1 back to the basket and safely back to the surface. Decompression was not necessary owing to the shallow water depth (10-16m) and bottom time.

- ◆ Risk assessment and procedures:
  - hazard identification was neither suitable nor sufficient for the project
  - company manuals and procedures were not followed;

- ◆ The client provided necessary information only at a late stage;
- ◆ There were “*adverse environmental parameters*” – heavy seas were causing significant movements of buoy and chains;
- ◆ The vessel was in the wrong place, and the vessel’s movements were inappropriate for the ongoing operation; i.e. the dive basket moved during dive while diver was on the bottom.

- ◆ More effective hazard identification (HAZID);
- ◆ Ensure all necessary information for safe operations is available in a timely way;
- ◆ Reiterate the full authority and responsibility of the Dive Supervisor in diving operations.

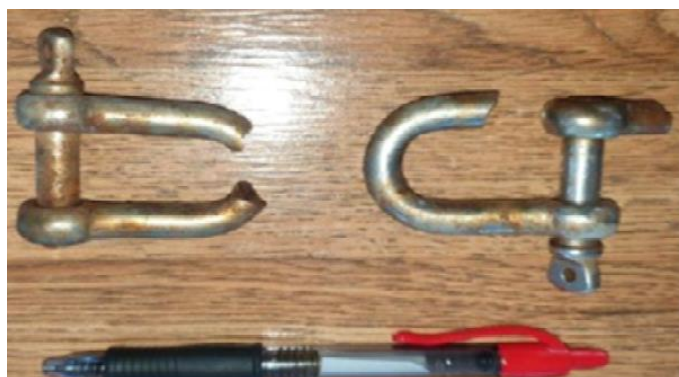
There was a failure of two stainless steel “D” shackles forming part of a life raft hydrostatic release assembly on a vessel. This was discovered whilst the vessel was in the 500m safety zone of an installation. A crew member noticed one of the vessel’s starboard life raft containers was in the water. The life raft was still attached to the vessel via the painter (rope). The crew member immediately notified the bridge team who stopped all non-essential operations and informed the installation. The vessel deck crew attempted to recover the life raft intact by using the painter; however, the life raft inflated. The inflated life raft was secured to the side of the vessel which then departed the 500m safety zone and safely recovered the life raft to deck.

The failed/parted shackles released the strap securing the life raft container to its stand. As a result, the life raft container fell into the water but remained connected to the vessel via the painter. The life raft inflated (as expected) when tension was applied to the painter. The shackles potentially failed due to crevice corrosion over time.

- ◆ Appropriate authorities were informed, and arrangements were made to replace the inflated life raft;
- ◆ All remaining life raft stainless steel shackles were replaced;
- ◆ Inspections were carried out to identify vessel equipment with potential for crevice corrosion and galvanic corrosion;
- ◆ Weekly checks to be carried out on the condition of shackles during weekly life raft inspection;

- ◆ The preventive maintenance schedule was improved to ensure the timely replacement of such stainless steel shackles before they fail.

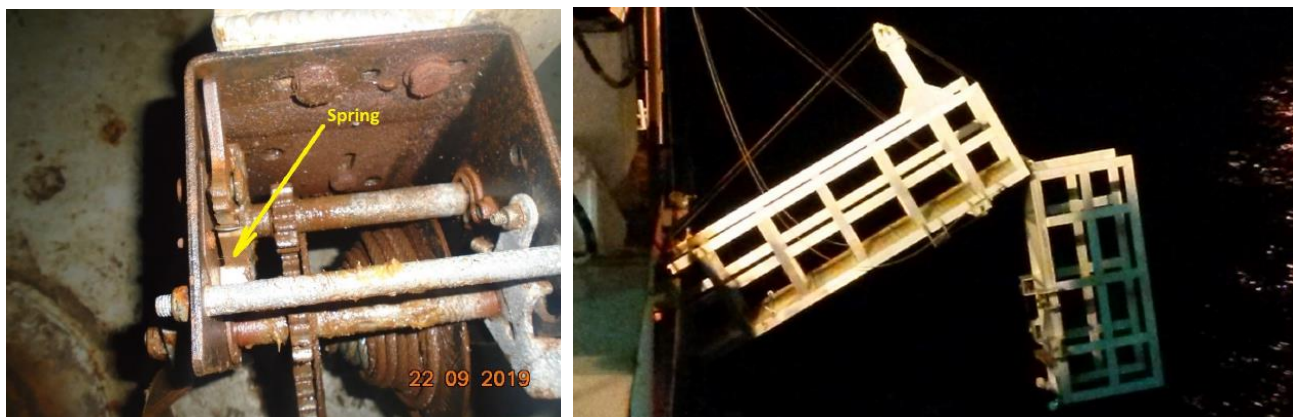
During lifting up and securing of a vessel's retractable gangway, the spring latch of the lifting device disconnected causing an uncontrolled release of the holding wire, and the gangway fell. The hand-crank of the lifting winch began rotating at high speed causing risk of injury to operating personnel.

- ◆ An unsafe gangway had been provided and requests for repair had not been met with any response;
- ◆ The vessel crew did not use “**stop work authority**”.

- ◆ Inspect all lifting appliances for the gangway;
- ◆ Replace damaged parts – spring latch replaced;
- ◆ Modification to gangway to secure it from possibility of uncontrolled fall.

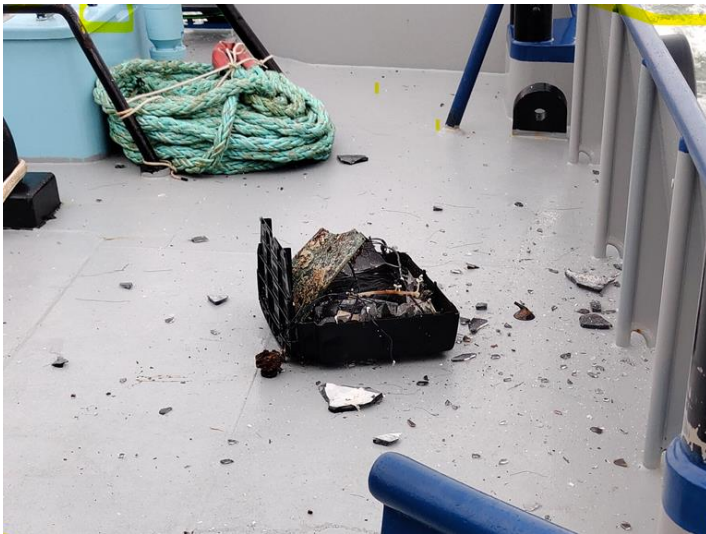
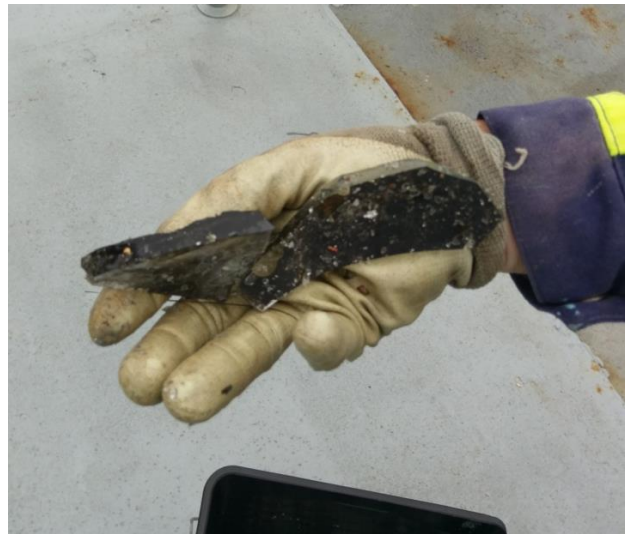
Just before they were going to land it, the television set exploded violently, destroying its case and sending shards of glass all over the aft deck. The crew were fortunate indeed; had their timing been different the TV set could have exploded in their hands on deck. Fortunately, in this incident, both crew members were still in the wheelhouse and fully protected.

The television set was covered in weeds and shells, indicating that it had been in the water for some time.

Ensure that you are wearing appropriate personal protective equipment (PPE) and treat objects recovered from the sea with extreme caution.

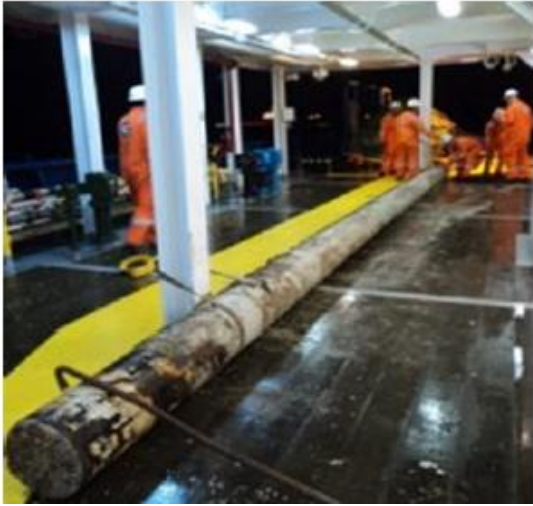
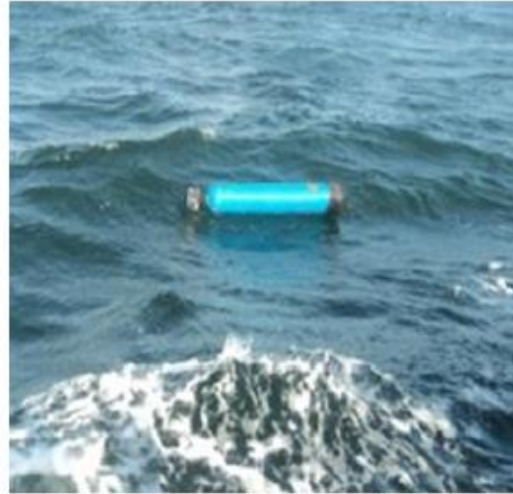
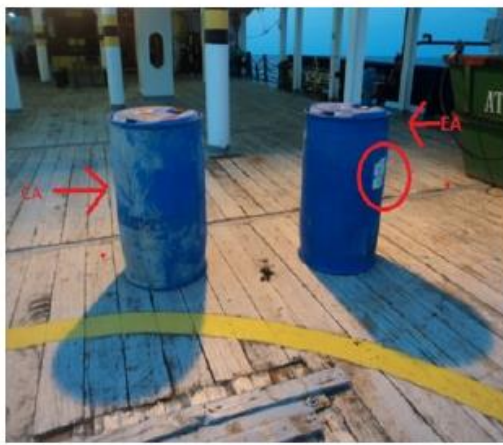
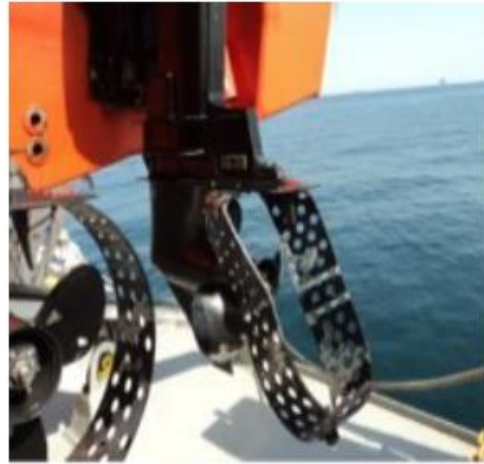
Several floating objects were identified in the 500m safety zone of an installation. Our members' vessel was requested to remove/tow these objects out of the safety zone to protect the installation. While doing so, the propeller of a fast rescue craft was damaged.

- ◆ Unknown floating objects in the water creating a potential hazard for damage to vessels and small boats at work or offer a potential hazard to the installation.

- ◆ The potential risks associated with unidentified objects at sea, whether floating or on the seabed, should be properly and thoroughly assessed, particularly when retrieval, towing and handling, or other intervention, is indicated. This risk assessment should include whether or not such objects are hazardous by nature and to what extent they could harm crew or assets;
- ◆ Any potentially hazardous objects should be reported to relevant emergency response services to be dealt with. Relevant agreements should be in place and well known by crew members and to be followed;
- ◆ Vessel crew and small boat/workboat crew should be vigilant and monitor any floating objects in water.

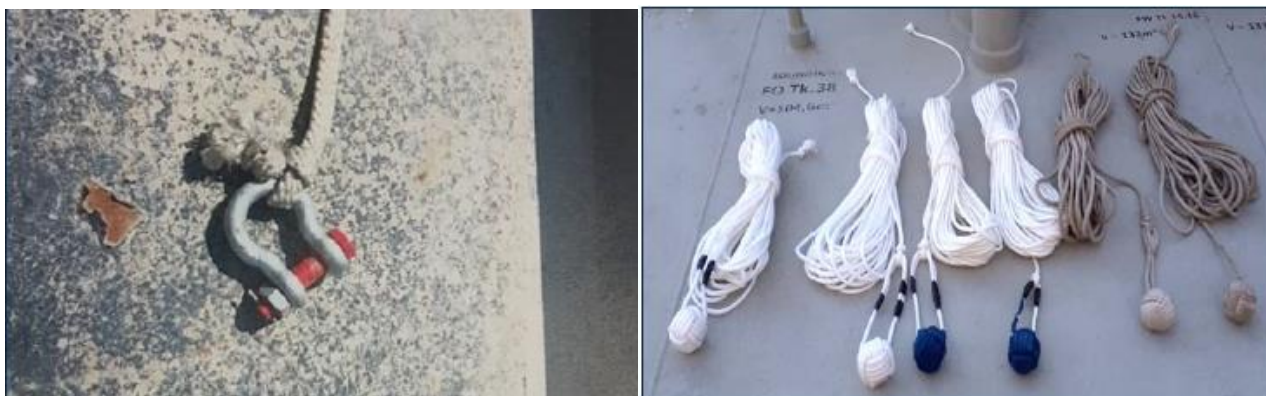
During a mooring operation, vessel crew were found to be using a 4 ton shackle attached to a heaving line (instead of proper “monkey fist”).

- ◆ The crew did not have an available heaving line with a “monkey fist”.

- ◆ Risk assessment for mooring operations to be reviewed.
- ◆ A check to be included to ensure that a sufficient number of heaving lines with "monkey fist" are available. In this case, at least 9 heaving lines were to be kept on the vessel (2 for use at each mooring station plus 1 spare).
