## IMCA Safety Flash 31/16

November 2016

### Focus: Diving Incidents

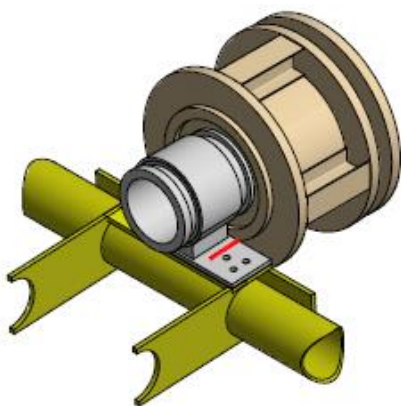
Following this risk assessment, the removal of the bolts, gusset plates and other cuts were completed successfully and without incident using burning equipment. The diver was nearing completion of the final horizontal cut on the securing collar doubler plate when a suspected 'blow back' occurred. This 'blow back' is believed to have caused the diver to lose consciousness.

Showing horizontal cut on doubler plate

- ◆ The engineers responsible for the development of the procedures had limited experience in underwater burning operations;
- ◆ The **immediate cause** was believed to be a build-up of gas in a location within the doubler plate and structure, which had not been identified in the risk assessment or procedure as a hazard. As the investigation remains ongoing, the **root cause** of the incident cannot be fully determined until the structure has been recovered to surface and assessed further.

- ◆ Suspended underwater burning operations until the root cause of this incident has been fully determined and a programme established and verified to ensure all lessons learned/actions from this incident have been met;
- ◆ Assessment of the company systems and processes for:
  - assurance of competency of personnel
  - effective MoC
  - identification and adequate control of risk
  - ensuring personnel comply with company process and procedures;
- ◆ Thorough review of dive project plans and scope of work procedures;
- ◆ Verification with client of 'As Built'/'As Found' information and data;
- ◆ A review of the operational MoC and SRA process to determine opportunities for improvement in relation to the timeline of this specific incident.

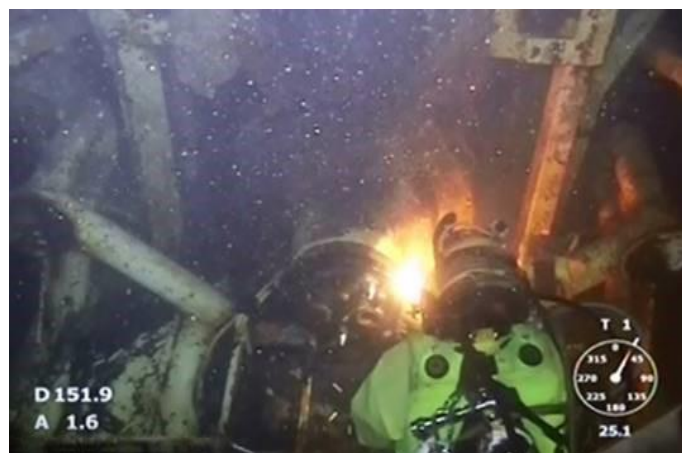
Showing diver position at the moment of the suspected blowback

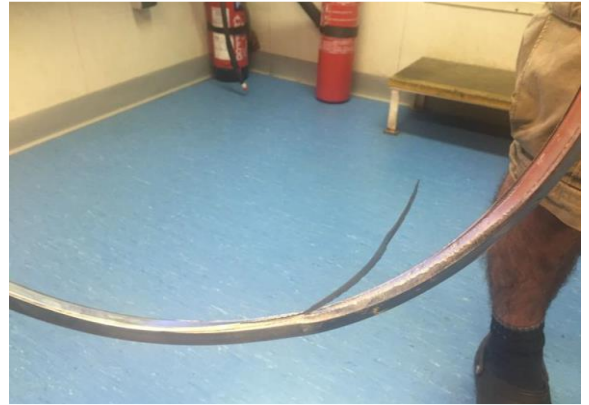
A member has reported an incident in which a diver received a hand injury during diving operations. The event occurred during joint rectification activities on a riser flange at 169 msw, following a report of a leak during commissioning. The divers were de-tensioning the flanges, and once the flanges were separated, the ring joint became free and fell off the middle of the flange to the seabed. A diver went to recover the ring joint from mud unaware that it was damaged (see photo showing details of damaged ring joint).

- ◆ The ring joint had been installed on a previous diving project by another diving subcontractor;
- ◆ The ring joint came free and fell down into the mud as soon as the flanges were separated;
- ◆ There was no chance for the diver to ascertain the ring joint conditions;
- ◆ This occurrence was unlikely – it was the first occurrence in over twenty years of a similarly damaged ring joint;
- ◆ The **direct causes** of the incident were found to be:
  - improper installation of the ring joint during a previous diving campaign with consequent deformation and damage of the latter
  - ring joint falling to the seabed
  - mud on the seabed;
- ◆ Other **causal factors** identified were:
  - great difficulty in ascertaining the condition of the ring joint before recovery from the mud
  - the diver's gloves (fit for diving purpose) were not designed to protect against cut and perforation.

- ♦ Before recovery from mud by hand of potentially damaged equipment having possible sharp edges or points, divers should:
  - wear anti-cut/anti-perforation gloves
  - perform a preliminary check of the equipment using a hook.

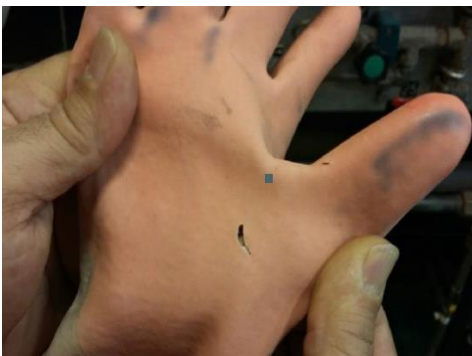
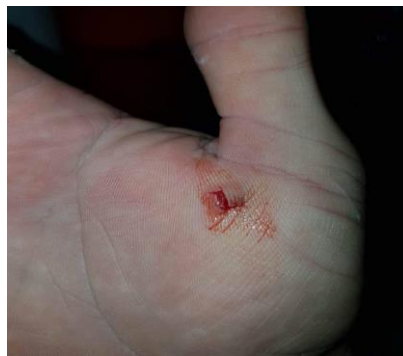
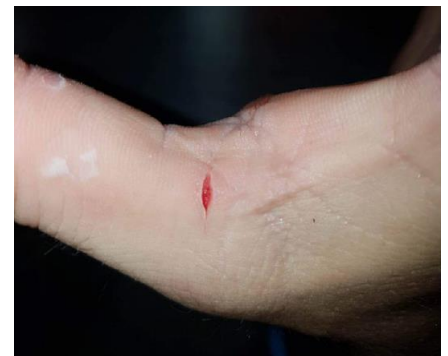
The damaged part of the ring joint punctured the divers' soft neoprene glove and caused two small penetration wounds to his right hand, between the thumb and index finger (see below). The injured diver returned to the diving bell and received first aid (the wounds were washed with fresh water and cleaned). The bell run was terminated.

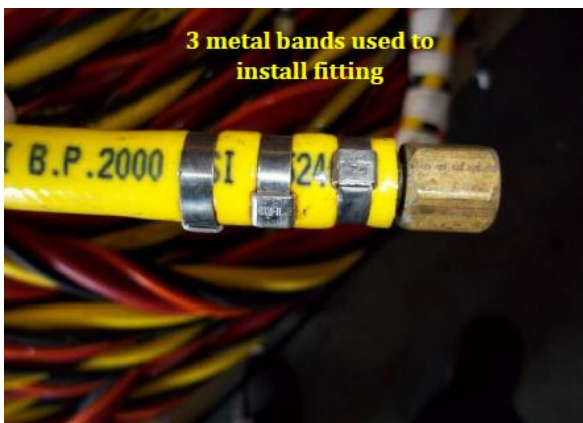
Fittings on 3/8" Gas Hoses (HDA0106) were installed with three metal bands;

- ◆ Use of the illustrated methods for fitting hoses in the field can compromise diver safety;
- ◆ The illustrated methods are not recommended or approved by manufacturers, nor is the use of re-useable fittings;
- ◆ The use of re-useable fittings can lead to pressure loss and/or water ingress, which can occur when the outer jacket of the hoses is compromised. This can lead to catastrophic failure at the fitting if the metal bands were to compromise the pressure control braid in the hoses – see above middle photograph;
- ◆ Water ingress into the hose layers can contribute to the build-up of bacteria leading to hose odours.

- ◆ Use only standard fittings involving a swaging or crimping technique;
- ◆ Do not remove bend restrictors from the hoses as this can allow movement at or around the fitting that could lead to early damage of the fitting spigot and accelerate the damage to the hose jackets and linings;
- ◆ Do not use reusable fittings as they can fail or come off at pressure if not exactly sized and correctly installed.

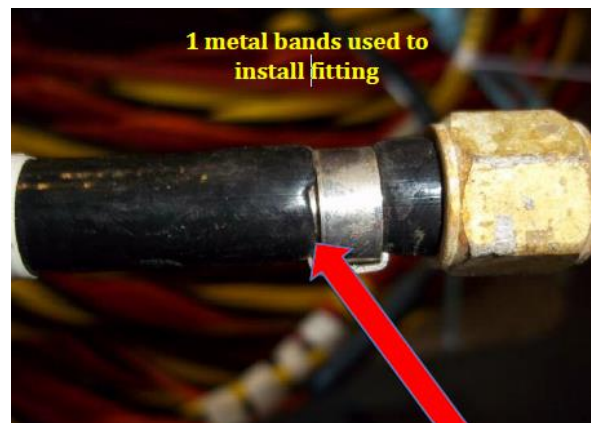
Fittings on the 1/4" Pneumo Hose (HDA0104) were installed with a single metal band;  
Red arrow indicating cut jacket, exposing braid

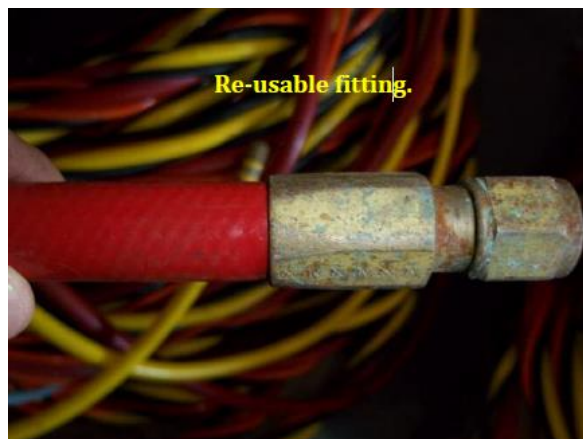
Fitting installed on the 1/2" Hot Water Hose (HDA1108) were re-usable fittings.

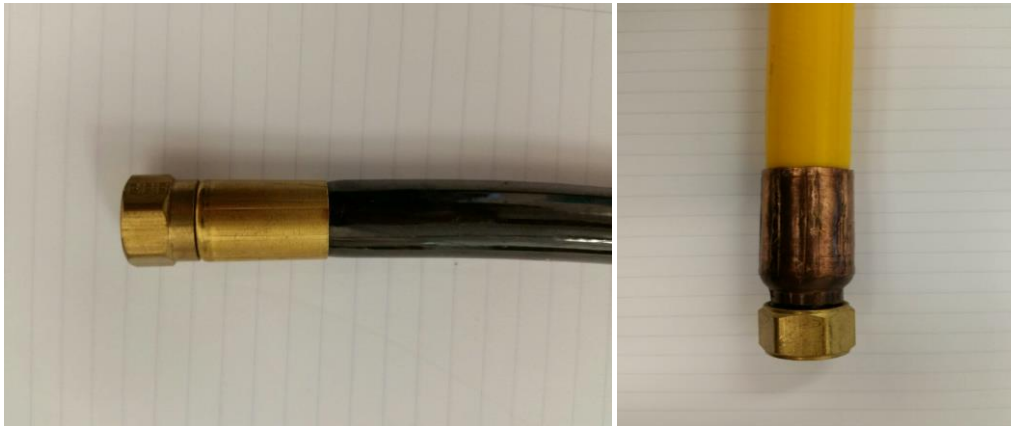
*Showing crimped fittings*

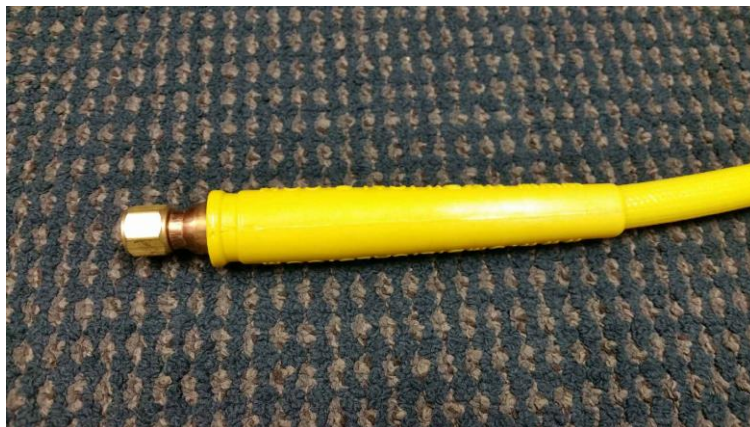
*Showing a bend restrictor*
