## IMCA Safety Flash 31/17

December 2017

### 1 Potential Engine Room Flooding: Maintenance and Equipment Failure Issues on A Laid-Up Vessel

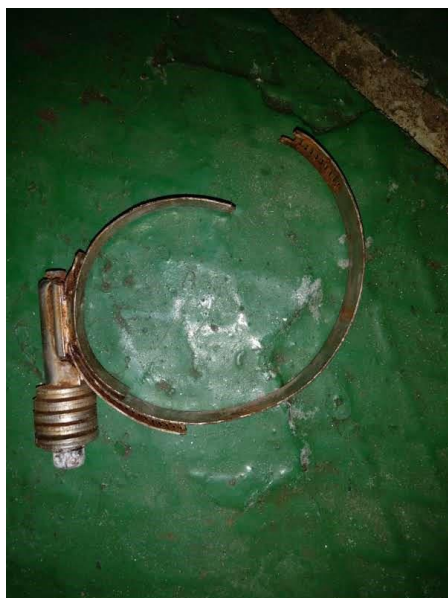
*Failed hose clamp, mounted on the discharge side*

- ◆ Equipment failure:
  - The failure on the cooling line was traced to a broken hose clamp with signs of corrosion, which allowed a flexible hose to get disconnected from the rigid connecting pipe
  - The intermediate valves from the crossover sea chest line were found to be seized;
- ◆ Procedures:
  - The crew did not have portable radios, so there was no remote communication between the crew members
  - Crew on laid-up vessels did not have access to the company's document management system, and hence no access to the company safety management system (SMS) and other important information
  - Repair and maintenance conducted were not being recorded in the company planned maintenance system
  - Vessel crew were unaware of documented company emergency response plan and procedures
  - Vessel crew were unsure of whom to contact for daily operational needs.

- ◆ 46,000 litres of oily water were pumped out of the engine room bilges. Due to lack of information, it could not be confirmed whether this amount was all due to the incident or possibly could have been there before that;
- ◆ A new hose clamp was installed, the engine tested and all found to be in good order.

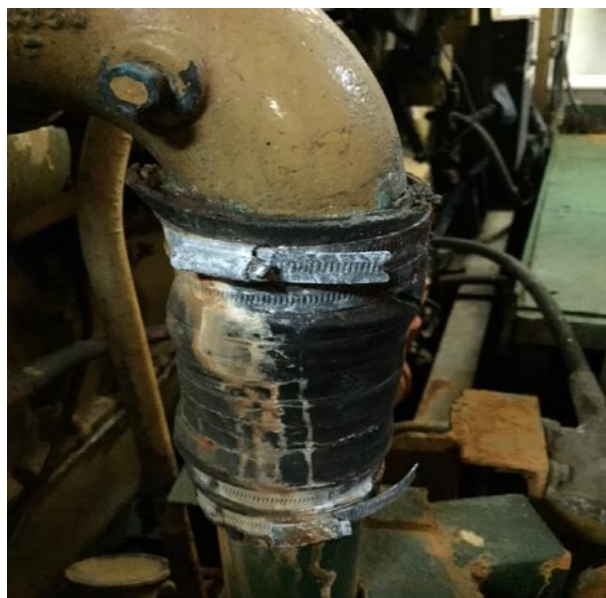
*Hose clamp condition - in use on suction side of sea water cooling pump, found on the day of investigation, on the same engine where the failure occurred*

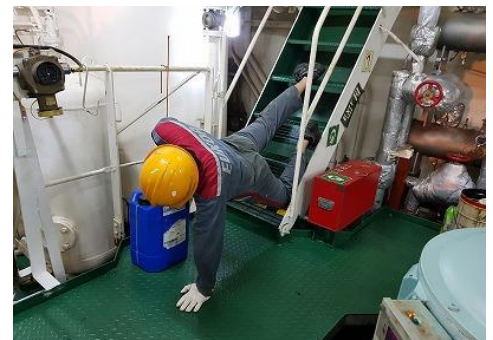
*Showing re-enactment*

- ◆ He was going down the stairs without holding the handrail;
- ◆ The stairs were slippery;
- ◆ His foot got caught.

- ◆ Could there be a better or safer way to transfer this oil?
- ◆ All should be more safety conscious when going down the stairs, particularly if carrying things;
- ◆ Handrails should be used; correct lifting and carrying procedures should be followed;
- ◆ Good house-keeping – ensure stairs, floors, safety shoes etc. are kept free of oil and grease.

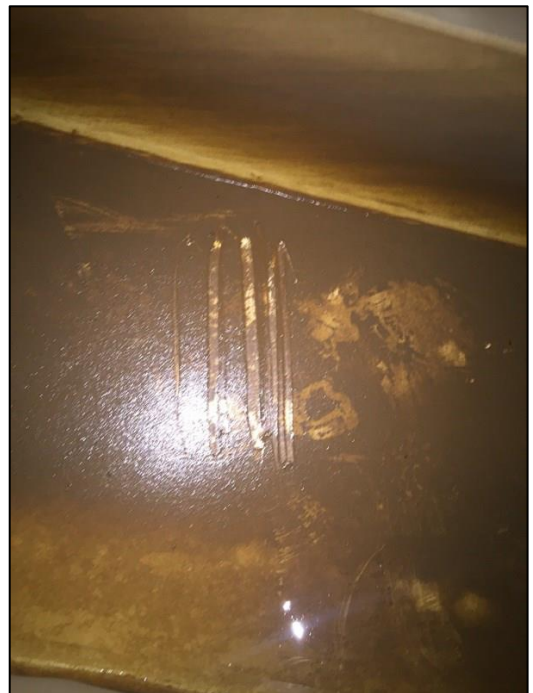
In the first incident, fresh water analysis carried out by a 3rd party indicated an increase in TVC (total viable count) of bacteria in the fresh water system of some vessels. Inspection of vessels' fresh water tanks revealed that they were dirty and had not been cleaned or maintained for a long time. See image *to the right* of mud in the freshwater tank:

- ◆ There was a recurring failure to inspect and maintain vessel fresh water tanks;

- ◆ Vessel fresh water tanks should be regularly inspected and cleaned;
- ◆ Drinking water bottles should not be re-used;
- ◆ Arranged for proper and scheduled cleaning of fresh water dispensing equipment;
