IMCA Safety Flash 32/16

November 2016

Basic Safety and Seamanship

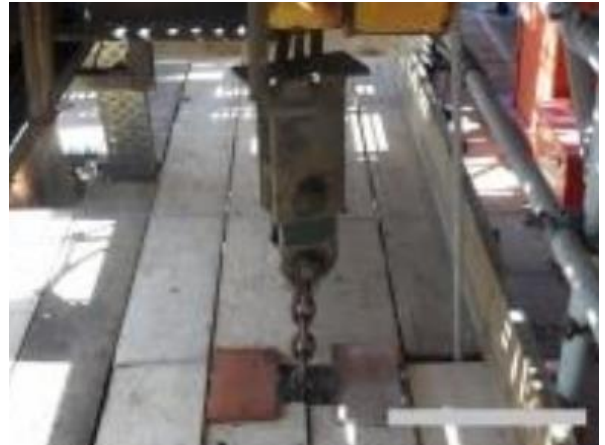
Step Change in Safety has published the following safety alert regarding an incident in which lifeboat launch capability was compromised. The incident occurred when scaffolding was erected in close proximity to the lifeboat. It had been erected to allow safe access for sub-contract personnel to surrounding structures. During a worksite visit it was noted that the scaffold had been erected around the winch chain on the aft end of the lifeboat.

This would have rendered the lifeboat very difficult to launch. It was identified that the opening left to allow the winch chain and winch block to pass through was significantly smaller than the winch block itself. On the underside of the scaffold boards there was a scaffold pole support that would also have impaired the descent of the lifeboat.

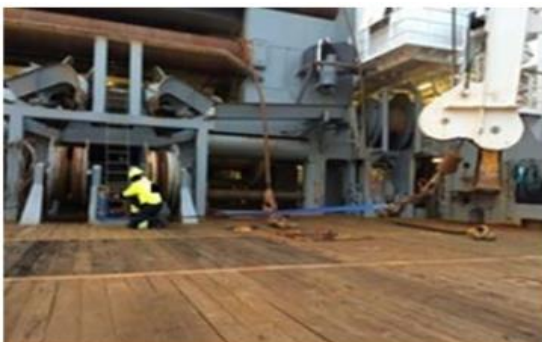
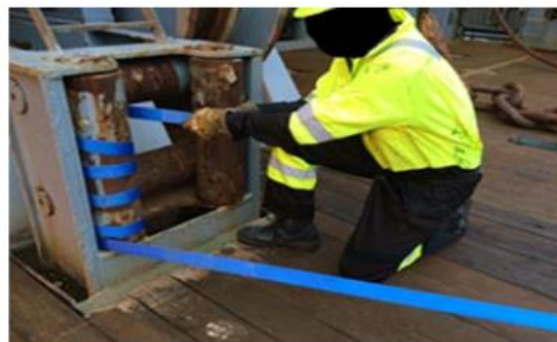
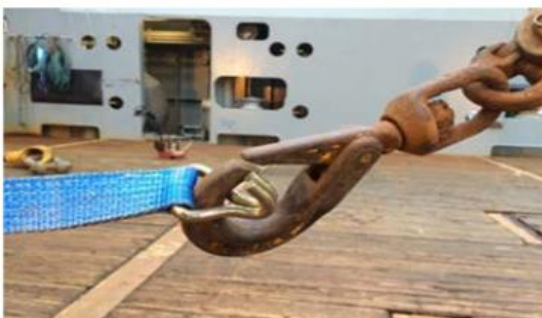
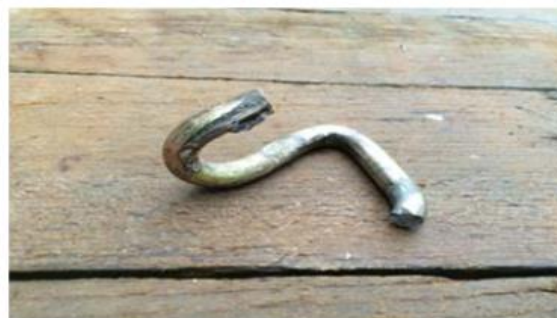
The Marine Safety Forum (MSF) has published a safety alert regarding an incident in which a strop hook broke and hit a crewmember. The incident occurred during maintenance on deck. Vessel crew discovered a roller on a winch that was stuck. They decided to try and loosen it by using the rail crane fitted on the vessel. When the crane driver tried to pull it loose the pallet strap hook broke off the crane hook and hit a sailor in the back. He was severely injured.

- ◆ The pallet strop hook was incorrectly secured to the crane hook making it much weaker than the safe working load (SWL) of the lifting strops;
- ◆ Equipment was used incorrectly;
- ◆ Crew were stood in the snapback zone;
- ◆ There was inadequate planning and risk assessment.

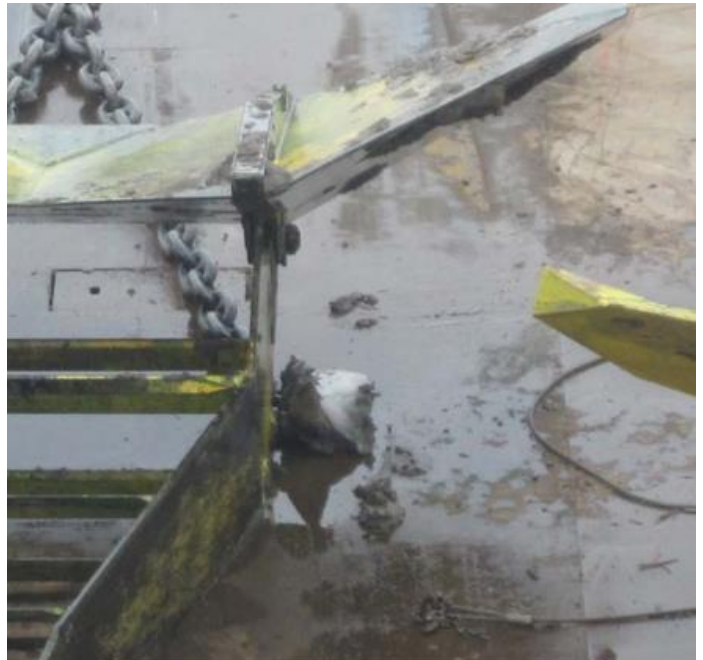
The MSF has published a safety alert number regarding an incident in which a person was hit by mud/clay during anchor handling operations. The incident occurred during recovery of anchors from the seabed. A person was injured when a 50 kg lump of mud/clay rolled onto his back as he was checking the identification number of a shackle. The injured person was a marine representative. The anchor was secured on deck and tension was off but the anchor had not been disconnected and moved to the stowage area. Most of the mud/clay had fallen off during the recovery but some mud/clay was still attached to the anchor.

The submitter of the report notes that the injured person did not see the hazard and as he was leaning down the mud/clay rolled off and hit him over his back. He fell and sprained his ankle and suffered pain in his back as the result of the incident.

IMCA notes that the **root causes** of this incident are not in the report. Failure to properly control the worksite, inadequate risk assessment, and inadequate supervision, would appear to be amongst the causal factors in this incident.

It should be noted that it remains everyone's responsibility to **STOP** unsafe acts and to ensure all persons on deck are operating in a safe manner.
