IMCA Safety Flash 33/16

December 2016

Summary

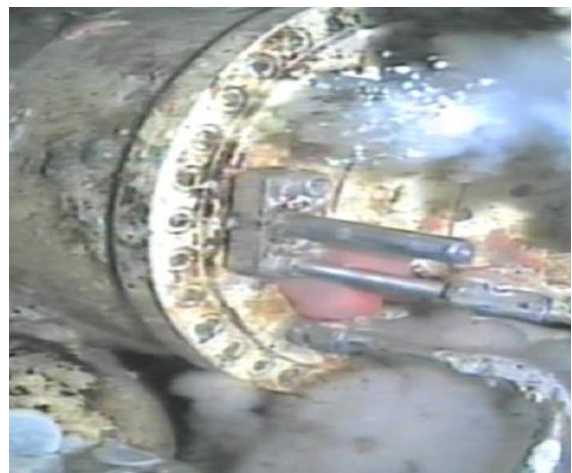
The incident occurred during subsea operations which involved divers monitoring a manifold valve. A hydraulic release occurred when a valve was operated by the client FPSO. This leak was not detailed on the Dive Log or as an anomaly within the Management of Change (MoC) step of the operation. It was not reported to the Offshore Management Team nor to the client representative on board at the time. The client became aware of the leak some four months later following a review of as-built video footage, and onshore project management were notified of the incident. In the regulatory framework within which the vessel was operating, it is a requirement that any such releases to sea are reported by the client within 6 hours of such an event occurring.

No personnel were harmed or equipment damage sustained; however, an unknown volume of fluid was discharged to the environment which was not reported at the time of the incident.

- ◆ The requirement to report all subsea leaks was not followed. Personnel were not familiar with company procedures in place to ensure compliance with local regulations;
- ◆ Project process to manage implementation of client site instructions for additional works were not clearly defined.

- ◆ Ensure that pollution reporting process requirements are understood by all key personnel both onshore and offshore;
- ◆ Dive Plans should clearly reflect requirement to notify both client, master and project engineer of any discharge observed from subsea infrastructure.

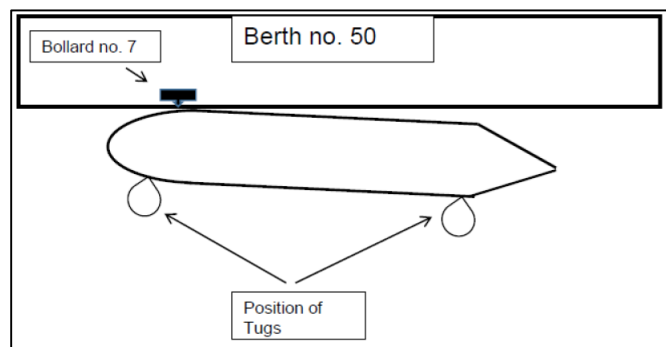
The after tug pushed more and instead of landing parallel to the berth, the vessel's port quarter landed heavily on the quay near Bollard 7. The vessel's port side shell plating was damaged near a fuel oil tank, and there was damage to the concrete of the quay itself.

- ◆ The Pilot misjudged the tugs pushing power;
- ◆ The pilot was giving instruction in a language which was not understood by the bridge team.

- ◆ Risk considered tolerable – this was considered by the Pilot to be a routine recurring task;
- ◆ Inadequate Standards – there were no company procedures to cover the situation, particularly with regard to the working language on the bridge during navigational operations where Pilot/tug assistance is required.

- ◆ Remind Masters that they should override the Pilot's instructions if they are considered to be incorrect or unsafe;
- ◆ Establish formal working language for ship's movement at all times including berthing/un-berthing operations;
- ◆ Ensure compliance with guidelines on relationship between Master, Officer of the watch (OOV) and Pilot.

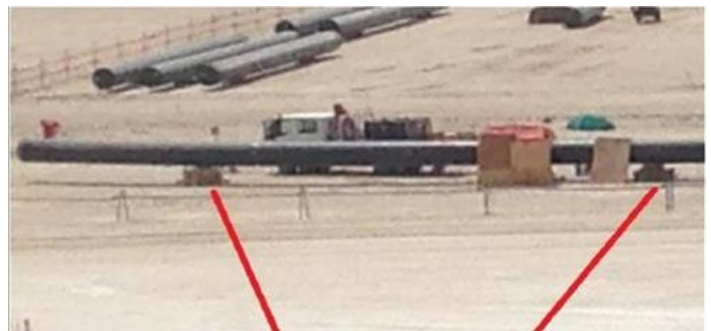
A section of 36-inch gas export line they were working under or near fell off the approximately 60cm high temporary wooden supports (skid stacks) and crushed them. The two employees, a grinder and a welder, were completing a construction weld repair at the north-eastern-most weld joint of an approximately 120m curved section of the export pipeline.

Position of pipe before falling from the two supports pictured (of eight total)

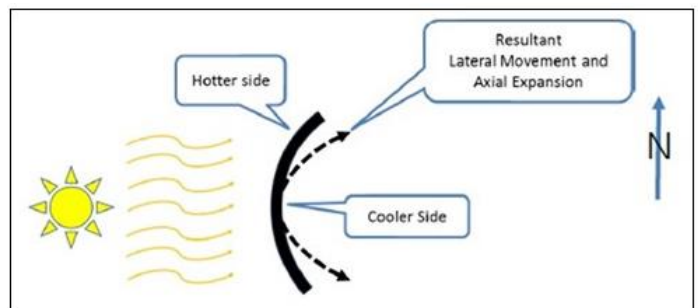
- ♦ The work permit system in place was rigorously applied to the known risks, but there was a lack of awareness of:
 - The hazard presented by temporarily suspended pipes, which constituted a dynamic load / dropped object hazard
 - The hazard of thermal expansion, differential heating, and residual pre-stress forces contributing to the lateral movement of curved pipe segments.

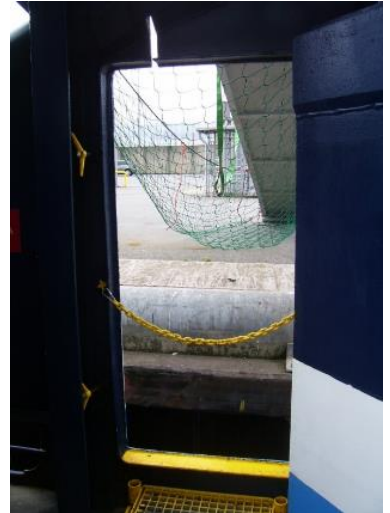
During the most recent incident, a surveyor from a classification society boarded the vessel whilst it was still being made fast, having just come alongside. The side door had been open to facilitate monitoring of the launch and recovery of the rescue boat for survey purposes – however, the safety chain was across the space. The surveyor removed the chain and jumped from the quayside onto the ship. The aft mooring station had only just confirmed to the bridge the vessel was all fast, and the engines and thrusters were still running when the incident occurred.

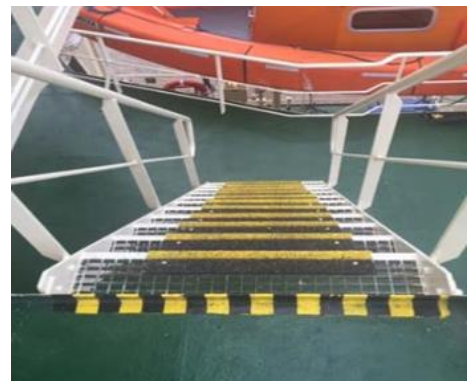
The MSF has published the following safety alert regarding an incident in which a crewman fell down the stairs and was injured. The incident occurred following recovery of the vessel's daughter craft (DC) when the crewman had informed the Officers in the bridge that the small boat had been recovered and safely stowed. He left the bridge and was making his way down the external stairway to the boat deck when he slipped and fell down the stairs to the deck below. He broke his arm and was transferred from the vessel via helicopter to hospital.

- ◆ The stairs were in good condition and were fitted with grips which were in good condition;
- ◆ The injured person was wearing all appropriate PPE, including his safety footwear, which was in good condition;
- ◆ Weather: cloudy, wind force 3 knots, sea height 1-2m, although the IP stated the vessel rolled just prior to his fall;
- ◆ The injured person stated he was using the trailing hand technique whilst going down the stairs, although he had a radio in his other hand;
- ◆ There were no radio sling/holsters on board;
- ◆ The incident occurred after the original work task had been completed. This was identified as a trend in this particular vessel owners fleet.
