# IMCA Safety Flash 16/20

May 2020

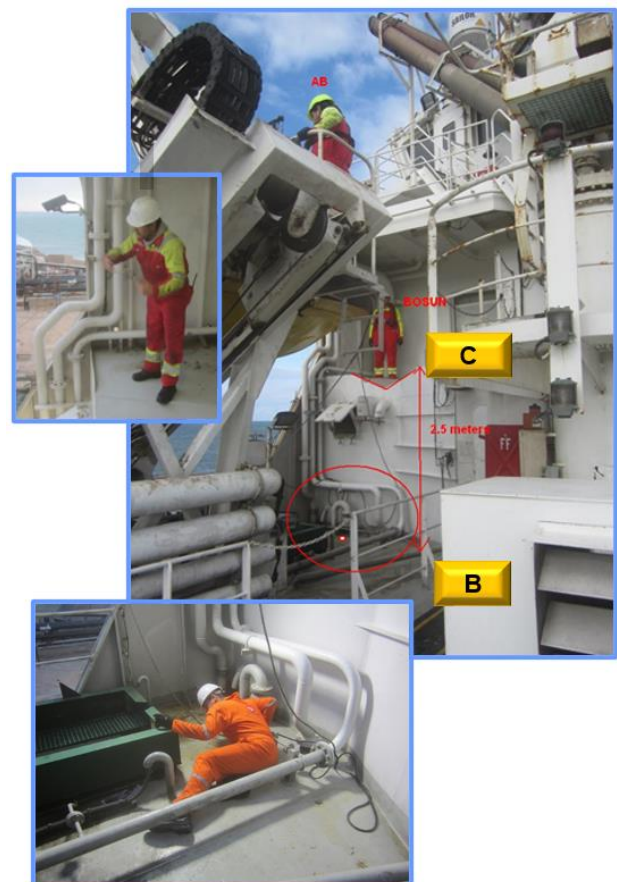
During work to change a wire on an FRC davit, a crewman lost his footing, slipped and fell 2.5m to deck below. At the end of the operation, the bosun proceeded to a place where he could monitor the stowage of the FRC. The area of deck near to where the FRC bow was stowed was uneven and sloped to allow for FRC stowage. He slipped and fell to the deck below. Due to the specific design of the vessel, there was no barrier or guard to prevent a fall when the FRC was not in the stowed position.

The bosun sustained damage to his ankle which was placed in a cast. He missed landing on several obstructions which had the potential to cause life-changing injuries had he landed on them. This incident was considered high potential by our member.

- ◆ The area on C-deck was not clearly marked as hazardous or no-go and the area where bosun was standing is not used during retrieval stage;
- ◆ The design of the area and the way the FRC was positioned when stowed meant the area could not be fenced off. The stowed FRC fully closes off the dangerous area, effectively mitigating the risk of falling from height.

Contributing causes identified were that there was no non-slip coating, and an uneven surface, in a hazardous area. This had not been identified.

- ◆ Improved signage requiring fall protection equipment at certain locations;
- ◆ Review and amends to JSA for FRC launch/retrieval;
- ◆ Dedicated check on all vessels during the next hazard hunt for ‘latent’ or ‘less visible’ hazards such as:
  - similar unguarded areas such as when a davit or crane is swung outboard;
  - ineffective spill containment;
- ◆ Have ‘cold eyes’ perform the next hazard hunt – get someone not familiar with the space, e.g. deck crew in engine spaces or engine crew in deck areas;

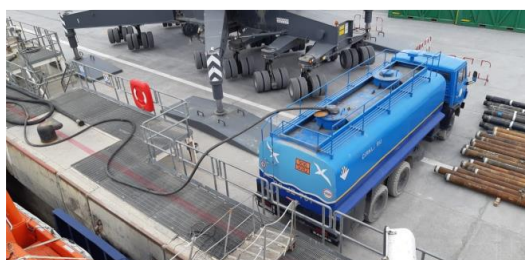
*Incorrect connection practices – hose hung through the tank hatch*

- ◆ An incorrect connection method was used. The correct hose connection was not available on the truck. The sewage transfer hose was hung through the hatch of the tank and secured by rope only;
- ◆ An unsafe latent condition was left unattended; the unsafe condition was neither reported nor challenged until after the actual spill had taken place;
- ◆ There was a lack of communication – no radio was provided to the truck driver, so there was a delayed response/shut down of transfer pump on the vessel;
- ◆ A company safety management system (SMS) requirement was not followed – a wet bulk transfer check list was not completed.

- ◆ Confirm that proper compatible hose connections and whip checks are available for all liquid waste trucks to ensure safe transfer operations;
- ◆ Confirm that all equipment utilized for sewage and oil water transfers are in good condition and certified in line with local regulations;
- ◆ Provide proper communications equipment – in this case, radios for all transfer operations;
- ◆ Re-iterate requirement to complete wet bulk transfer check list for waste oil and sewage transfers.

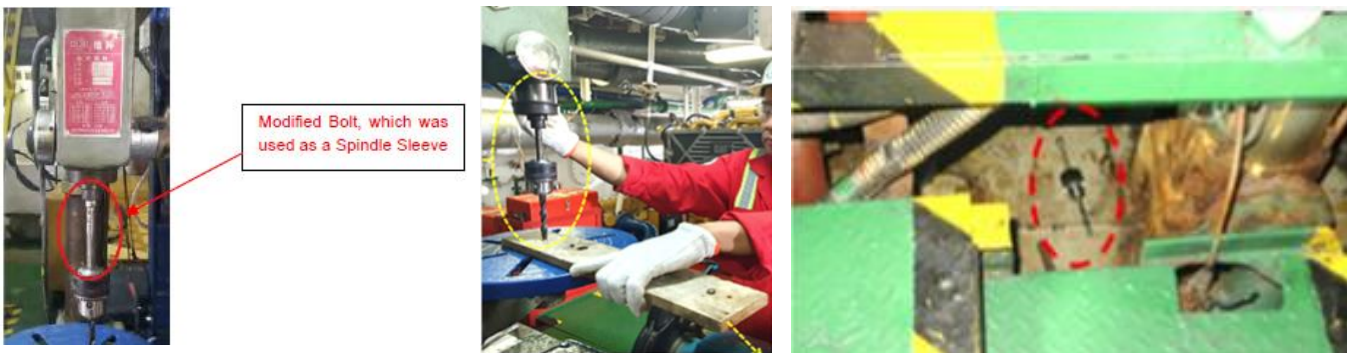
A crewman was drilling a hole through a wooden plank using a benchtop heavy drill machine in the vessel's engine room. The drill chuck assembly detached and hit the right side of his forehead resulting in a laceration above his right eyebrow.

- ◆ The bench top drill was not fit to use, as the spindle sleeve was not available;
- ◆ There had been an unauthorized modification of the drill chuck assembly (spindle sleeve) – a hexagon headed bolt was modified for use as a spindle sleeve;
- ◆ The injured person and the supervisor were not fully aware of the scope of the assigned activities or job requirements;
- ◆ The job should have been stopped but the risk was deemed tolerable. Safety controls were bypassed;
- ◆ No personal protective equipment (PPE) was worn;
- ◆ The injured person was not familiar with the bench top drill assembly, operation or safety precautions and it was his first time operating the machine.

- ◆ The immediate cause of the injury was the ejection of the chuck assembly along with the modified spindle sleeve from the spindle hole;
- ◆ The root causes were lack of appropriate supervision and lack of a safe system of work – the injured person should never have been allowed near the machine;
- ◆ Causal factors included:
  - risk was seen as tolerable by both the supervisor and the injured person;
  - the bench top drill had not been quarantined to prevent unauthorized use;
  - there had been no appropriate toolbox talk or risk assessment beforehand;

- ◆ Handmade or modified tools should not be used;
- ◆ Tools and equipment to be inspected for their fitness, and unfit equipment to be isolated – all equipment was subject to further inspection and unfit equipment was removed from the vessel.

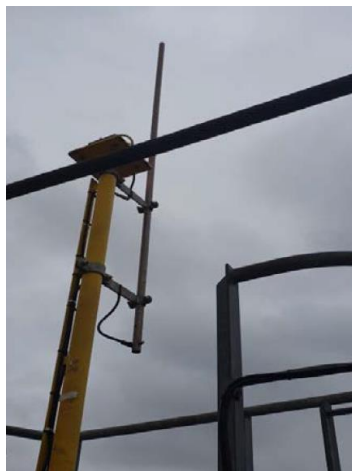
A lightning conductor mounted on top of a service crane came free from its mounting and dropped 75 meters. The conductor fell through the deck carousel hatch and landed on the carousel bottom plate. Five crew members were working in the carousel; however, they were not positioned under the open deck hatch area.

- ◆ The mast has been vibrating during high winds causing the lightning conductor to work itself free from the threaded housing;
- ◆ There was no material failure;
- ◆ The lightning conductor was not secured to its housing by any means other than the threaded connection – no secondary securing;
- ◆ The potential for the lightning conductor to become unscrewed was not recognised;
- ◆ The connection is not easily visible during regular drops inspections;

*Mast and lightning conductor*

- ◆ Consider the potential for a similar incident to occur on your vessels;
- ◆ Perform an inspection of all similar equipment at height and assess the secondary securing arrangements in place.

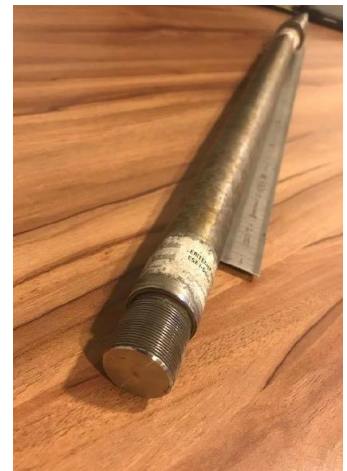
*Lightning conductor*
