IMCA Safety Flash 18/20

June 2020

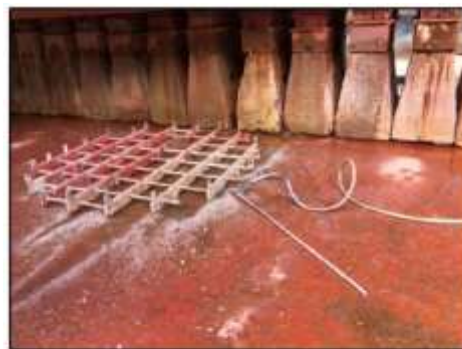
A work team supervisor sustained a laceration to his upper right thigh caused by a high-pressure water jet. The injury required several stitches and the injured party was retained in hospital overnight. The incident occurred when personnel from a third-party shipyard company were using a high-pressure water jet (250 bar) to clean the vessel thruster grating located on the dock floor. The operator of the high-pressure lance did not anticipate the hydraulic kick-back force when engaging the trigger of the lance. The surge in water pressure caused him to step back and turn to his left to regain his footing. In doing this, his lance turned with his body and inadvertently sprayed his supervisor who was standing behind him.

Thruster grating being cleaned at the time

The operator did not install barriers around his working area and the supervisor failed to enforce the use of barriers on the dock bottom. The use of barriers was required by the task risk assessment (TRA). The supervisor had placed himself in the line of fire by approaching the operator from behind without the operator knowing he was there.

- ◆ Take appropriate Time out for Safety (TOFS);
- ◆ Ensure all your site task risk assessments (TRAs) involving high-pressure equipment state the need for appropriate barriers to be in place, and at a safe distance from the work activity, to prevent access to all non-essential personnel;
- ◆ Ensure that those supervising tasks involving high-pressure equipment understand that they are non-essential personnel during the task;

- ◆ Ensure that any vessel in dry dock has a formal plan to restrict access to the dock bottom and barriers are in place where there are identified hazards on the dock floor;
- ◆ Ensure that all personnel involved in the operation of high-pressure equipment have the appropriate competency and use personal protective equipment rated to the pressure of the equipment in use.

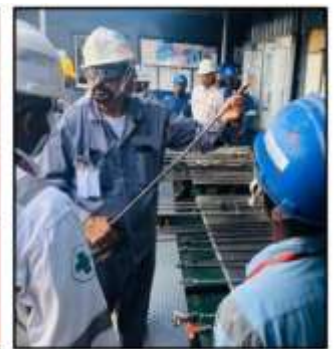
TOFS held with cleaning team

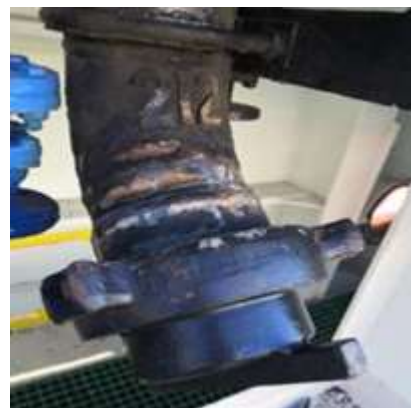
The Marine Safety Forum (MSF) has published [Safety Alert 20-05](#) relating to a spill of water-based mud. During routine mud transfer operations at an offshore installation the rig hose parted from the vessel's manifold resulting in a release of approximately 2,500 litres of mud to the deck. The crew quickly stopped the transfer and proceeded to use standard SOPEP equipment on-board to contain the spill on deck and recovered the contaminated mud within an empty mud tank. The spill was entirely contained with no loss to the environment.

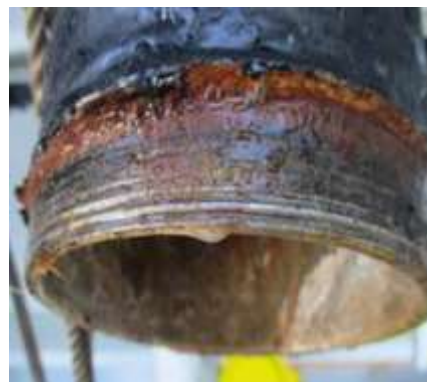
The manifold is normally fitted with a hammer union connection. It was discovered after initial inspection of the vessel's manifold that the thread between the manifold and the hammer union was found to be corroded.

Further inspection of the manifold threads determined that the threads in place were incompatible. The original manifold threads on-board the vessel were non-compliant to the standard National Pipe Thread (NPT) connection and therefore did not correctly engage. As a result, these threads did not provide an adequate seal which increased the opportunity for corrosion to occur. This led the connection, over a period of time to become weakened and resulted in the hose parting from the manifold.

- ◆ **Careful check to ensure different threads are correct and compatible with one another;**
- ◆ Regularly monitor and inspect the condition of the threads on manifolds by implementing into the vessels' planned maintenance system (PMS);
- ◆ Pre-use checks to be conducted as part of the wet bulk transfer checklist to incorporate visual inspections of the manifold connection threads.

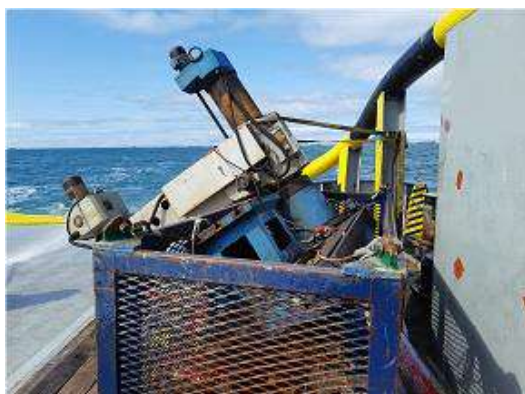
Basket with unsecured load

- ◆ There was no inspection by deck crew on basket acceptance. The unsecured cargo inside the basket was neither noticed nor reported;
- ◆ The weight of the load as understood in information received was 1800kg; but the actual load weighed 4000kg;
- ◆ Whilst the unsafe condition was identified during basket hooking process, the Stop Work Policy was not applied by the vessel crew.

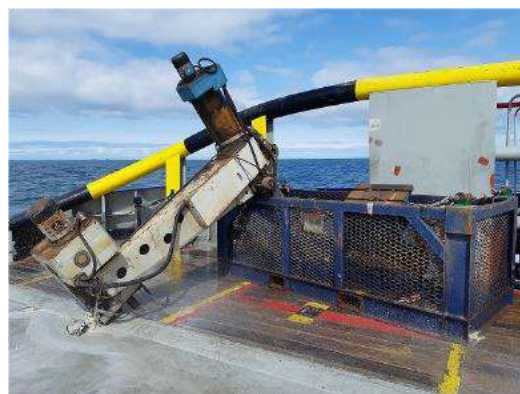
A cargo basket containing equipment was to be lifted from the vessel deck to an offshore installation. The crane on the offshore installation was unable to lift the load, resulting in the basket dropping back to deck and some of the equipment sliding out the basket onto the vessel deck.

Equipment slid out of basket during lifting

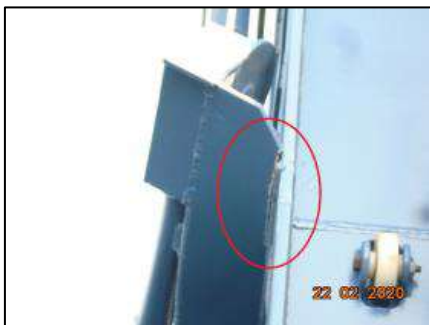
On further inspection of the gangway some cracks were found on the welding seams, which also needed to be addressed before the gangway could be safely used. The Captain ordered the quarantine of the gangway until the corrective actions that he and his crew had identified could be implemented.

Cracked welding

- ◆ Remind crew that they are authorised and expected to exercise the Stop Work Policy without fear of reprisal if they are in doubt about any aspect of safety;
- ◆ Conduct a prestart/installation inspection of all equipment, including equipment delivered by the client, to ensure that it is fit for purpose and safe to use;
- ◆ Any equipment found to be unsafe should be quarantined and communicated as unfit to use.

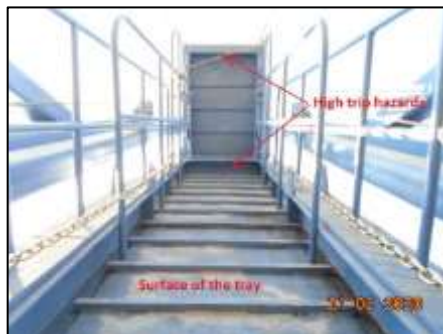
A newly installed gangway was found inadequate and unsafe. After the first transfer test on the gangway, the Captain observed several unsafe conditions – a trip hazard and a minor hydraulic leak – and he immediately exercised the Stop Work Authority.

Highlighting a trip hazard

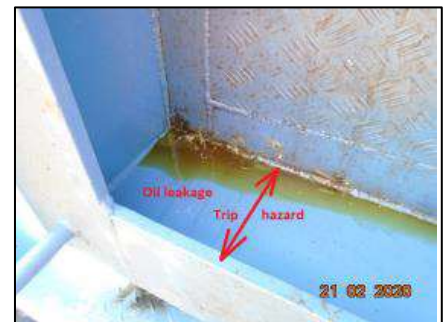
Hydraulic oil leak
