IMCA Safety Flash 21/20

July 2020

1 Double Man Overboard Resulting in one Fatality

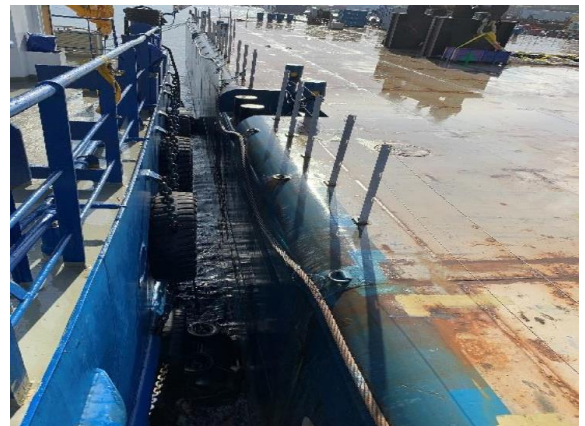
Following a worsening of the weather, it was decided to disconnect the tow tug from the barge. The Chief Mate stepped over to the barge to check certain equipment, but found that he needed a torch to do so. He called for a torch by radio. An AB collected a torch and made his way to deck where the 2nd Mate was acting as safety watch for the Chief Mate. The AB handed over his radio to the 2nd Mate, who did not have a radio. Whilst the 2nd Mate was occupied with the radio, he took his eye off the AB who, at this point, fell into the water. When the 2nd Mate realised what had happened he shouted “Man Over Board” and attempted to rescue the AB. During his attempts he also fell into the water. In the meantime the MOB alarm was raised and all hands were on deck. The 2nd Mate was helped out of the water. The AB was still in the water and had now lost consciousness. After a number of attempts he was pulled towards the rescue zone door by a boat hook, where he was manually lifted out of the water. The 2nd Mate was treated for hypothermia. The AB was administered CPR and AED by the crew until medical assistance arrived. The AB was medevaced by helicopter but did not survive.

- ◆ Vessel to vessel transfer was accepted and regarded as a routine activity;
- ◆ Risk awareness did not deal with specific risks of routine activities in non-routine circumstances. The focus is on what has to be done, not on how/risks involved;
- ◆ MOB between two stationary vessels was not specifically addressed in procedures, risk assessments or drills related to MOB. Rescue equipment was not primarily suitable for rescuing MOB from between two vessels.

Our member notes that both the AB and the 2nd Mate were wearing inflatable lifejackets which slipped up their heads whilst they were in the water.

- ◆ Procedures, risk assessment and toolbox talks:
 - Review procedures with regard to direct vessel to vessel personnel transfer;
 - Include the risk of hypothermia in procedures and risk assessments related to falling in the water;

- Review MOB procedures and drills to include MOB situations between two stationary vessels/between vessel and quayside;
 - Ensure that toolbox talks not only deal with what has to be done, but also with how it should be done and the specific situational risks involved, including changes in operating conditions. Ensure that when work cannot be carried out safely anymore, the **Stop Work authority** is applied.

- Properly assess additional risks of carrying out **routine activities under non-routine conditions**;
- ◆ Equipment
 - Ensure that heaving line and bag are applied for transfer of equipment/tools (such as a torch in this case) from vessel to vessel;

- Ensure that the required equipment/tools are defined prior to carrying out a non-routine job;
 - Review MOB equipment and techniques used for rescue in limited situations, for example between two stationary vessels or between vessel and quayside;

- Consider introducing life jackets with crotch straps.

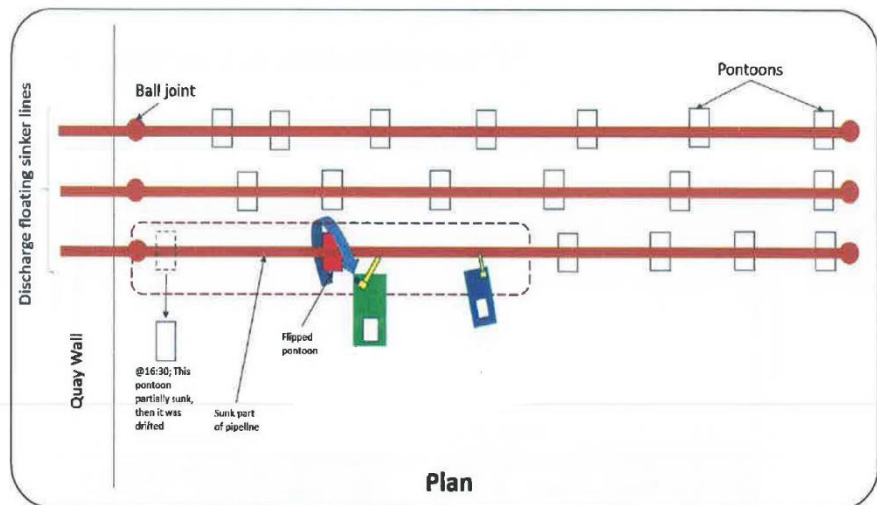
A member reports a man overboard fatality which occurred from a multi-cat engaged in shallow water construction in an inshore environment. The task involved recovery and re-arrangement of a pipeline configuration, consisting of 3 x 300m sinker-pipe, which was connected to shore using 7 floating pontoons. Three separate pipes were used for dewatering a reclamation site. One of the pipes including pontoons was partly submerged. The operation took place in low light conditions during the hours of darkness.

The initial plan was to re-float the pipeline with a technique using compressed air. Whilst the task was ongoing, there was a change to the plan, and it was decided to lift the floating pipeline configuration using the crane on the multi-cat. As the lift started, one of the floating pontoons flipped over the pipeline and hit the Chief Engineer who was operating the crane, causing him to fall overboard. Immediately an AB on deck jumped overboard to help him; the Chief Engineer was recovered and first aid /CPR undertaken. He was transferred to hospital but was unfortunately declared dead later that evening.

During the operations, the decision was made on-site to change the plan and use the deck crane of the multi-cat to lift the pipe-line and use another workboat to place a pontoon underneath. One of the pontoons was not secured to the pipeline; this came loose, surfaced and flipped over the floating pipeline, hitting the multi-cat crane and the Chief Engineer, who was driving the crane.

- ◆ Inadequate worksite supervision
 - Site supervisor ignored the instructions to postpone the operations after the first attempt to follow the initial plan. He changed the plan, without following the appropriate MoC process;
 - Operations were conducted in hours of darkness, against company instructions;

- ◆ Unsafe Lifting Operations
 - The sunken dewatering-line was lifted using the Multi-Cat deck crane;
- ◆ Lack of Situational Awareness
 - There was no adequate (risk) assessment of the job or work area;
 - No-one involved recognized the hazardous situations and did not use **STOP WORK authority**.

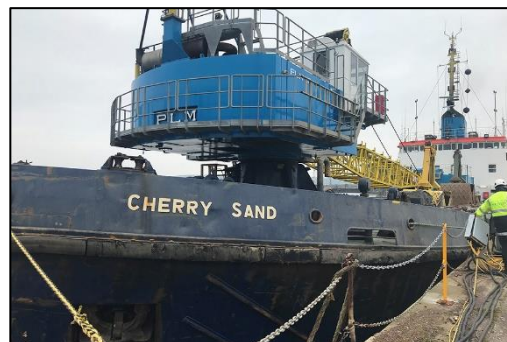
The Master had climbed over *Cherry Sand's* bulwark and on to the rubbing band in readiness to step ashore as part of a self-mooring operation. The chief officer was still manoeuvring the dredger towards the berth when the master took a single step towards the quayside. *Cherry Sand* was too far away from its berth, with the result that the Master's foot missed the quay, and his upper body struck the chains and quayside with force before he fell between the quay wall and the vessel. He was crushed by the moving dredger before slipping into the water.

- ◆ The method used for self-mooring *Cherry Sand* was inherently hazardous, and crew routinely stepped ashore/on board when the vessel was not tight alongside;

- ◆ Linesmen were not used, and no measures had been taken to avoid having to place a crew member ashore while the vessel was unmoored;
- ◆ Safety management system audits had not identified that *Cherry Sand's* operational practices, and the general safety culture on board, were below the expected level;

- ◆ The UK Maritime and Coastguard Agency (MCA) were to amend the *Code of Safe Working Practices for Seafarers* to provide guidance on mooring and unmooring operations, and when it is permissible for vessels to self-moor;
- ◆ A recommendation was made to Associated British Ports (aimed at ensuring a common approach to safety and fleetwide application of company procedures;
