IMCA Safety Flash 22/20

July 2020

1 Finger injury caused by incorrectly secured console cover

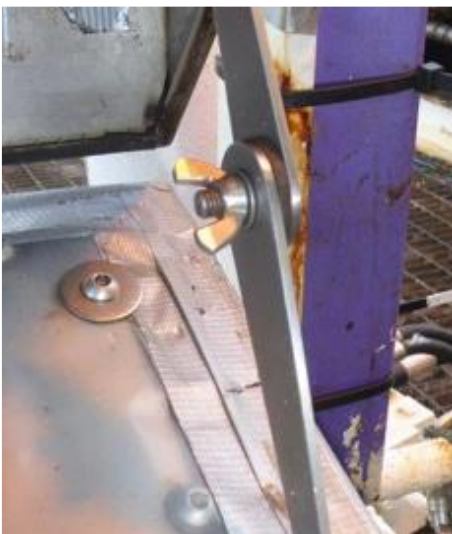
Hinged mechanism was retained by two unsecured wing nuts

- ◆ The hinge was found to function correctly, as designed, but the wing nuts that secured the hinge in place had not been sufficiently tightened;
- ◆ The console cover, possibly affected by weather or vessel movement, dropped at the same moment the injured persons finger was placed in the line of fire;
- ◆ The design of the console weather cover hinge was completely reliant on correct wing nut tightening and requires an improved means of securing to avoid similar cover displacements;

- ◆ Hinge mechanisms that do not lock automatically or “lock-safe”, introduce the risk of injury from unintentional or unexpected closing of the covers.

- ◆ Reiterate the potential risks for injury from being “in the line of fire”;
- ◆ Carry out a “Hazard Hunt” on your vessel to identify all hinged cover mechanisms that have the potential for repeating the incident outlined in this alert;
- ◆ Install improved hinge locking arrangements wherever a significant risk of hand or finger injury is identified.

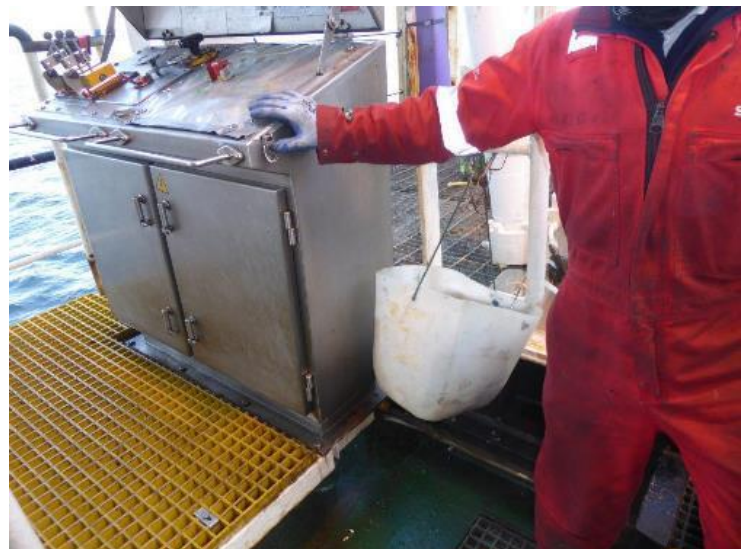
The injured person had been descending the raised platform and placed his hand on the console to steady his descent

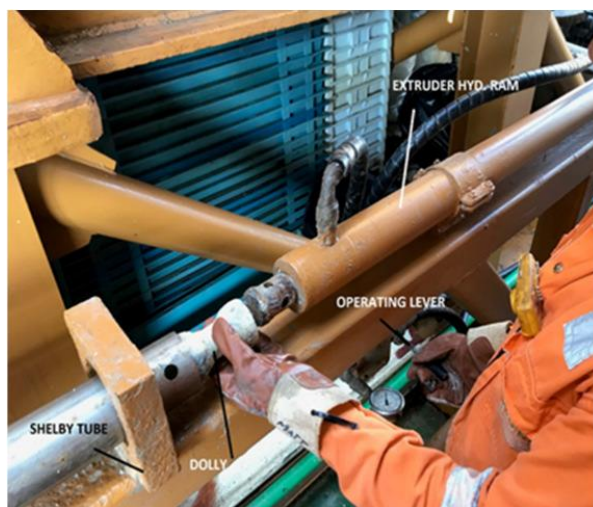
Whilst using a hydraulic sample extruder in a laboratory, the technician caught and injured his finger between the Shelby tube and extruder ram while trying to stabilise the dolly.

- ◆ Training - insufficient task training and competence assessment;
- ◆ Supervision - ineffective supervision;
- ◆ Risk Assessment - the task risk assessment did not consider the equipment limits and functions or advances in technology, therefore not all the hazards and associated risks were identified or controlled;
- ◆ Design - the sample extruder design is dated and does not consider human factors or ergonomics;
- ◆ Line of Fire - the technician placed his hand between the moving hydraulic sample extruder ram and Shelby tube.

- ◆ Reviewed and revised equipment and task risk assessments;
- ◆ Improved signage and labelling, start/stop controls and added guard for moving parts / shear point;
- ◆ Standardised hydraulic sample extruder design / type and use across the company;
- ◆ Develop common operating procedures for this equipment.

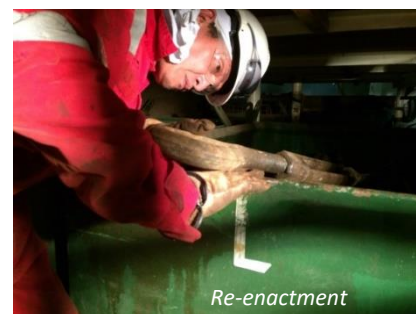
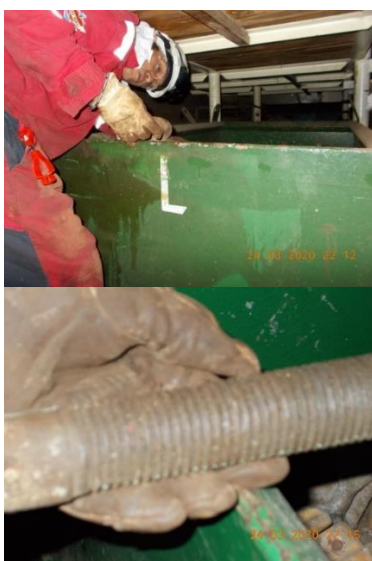
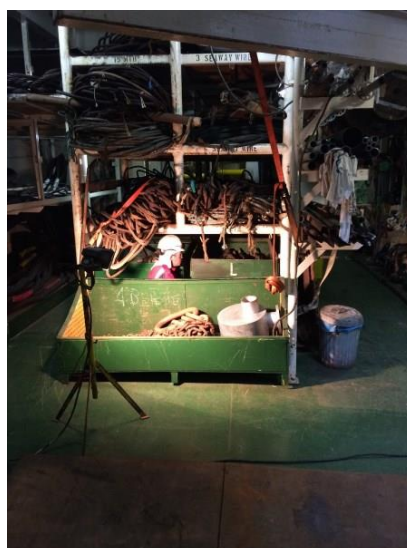
While crew were moving lashing materials (chains, shackles and turnbuckles) from the garage deck into a storage space, the bosun suffered a serious finger injury. The incident occurred as part of routine housekeeping activity on a vessel at anchor. The bosun was in the storage space putting equipment into storage bins. These bins were under shelves in a limited space. Suddenly, the turnbuckle slipped on the bosun's finger while he was placing the turnbuckle in the storage bin. The thread of the turnbuckle hit his finger. He took off his gloves, to find that his middle finger tip was missing and it was found inside his glove.

It was noted that there was limited storage for handling the turnbuckles, and the device slipped on the bosun's finger. More job preparation – removing the bin from the shelves using a pallet truck – might have helped but this was not done as the the storage bin, which was very heavy, was left in place.

- ♦ Moved the storage bins under the shelves to a better location;
- ♦ Devised procedure to eliminate manual handling of the turnbuckles.

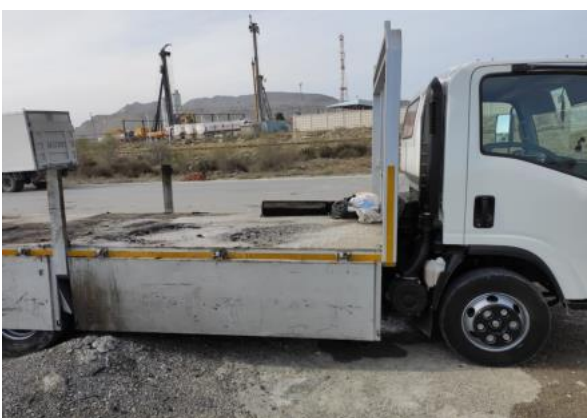
There was a fire in the cargo on the back of a truck whilst moving materials from the warehouse to the vessel. Whilst in transit, the driver observed flames coming from the truck bed. He stopped the vehicle and used the vehicle fire extinguisher to tackle the fire. He was successful, despite very strong winds, and then returned to the warehouse safely. No injuries to personnel, no damage to truck.

Truck bed after the fire

- ◆ The transported cargo appeared to have not been secured or belted in the truck bed;
- ◆ Bottles of hand sanitizer, known to be a petroleum-based flammable material, formed part of the load. Prior to loading, there was no check made of the integrity of the bottles of hand sanitizer to see if there are any damage, leakage or container lids not properly closed. [NB this incident occurred in a hot country];
- ◆ There was no segregation nor proper packaging of transported materials. Spirit containing sanitizers were stored next to lead-acid batteries and other equipment with metal elements (chairs and spare parts etc.) It was considered that loose metal parts could have potentially damaged the bottles of hand sanitizer, causing leakage of flammable material, or, interact with batteries causing sparks.

- ◆ All transported loads should be packed & secured properly;
- ◆ The integrity of the load should be checked to ensure no damage, leakage or container lids not properly closed;
- ◆ Any internal and external potential for fire or sparks should be evaluated and eliminated before the journey.

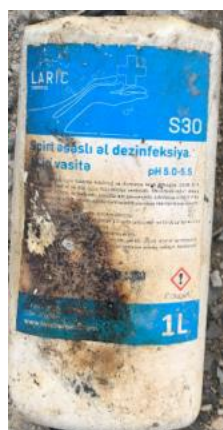
Hand sanitizer

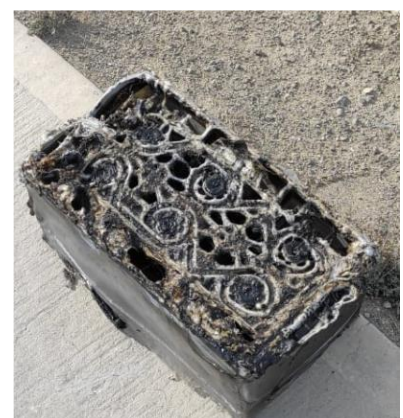
Lead-acid battery
