IMCA Safety Flash 25/20

August 2020

1 Emergency Lithium battery failed catastrophically in a diving bell

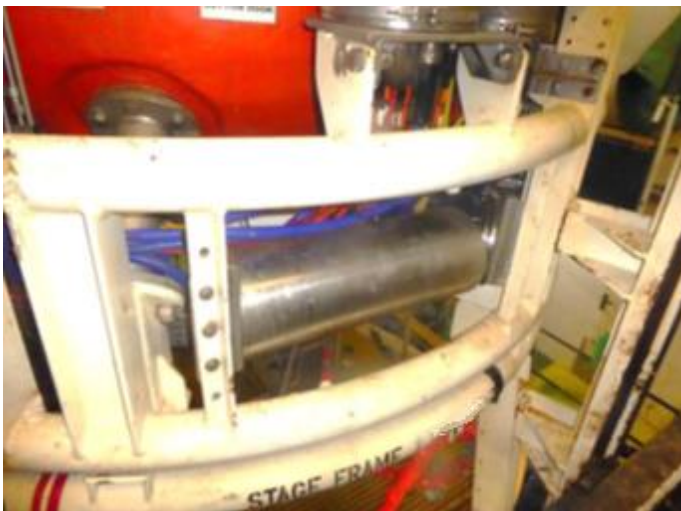
During regular planned maintenance, a 24V DC emergency Lithium battery pack in a diving bell activated and failed catastrophically causing an explosion and small fire. There were no injuries; the bell was unoccupied at the time. The incident occurred when a check valve on each of the Bell Emergency Battery Pack Pods was changed out for a more widely available type.

Battery pack (silver cylinder) located within the Bell Frame

After launch, the starboard bell status alarm for the 24V DC emergency battery pack activated. Initial visual inspection indicated no obvious fault. Upon recovery to the bell hanger the battery pack failed catastrophically, a loud noise was heard, and smoke and flames were emitted from the battery pack.

The battery pack pod had flooded through an incorrectly fitted check valve, causing the failure of the pod and subsequent fire.

- ◆ Review of similar Emergency Battery Pack pods to review the check valves fitted to ensure they cannot be fitted incorrectly. Check valves with male/male threads to be removed;
- ◆ Ensure that a thorough and appropriately technical Management of Change (MoC) process is carried out when changing out dive related components and equipment;
- ◆ Personnel involved should ensure that they have a thorough understanding of the most appropriate immediate actions in the event of a Lithium type battery fire.

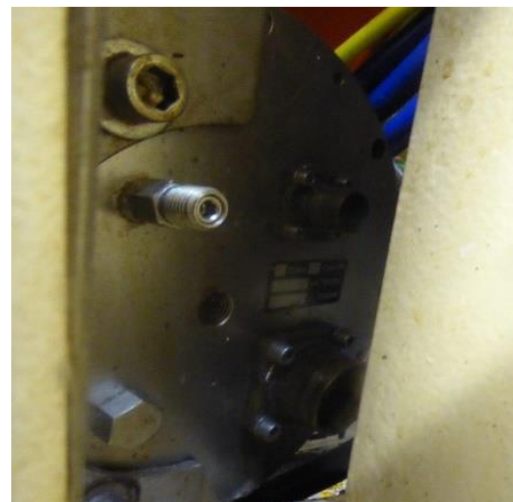
Check valve location on the battery pack

Crucially, the original valves were only threaded on one side with a male thread whereas the replacement type had the same male thread at each end. A second thread on the new valve was not required as it does not connect to anything. This identical second thread introduced the potential for the new valves to be fitted in the wrong orientation.

- ◆ There had been no Management of Change (MoC) process conducted and there had been no technical consideration of any new potential risks;
- ◆ Valves with identical connection points can easily be fitted in the wrong orientation;
- ◆ The crew were unaware of the immediate required action to extinguish the resulting fire.

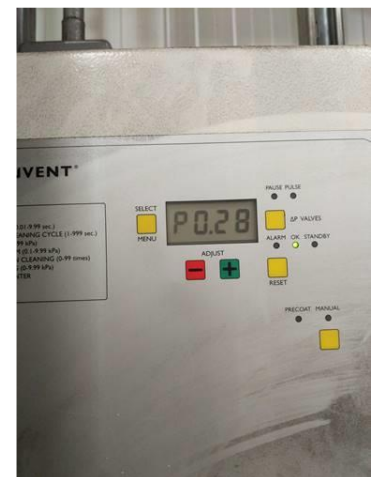
Following initial investigation and discussions with the supplier it was found that the filters were blocked which allowed metal particles to build up, oxidize on the filter surfaces, heat up and eventually lead to a fire.

- ◆ The unit was well within its annual inspection period and nothing related to filter replacement was highlighted at the previous inspection;
- ◆ The supplier advised that blocked filters are indicated by a reading of 2.0 or above on the unit's display (2000 Pascals). As an example, the display from an operational unit is shown here. This indicates 0.28 (280 Pascals) showing it is nearly new and well within the limit.

Where similar systems are used, check the display for high or excessive pressure readings as outlined in the manufacturer's instructions and ensure that this check is included in regular operational and maintenance checks.

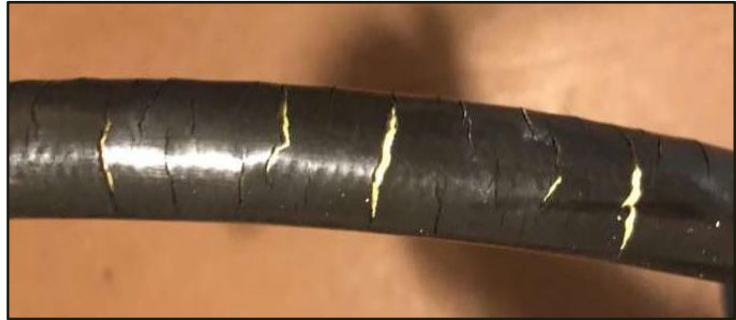
The hose had been in place since 2010 and there was substantial degradation along its full length. The hose was not identified on a hose register and therefore not subject to any planned maintenance or inspection regime.

- All pressurised hoses should be correctly secured and coupled using properly rated hose whip check restraints.
- All hoses and fittings should be visually inspected prior to use and should be examined regularly in service for wear and should be changed out as necessary or as part of a planned maintenance schedule

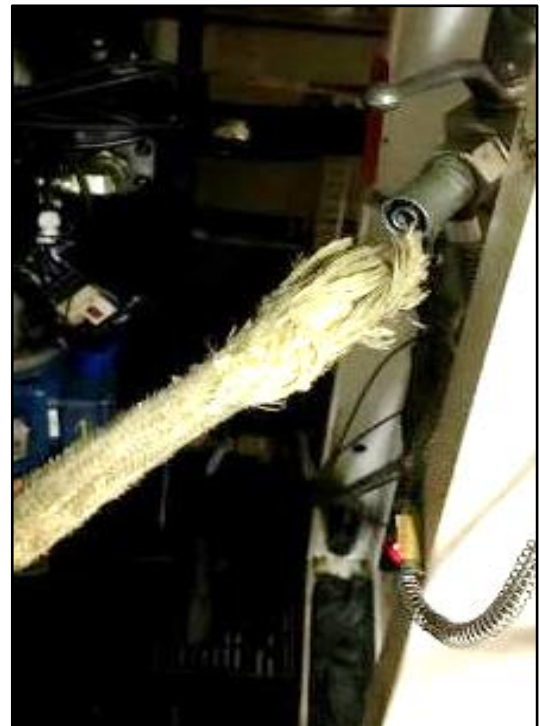
It was later identified that a supply hose had detached from its ferrule and approximately 165,000 litres of pure nitrogen was released into the room. Consequently this reduced the oxygen levels in the room to approximately 17.4% (normal oxygen content in the atmosphere is 20.8%).

- Ensured adequate 'Restricted Access' signage is posted at all entrances to the nitrogen storage area;
- Ensured suitable low oxygen detection alarms are installed within the immediate area.

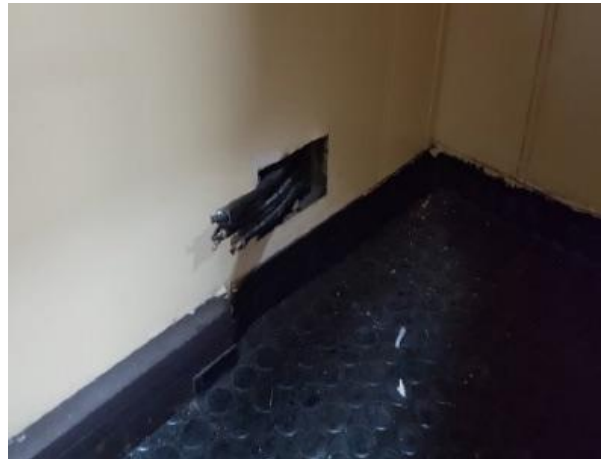
Whilst tidying a mobile office (freight) container, an employee sustained a mild electric shock by inadvertently touching an exposed live electrical cable which was obscured by

several boxes below a desk. The cable had been left in position following the removal of a piece of fixed equipment whilst the container was in storage (out of use).

- ◆ Checks on the container, pre and post mobilisation, did not identify the potential risk;
- ◆ No formal verification of the condition and safety of the electrical installation in the container had been carried out prior to energising.

- ◆ Isolated and inspected the container electrical installation and the termination of exposed electrical cables;
- ◆ Reviewed and assessed mobile container electrical installations elsewhere in its operation;
- ◆ Developed and implemented formal work instructions for the fit out and/or modification of mobile offshore containers including the electrical installation.

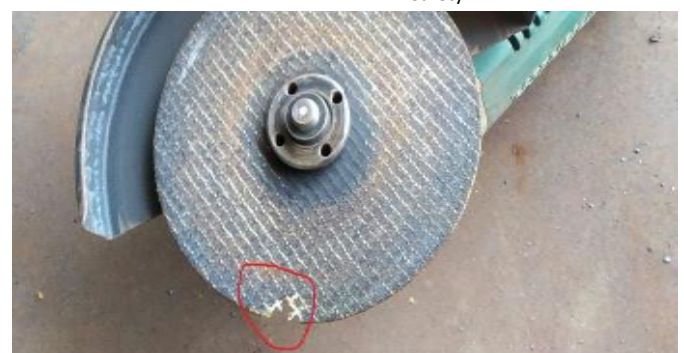
Grinding machine was observed as used with damaged grinding disc. Broken disc projectile could potentially cause serious injuries. Many other workers have been injured when angle grinders have kicked back, causing cuts and lacerations.

- ◆ Lack of awareness of hazards associated with use of damaged grinding discs.
- ◆ The task specific risk assessment did not cover the associated risks and relevant control measures, such as monitoring of wheel condition by user;

- ◆ There was a violation of company SMS requirements relating to the use of electrical tools and equipment;
- ◆ Lessons learned from previous similar incidents were not followed, not embedded.

- ◆ Conduct inspection and check condition of all grinders & discs on vessel;
- ◆ Ensure damaged discs are thrown out and not re-used;
- ◆ Refresher training presentation on abrasive wheels safety for crew.
