## IMCA Safety Flash 26/20

September 2020

### Safe Mechanical Lifting

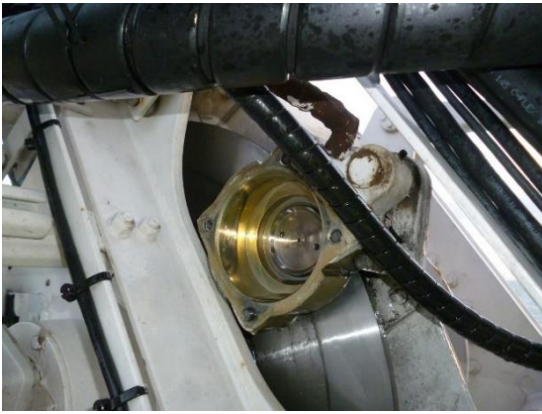
*Brake housing showing sheared bolts*

It is likely that the bolts holding the calliper assembly together failed due to repeated overloading.

- ◆ Affected lines were isolated by blanking. allowing safe continued use for general loads, although no man-riding can take place;
- ◆ Ensure all pressure-relief valves are correctly adjusted, in order to prevent further overloading;
- ◆ Advise manufacturer reviews robustness of Management of change (MoC) and commissioning procedures; and personnel competence;
- ◆ Review on-board maintenance procedures for suitability;
- ◆ Advise manufacturer to verify correct adjustment of valves on other installations.

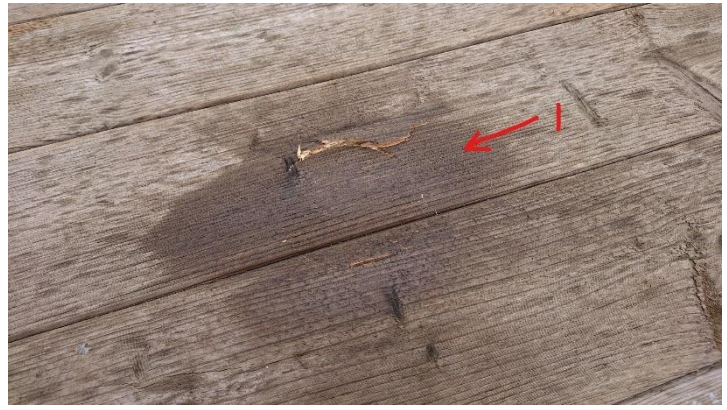
Five items were found on the deck below, these would have dropped from a height of about 25m. Two of the largest items dented the wooden sheathing to a depth of 1 - 3 mm. One of these weighed 1100g, the other, 460 g. The remaining three items left no indents.

*Dents in the wooden deck*

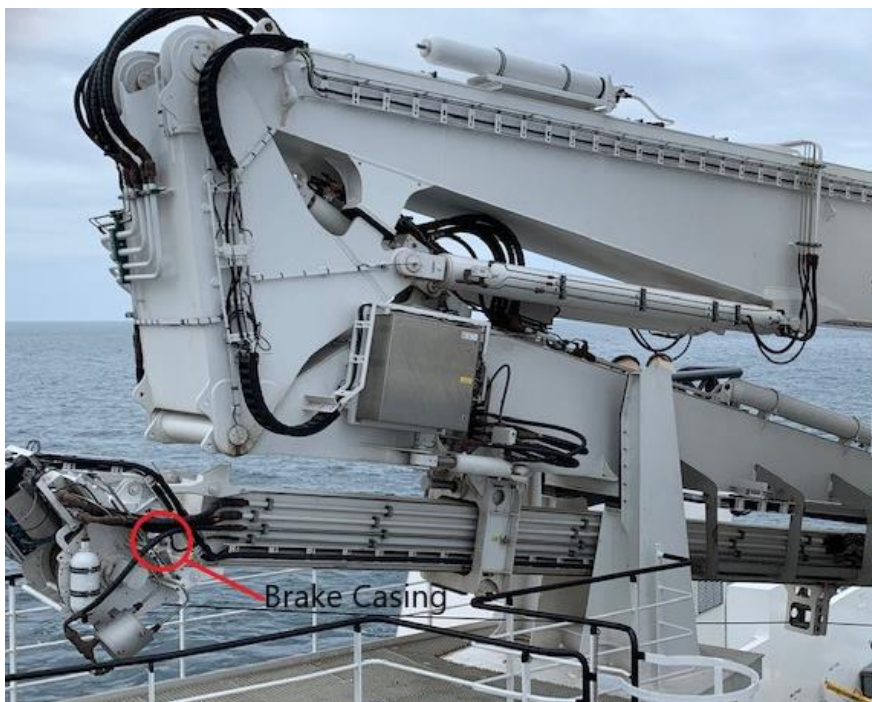
*Location of brake at head of crane*

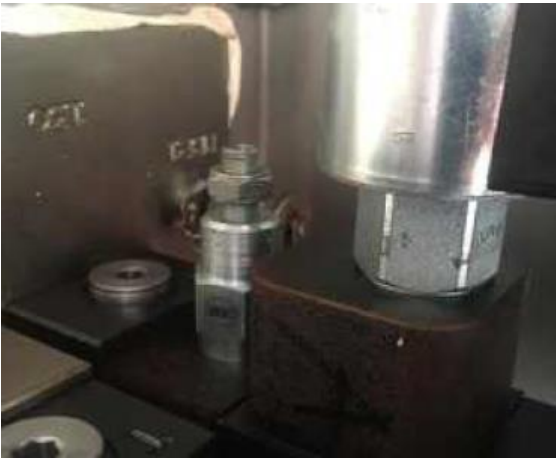
Subsequent preliminary investigation by the manufacturer showed that the calliper had been subjected to significant hydraulic overpressure (up to 260 bar, as opposed to 170 bar design). Of the two pressure relief valves fitted to the man-riding brake system, which should have been adjusted during commissioning (the crane had been in service for only six months), one had a loose locking nut, the other was found screwed fully in, suggesting neither had been correctly set.

*First valve with slack locking nut*

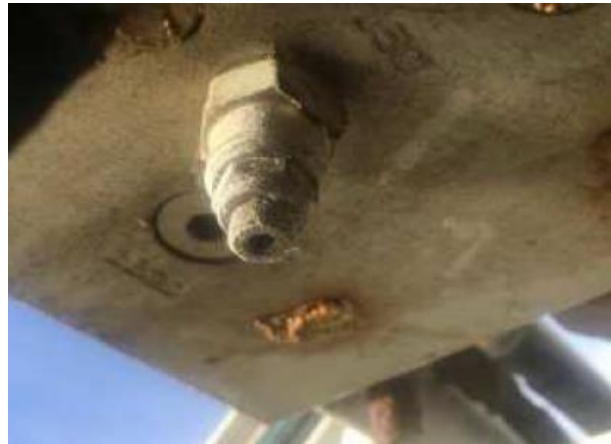
*Second valve set incorrectly*

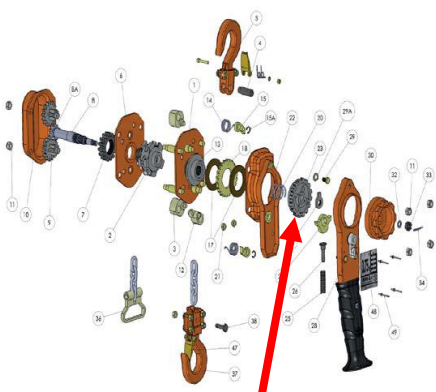
*Figure 1 showing worn part*

- ◆ On investigation and inspection, worn cog teeth were found. A toothed part of the gear assembly (see figure 1) was found to have excessive wear;
- ◆ This gear assembly was not visible without stripping the unit, so wear would not have been evident during pre-use checks. Strip down of a working unit would invalidate the manufacturer's warranty and certification;
- ◆ Our member noted that a thorough examination cannot be conducted *in situ* and units must be taken to a workshop for full examination.

- ◆ Review and amend the process for recertification of rigging with moving / wearing parts;
- ◆ Arrange for supply of newly certified rigging lofts on a 6-monthly basis;
- ◆ Revised internal documentation on lifting operations appropriately.

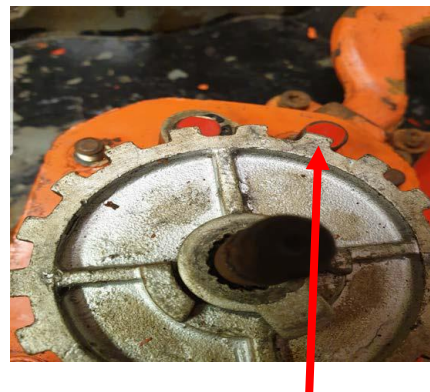
*Worn cog teeth found*

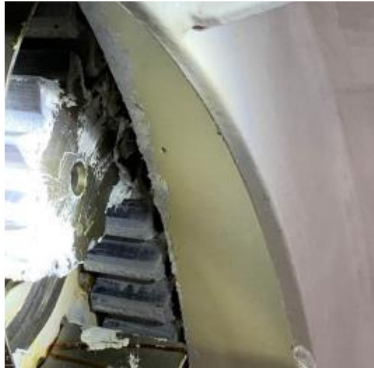
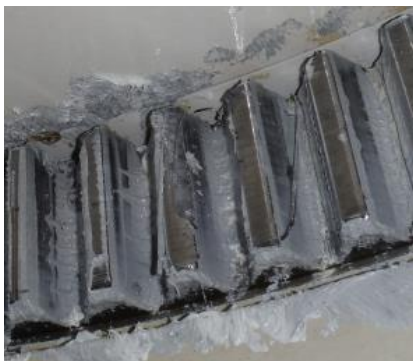
During vessel mobilization the boat cradle had to be shifted from centre of the main deck towards the starboard side closer to the accommodation. The Main Crane was used for this lift and the Provisions Crane was parked in standby facing aft. While slewing the Main Crane to starboard, the Main Crane jib crane came into contact with the jib on the Provisions Crane. The Provisions crane was inspected after impact and mechanical damage was found on the slewing gear and pinion gear.

*Pinion gear damage*

- ◆ All crew and mobilization team to be included in the mobilization plan toolbox talk;
- ◆ A procedure would be implemented for parking the Provisions Crane;
- ◆ An emphasis would be placed on communication and awareness for the crane operator and banksman as well as the mobilization team.

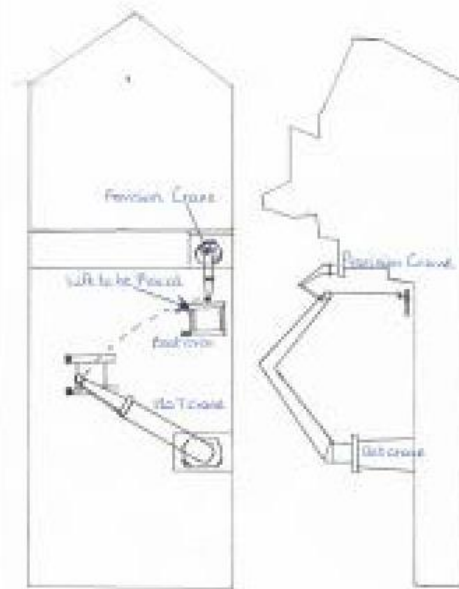
*Sketch of Movement and position of cranes*

- ◆ The Provisions Crane was in the blind spot of the Main Crane operator cabin;

- ◆ The Banksman was focusing on the lift and not the position of the Provisions Crane;
- ◆ The Provisions Crane had been left parked facing aft in standby;
- ◆ The person who had most recently operated the Provisions Crane had not been part of the mobilization plan toolbox talk.

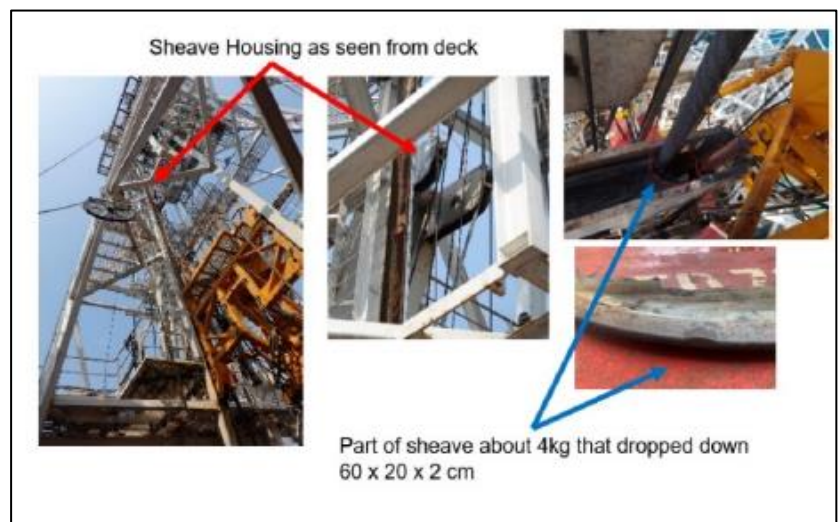
The sheave had seized and failed due to a combination of the following:

- ◆ Design - lack of inspection hole in the sheave;
- ◆ A small fleet angle resulting in lateral forces on one side of the sheave;
- ◆ Installation - incorrect thickness spacer fitted by a contractor during refurbishment and a lack of a protective coating (paint);
- ◆ Quality control - inadequate inspection & testing of the installation / contractor's work;
- ◆ Maintenance and inspection - failure to spot equipment defects and inadequacy of secondary retention.

- ◆ Amended vessel preventative maintenance system to include more detailed requirements for the inspection of ancillary equipment (e.g. sheaves, floodlights and other potential dropped object hazards) including the details of any applicable standards;

- ◆ Implemented Work Report templates to be prepared and submitted by contractors describing completed refurbishment / maintenance works;
- ◆ Revised designated 'Red Zones' to include "Safe Standing Zones" with overhead protective shielding.

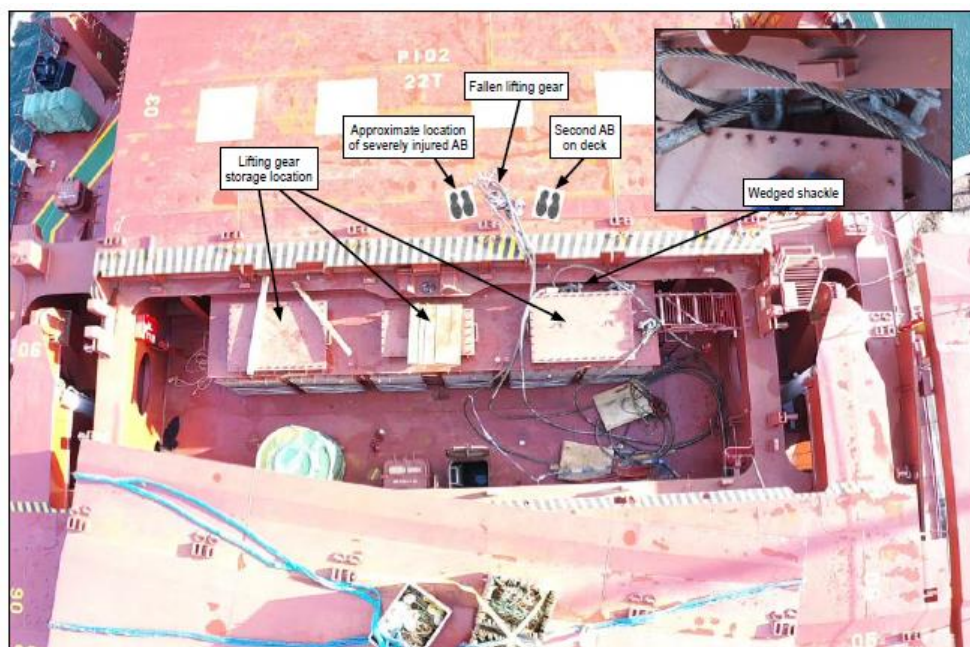
The suspended load was the cargo hatch lifting gear; as it was lifted by crane from where it had been stored, a shackle on the gear snagged. The crane was stopped but not before the fibre sling attaching the gear to the crane's hook parted under tension, and the load fell to the deck, striking the two crewmen. Both crewmen had been standing close to the suspended load in order to guide it out its storage area, where previous snaggings had occurred.

- ◆ Both injured crewmen were standing within the hazardous zone beneath a suspended load, but no action was taken to halt the operation;
- ◆ The operation being undertaken had not been subject to a risk assessment and the storage areas was inappropriate due to the snagging hazards.
