# IMCA Safety Flash 08/13

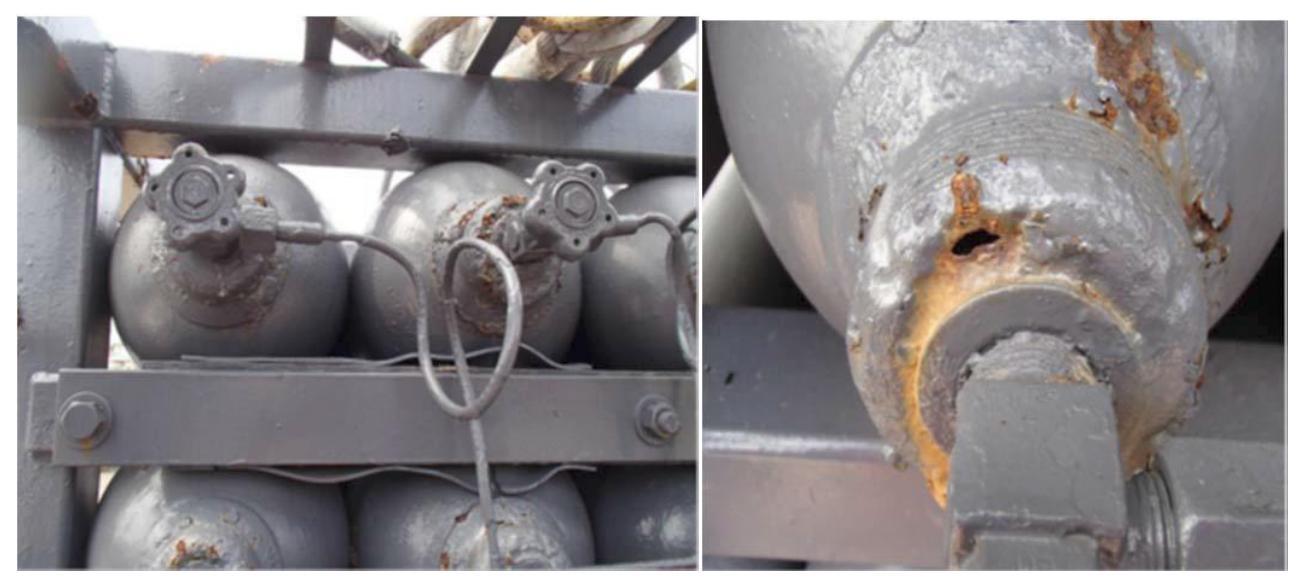
A member has reported an incident in which two nitrogen quads were delivered in very poor condition to a vessel in a shipyard. Following delivery the quads were inspected, and observations were made regarding the amount of corrosion around the necks and valve areas of the bottles. The nitrogen quads were immediately quarantined and removed to a safe area of the yard to await collection by the supplier.

Figure: Showing corrosion and poor condition of gas quads as delivered

- The incident highlights the importance of checking ALL equipment upon arrival and before use to ensure that it is fit for purpose;
- Certification documents ought not be used as proof that equipment is fit for purpose. Always check equipment;
- If equipment is found to be in unsafe condition on delivery, this should be reported and the necessary precautions taken to ensure that the equipment is not used until the defect has been rectified or other equipment supplied;
- Suppliers should also be audited (as required) to ensure that they have suitable management systems in place to provide fit for purpose equipment and services.

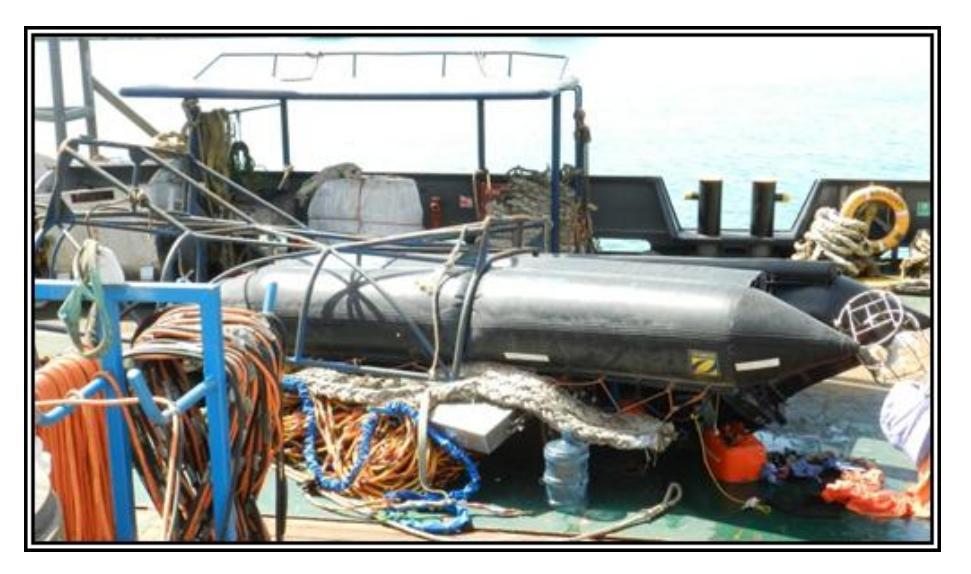
A member has reported an incident in which a zodiac inflatable boat was dropped onto deck. The incident occurred when a dive support vessel (DSV) was at anchor outside the offshore oilfield waiting on weather. The wind picked up suddenly to 35 knots and as a result the vessel began to roll violently. This caused severe shock-load on the four securing ropes for the

cradle supporting the boat. Two of the ropes (on the seaward side) snapped, whereas the deck side ropes were still secured. The vessel continued to roll violently and the small boat cradle slid from the stand and fell on the deck. The two deck side ropes which were still securing the small boat caused it to flip/turn over during the fall.

There were no injuries and no environmental damage. The small boat sustained some damage.

Figure: Showing zodiac inflatable boat after collapse of stand

- The securing mechanism was reviewed and modified;
- Cargo lashing belt was introduced as additional securing means;
- Additional skirting was fabricated and installed on the platform towards the deck-side as well;
- Our member noted that appropriate securing of equipment and cargo against vessel movements should not be neglected.

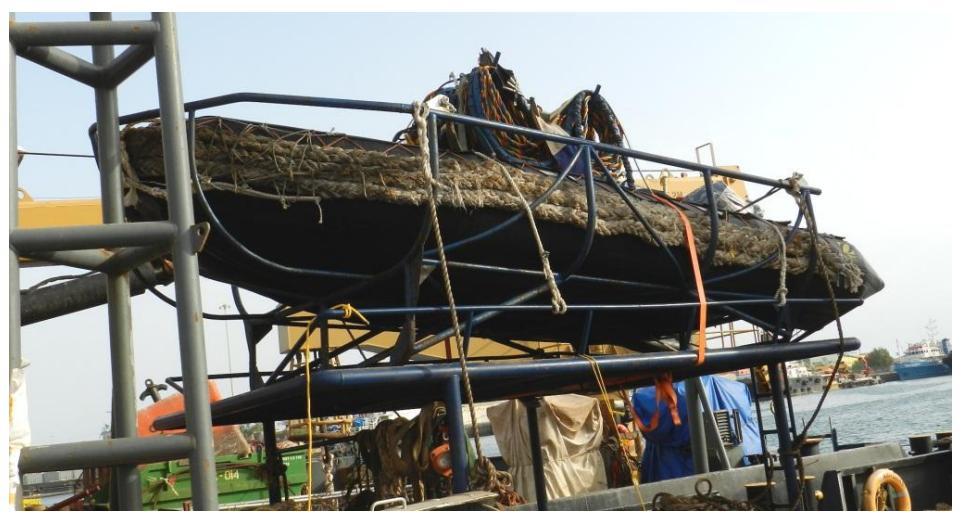
Figure: Showing inflatable boat on stand after reconstruction

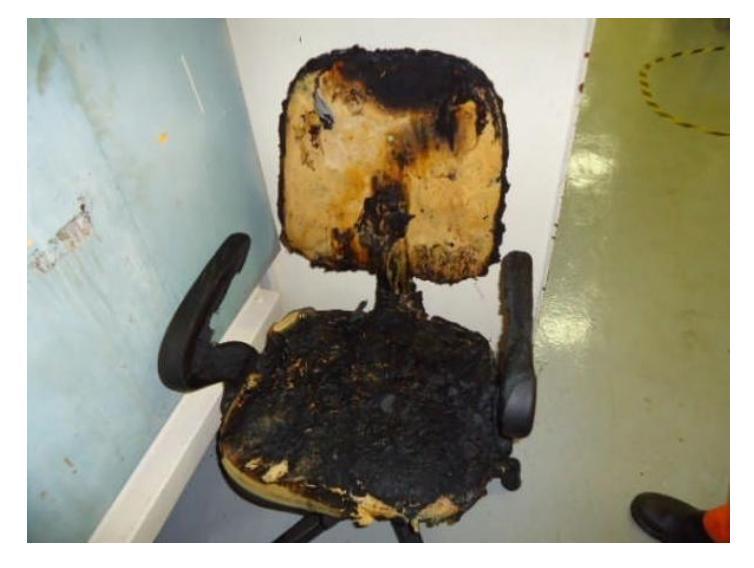
A member has reported an incident in which a small fire was caused by hot work taking place on the deck above. The incident occurred when a repair was being performed by a sub-contractor on a steel plate in the forecastle area. The job involved using an oxy-acetylene torch to remove an old corroded plate. During this activity, the oxy-acetylene cutting of the plate caused heat transfer from the forecastle deck area to the store-man's office area (located directly below the place where the hot work was being carried out). As a result, glowing slag fell on the store-man's chair, which caught fire. There was no-one in the storeman's office at the time. The fire detection equipment in the office caused the alarm to go off. There were no injuries.

Figure: Fire-damaged chair after the event

- Immediate causes:
  - Fire watch location was not well planned by supervision;
  - Melt slag felt on top of the store-man's chair.
- Root Causes:
  - Failure to control and conduct of safe work (permit to work planning failed);
  - Failed check of the workplace;
  - Inadequate risk assessment (warning about the smell of smoke in the store-man's office was not investigated by the fire watcher).

- Held discussion with all parties involved to ensure all understand their responsibilities;
- Ensured that any spaces identified as at risk of heat transfer from hot work are identified in the appropriate section of the job risk analysis beforehand;
- Raised awareness of correct identification of adjoining compartments/spaces in regard to hot work and heat transfer through bulkheads, decks, etc.;
- Double check (second pair of eyes) to identify any deck penetrations to improve spatial awareness;
- Ensure fire detection system is fully functional during hot work.
