## IMCA Safety Flash 04/17

### Shipyards Incidents and Failure to Assess Risk

#### 1 Crewman Struck and Injured by Forklift Truck

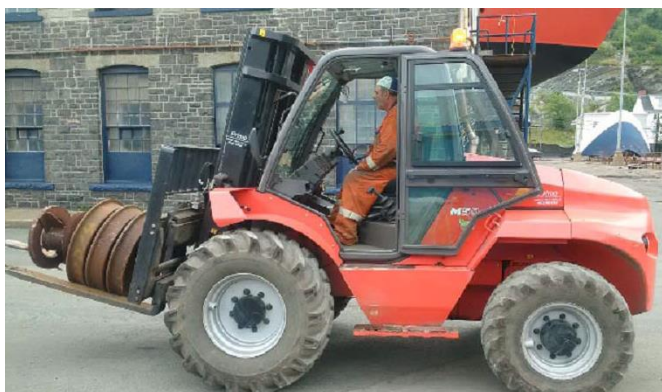
*Forklift of the kind in use at time of incident*

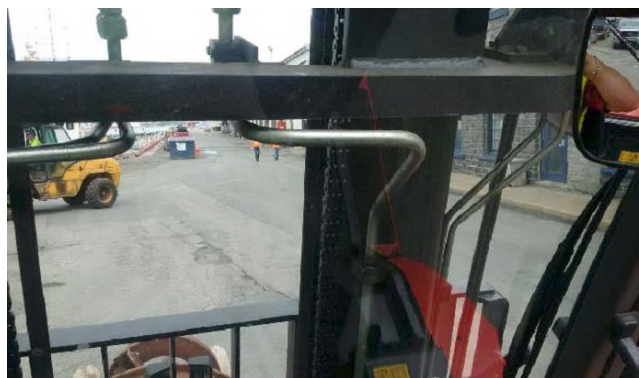
*Showing drivers view from inside cab – blind spot*

- ◆ The forklift operator reported that:
  - he did not see the injured person because of blind spots due to the design equipment
  - the blind spots were larger on this model of forklift than on other models in use at the yard;

- ♦ Shipyard to review CSA B335-15 *Safety Standard for Lift Trucks Section 4.5.5.2 (Traffic Management)* and adopt the recommendations made;
- ♦ Though it could not be determined that speed was a factor, limit the speed of the yard forklifts and other machinery to a maximum of 15km/hr;
- ♦ Recommend the shipyard release a bulletin highlighting the incident and inviting suggestions for improvement from their workforce.

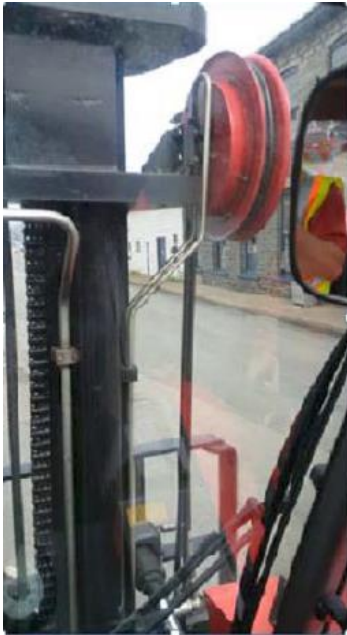
*View with forks straight and vertical*

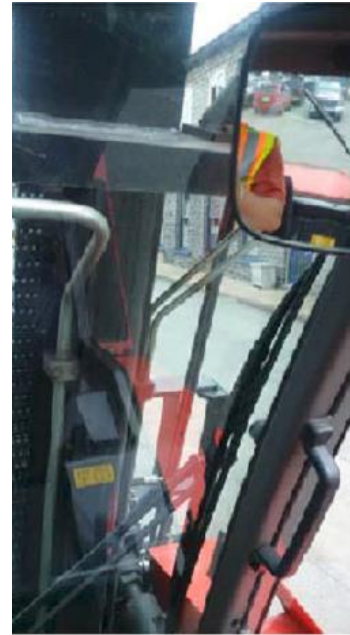
*View with forks tilted back during travel*
