IMCA Safety Flash 11/09

I Falling Object – Struck by Crane Stop/Striker Plate

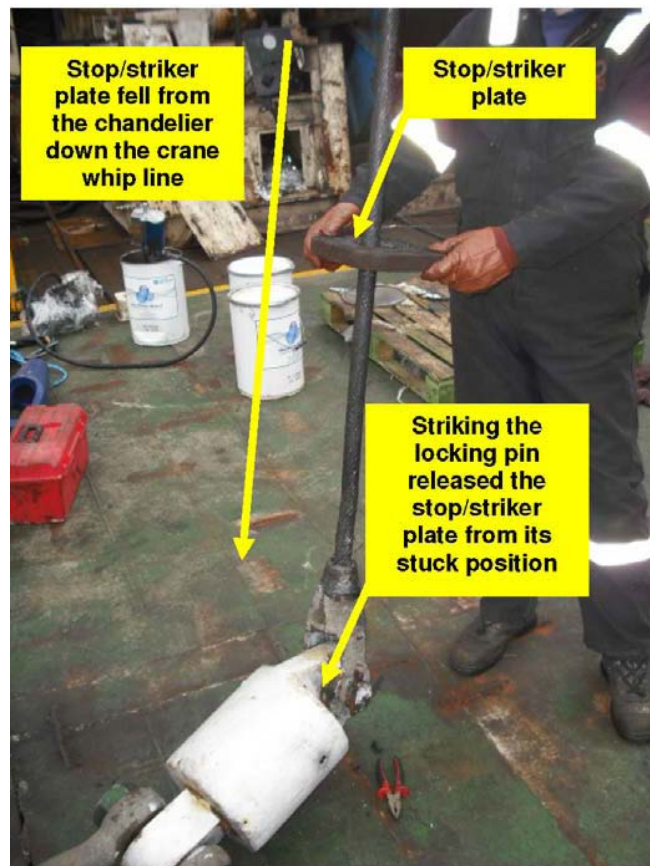
A member has reported an incident in which workers were struck by a falling crane stop/striker plate, causing injuries. Two third-party contractors were carrying out non-destructive testing (NDT), lubrication and cutting back vessel crane wires. Whilst one of the contractors was working on a whip line and removing the split pin, the stop/striker plate, weighing 5kg, fell from a stuck position against the chandelier and slid approximately 40m down the wire. One contractor sustained a fractured thumb, the other a minor first aid injury.

Stop/striker plate

- ◆ The introduction of stop/striker plates had not been formally risk assessed, including the need for permanently fixing the plates into position;
- ◆ Little documented history existed for the design and installation of stop/striker plates;
- ◆ Associated task-based risk assessment and toolbox talk did not include information relating the existence of striker plates;
- ◆ Third parties were not advised about ongoing problems with stop/striker plates sticking at the chandelier;
- ◆ Safety observations previously raised regarding the possibility of stop/striker plates sticking to the chandelier had not been fully addressed;
- ◆ There was an additional person involved in the task, beyond that identified within the permit to work.
