## IMCA Safety Flash 02/09

February 2009

### 2 Schat Harding Product Awareness Notice – Free-Fall Lifeboat Hooks

Members are alerted to the attached 'Product awareness notice' issued by Schat Harding in relation to its free-fall hook, type FFH13.

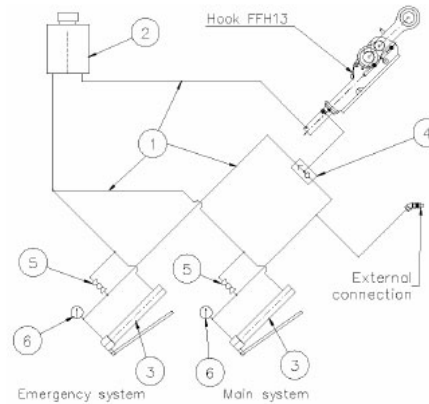
Fig.2

1. Hydraulic Hose
2. Hydraulic Tank
3. Hydraulic Pump
4. Alternating Valve
5. Ball Valve (Free-Fall valve)
6. Pressure Gauge 0-400 bar
