IMCA Safety Flash 02/14

February 2014

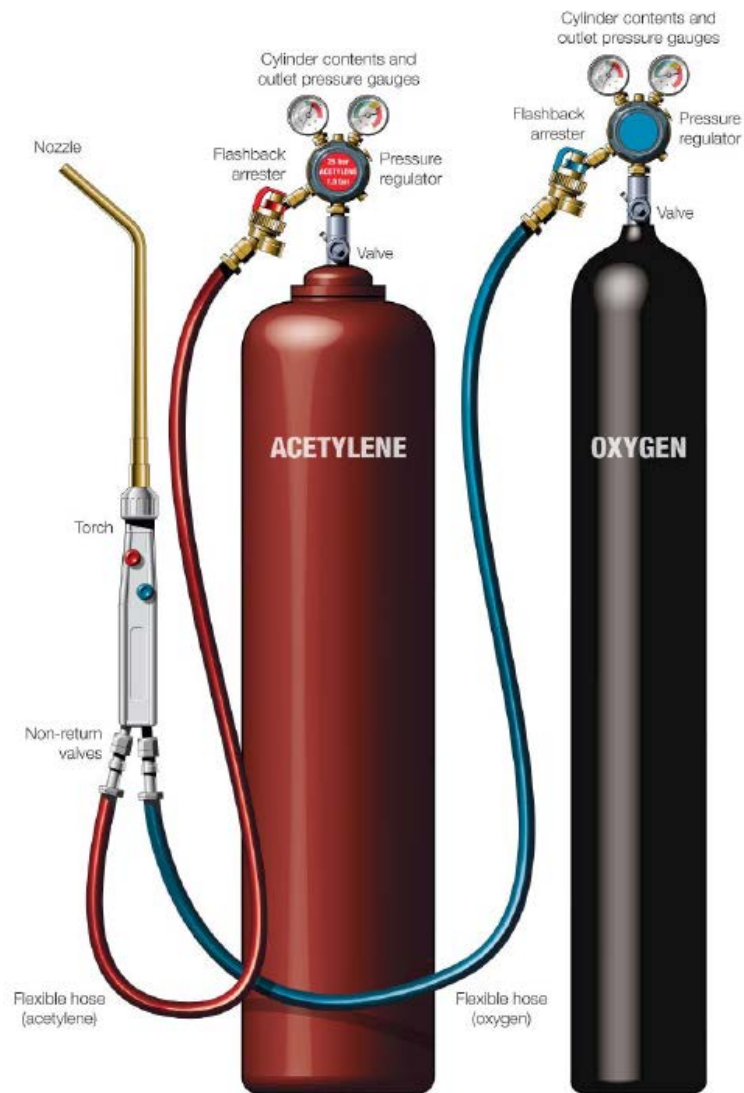
Figure: Showing correct set-up of Oxygen/Acetylene equipment

- ◆ All welding and cutting equipment should be inspected prior to use, including:
 - Condition of hoses any perished hoses should be replaced immediately

- Leak tested
 - Gauges are serviceable
 - All fittings are free from oil and grease contaminants
 - Ensure thread tape is not used on any connections
 - Bottle key in place on acetylene cylinder

- Cylinders securely stored upright
 - Bulk gas storage has a minimum separation of 3 meters.
