IMCA Safety Flash 04/09

I Burns Suffered in Confined Space

Understanding mooring incidents

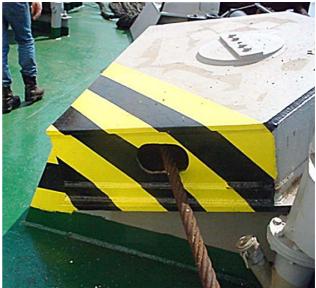
Hazard highlighting

Physical hazards to be highlighted should not be limited to bulkhead frames, mooring bits, pedestal fairleads and cleats. It should also include structures such as platforms at the windlass and hawse pipe covers.

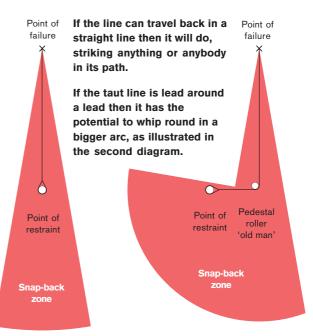
Highlighting mooring line snap-back zones ensures that crew can visibly see the danger areas without having to purposely think about them while working.

When a line under tension parts, it will whip back to the remaining point of tension.
