IMCA Safety Flash 05/15

April 2015

I Fatal Incident during Change-Out of Chain Wheel (Gypsy) on Anchor Handling Tug Supply (AHTS) Vessel

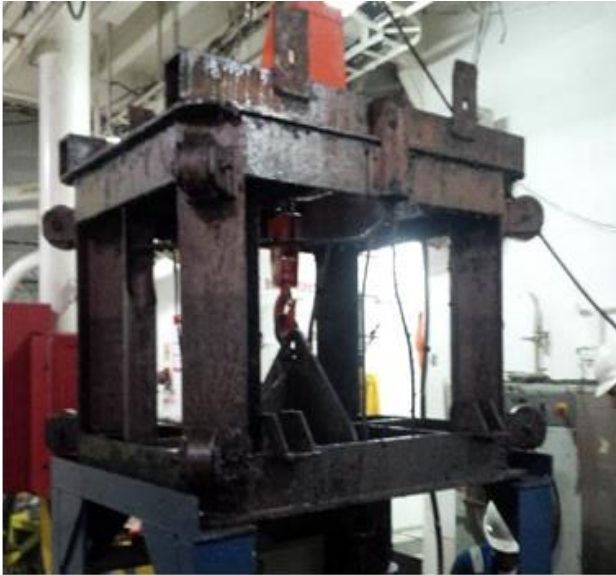
A member has reported an incident in which a chain hoist failed causing a 700kg load to fall into the moonpool. The incident occurred when crew were moving moonpool carriages and frames into position during mobilisation of multibeam echosounder equipment through the moonpool. The moonpool carriage was successfully positioned. As the crew lowered the second moonpool frame into position, the chain on the hoist crane suddenly parted and the frame and carriage fell into the moonpool damaging one of the stopper bars on the wall of the moonpool before being stopped by the other stopper bars.

Figure: Multibeam carriage before deployment to moonpool

- ◆ Update annual load test to include dye penetration test to check for unseen cracks on hoist chain;
- ◆ Update procedures and JSA for moonpool activity;
- ◆ Replace hoist and chain and repair stopper bar inside moonpool;
- ◆ Defective chain sent to certified third party testing for examination of strains caused by overstressing.

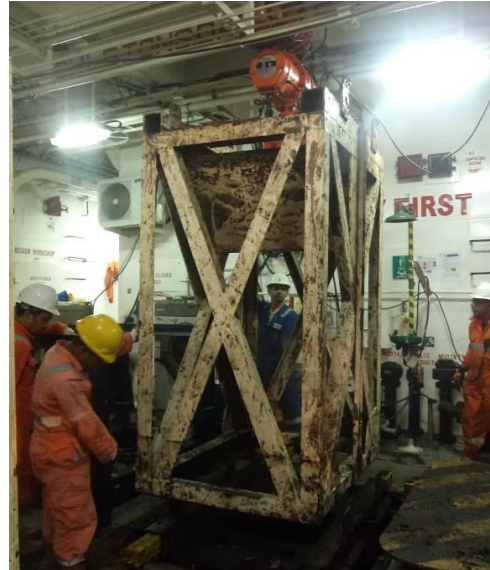
Figure: Frame before deployment to moonpool, attached to multibeam carriage underneath
