IMCA Safety Flash 05/19

March 2019

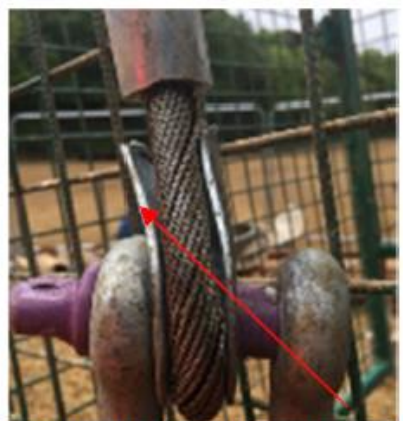
During drilling operations on a land-based drilling rig, the thimble within the hard eye of the winch wire momentarily caught (snagged) on the edge of the drill rig chassis. It then released in an uncontrolled manner very close to the driller. The incident occurred when the driller found it necessary to raise the drill mast, resulting in the winch wire being pulled upwards. As the winch wire was pulled up, the thimble caught on the edge of the drill rig chassis. The driller failed to notice that the winch wire had become snagged and continued to raise the mast, thus continuing to increase the tension in the wire until the steel thimble bent, causing the wire and attached hoist plug to release in an uncontrolled manner.

Damage sustained to chassis and steel winch wire thimble

The sudden and uncontrolled release of the winch wire and the attached hoist plug had the potential to cause significant personal injuries had it struck a member of the drill crew.

- ◆ Failure to identify and recognise snagging hazard;
- ◆ Incipient complacency in what was seen as a 'routine' task.

- ◆ Investigate engineering/practical solution: retract the winch wire to a safe position when not in use; where this is not possible, lower the winch wire to a safe location away from all structures and other potential snagging hazards. Keep contained within a trip tray or bucket to prevent a tripping hazard;
- ◆ Highlight the importance of managing all lifting operations, including winch operations and awareness of complacency creeping into routine tasks;
- ◆ Review procedures and task risk assessments to ensure that the potential for lifting equipment (winch wires) becoming snagged is appropriately considered and mitigated. All control measures should be included;
- ◆ Careful check of potential snagging hazards before operation of the winch or the lowering/raising of the drill mast.
