IMCA Safety Flash 10/18

April 2018

1 Incorrectly Selected Oxygen Welding Gas Hose Bursts & Catches Fire

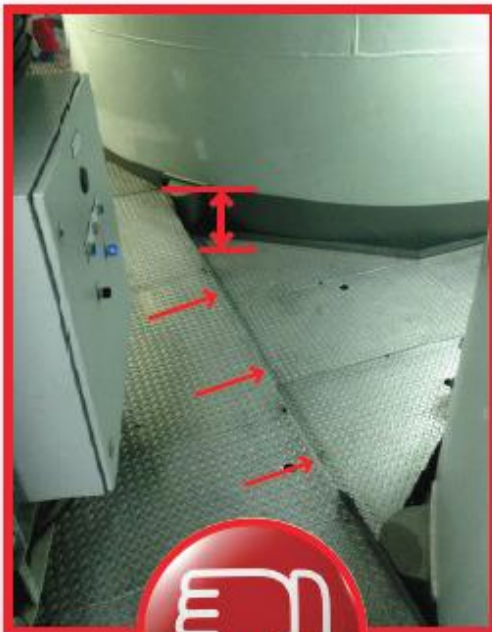
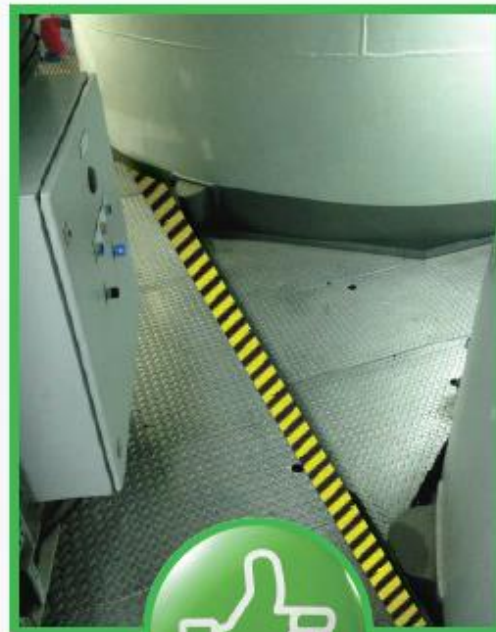
Edges and Ledges should be highlighted

Edges and ledges should be highlighted to avoid slips, trips, falls and impacts in all spaces.

Even the cleanest and best-maintained spaces may hide hazards - at first glance, there may appear to be no danger at all.

Always take measures to highlight hazards

Use any means available to temporarily highlight hazards (tape, warning signs etc.) until permanent markings can be applied or posted.

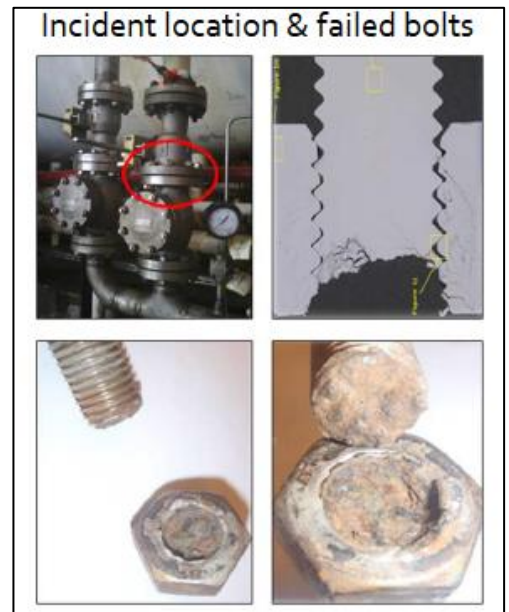
The International Association of Oil & Gas Producers (IOGP) has published [Safety Alert #297](#) relating to the unexpected failure of certain kinds of strain-hardened Type 304 stainless steel bolts, (ASTM A193 B8, Class 2). The failure occurred at an offshore facility during a pneumatic leak test of gas piping exiting a test separator. The bolts that failed were operating at temperatures below 50°C. The failure has been attributed to chloride-induced stress corrosion cracking (CISCC).

“strain-hardening austenitic stainless-steel nuts and bolts to increase their strength may increase their sensitivity to CISCC and reduce their safe upper temperature limit. Other factors such as aggressive environments (e.g. offshore and coastal facilities and areas exposed to wet deluge testing) and increased stress/strain may also increase susceptibility to CISCC.”

The IOGP’s intent in sharing this is to help mitigate the risk of such failures occurring elsewhere in new or existing facilities. The following corrective actions and recommendations were made:
