IMCA Safety Flash 14/18

July 2018

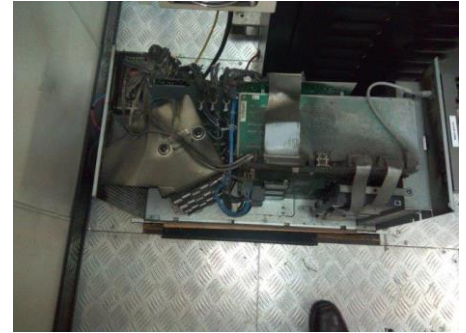
Operational guidelines for the equipment had not been followed. Planned maintenance procedures and manufacturer's instructions for maintenance of UPS should be followed at all times. The immediate cause of the incident in this case was wear and tear.

The risk of there being no UPS backup for the cargo valve control system, as a result of this kind of occurrence, should be taken into account.
